# Hurricane Katrina - What Happened? The Geology of the Katrina Disaster in New Orleans Field Trip Guide

August 2015

Stephen A. Nelson  
Department of Earth &  
Environmental Sciences  
Tulane University  
New Orleans, LA  
[snelson@tulane.edu](mailto:snelson@tulane.edu)

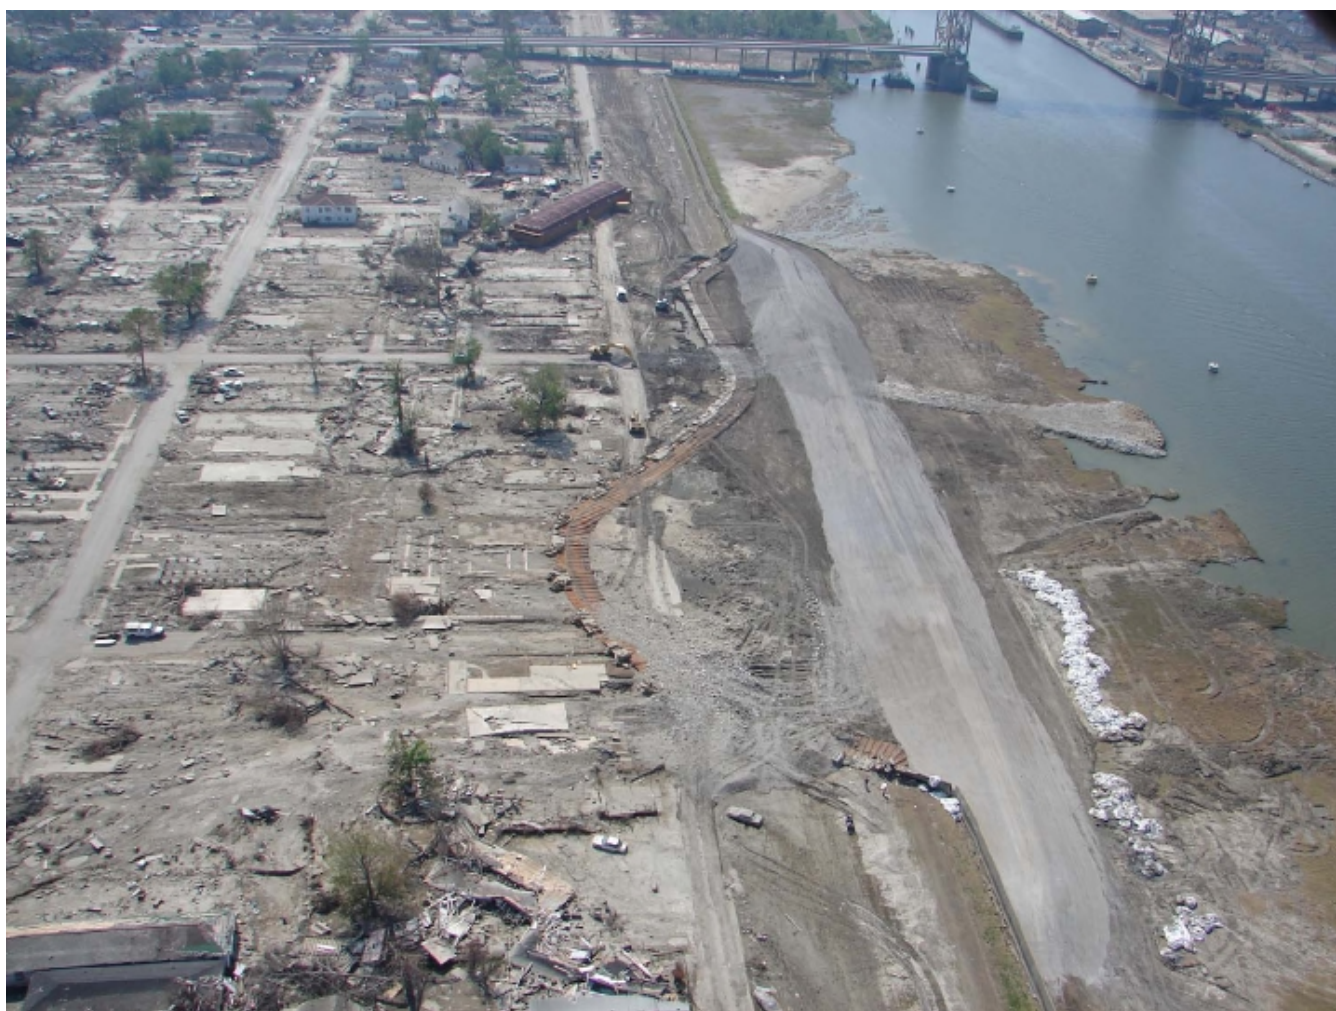
**Figure 14.** View of southern breach on the Industrial Canal, looking South. Note the floodwall and sheet piling (brown) strewn through the Lower Ninth Ward neighborhood where all houses were removed by the force of water coming through the breach. Gray deposits on right are breach repair gravels. Note barge near in the center near the top of the photo. Photo by L. Harder - Independent Levee Investigation Team Final Report (2006).

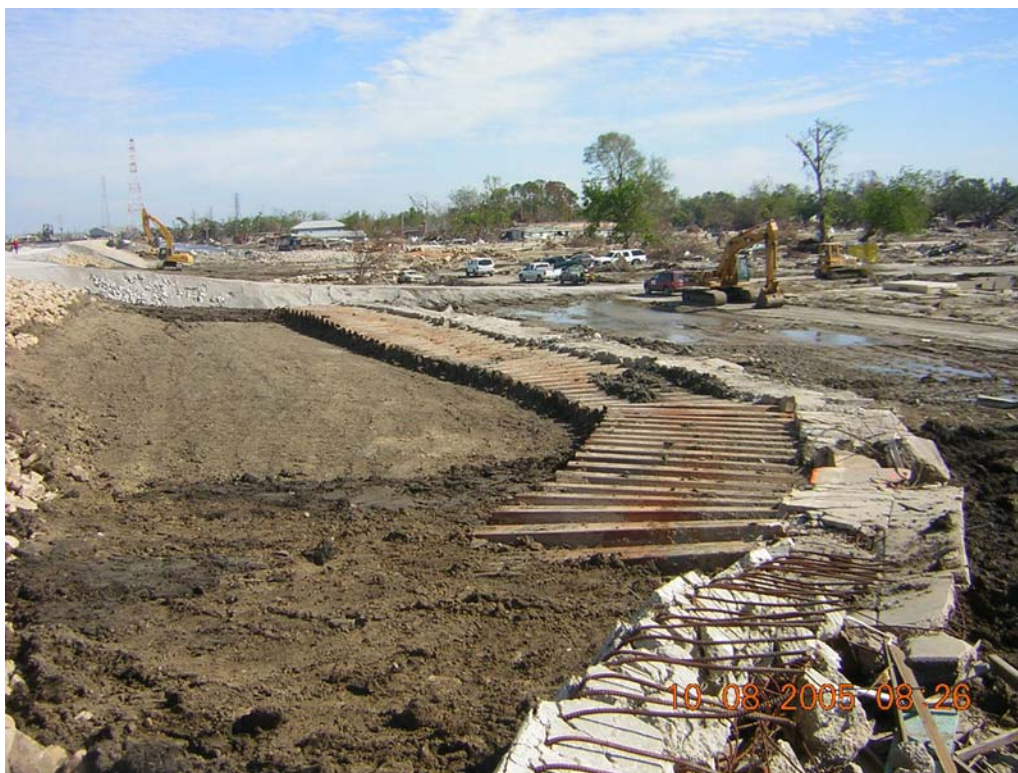
**Figure 15.** Floodwall and sheet piling strewn into Lower 9<sup>th</sup> Ward at the southern (larger) breach on the Industrial Canal. Photo from U.S. Army Corps of Engineers IPET web site.

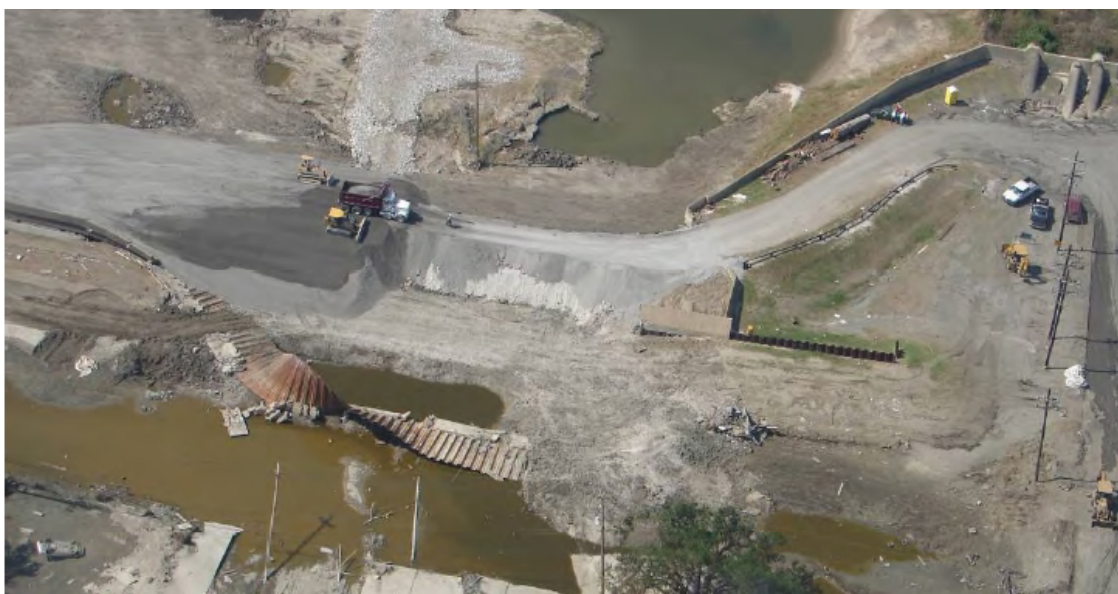
**Figure 16.** Aerial view of the north breach on Industrial Canal. Photo by L. Harder - Independent Levee Investigation Team Final Report (2006).

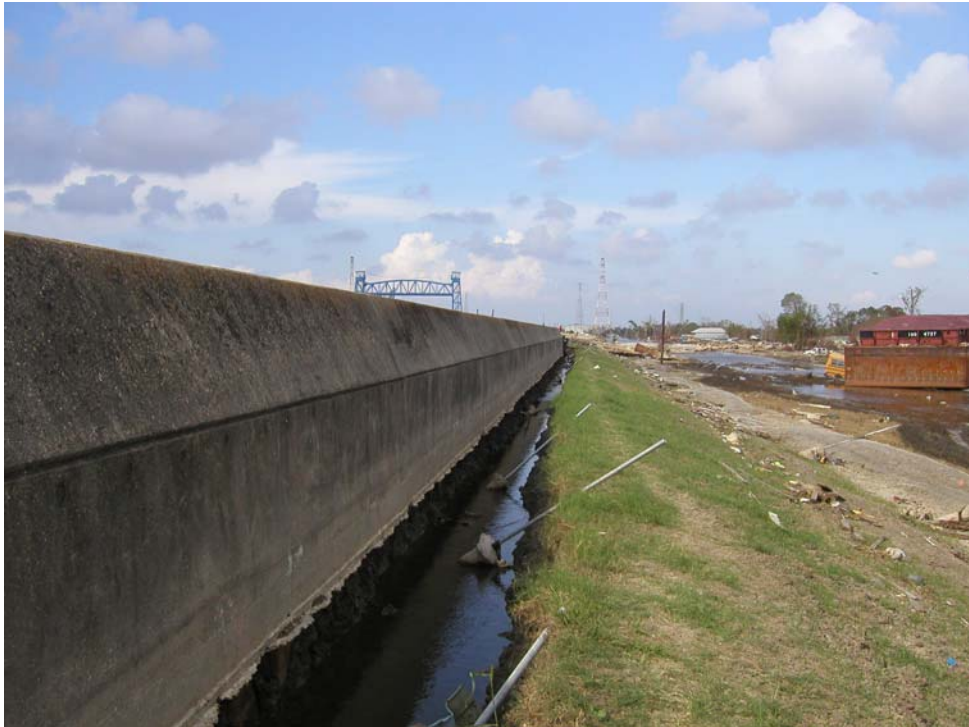
Photographs available on the U.S. Army Corps of Engineers, Interagency Performance Evaluation Task Force (IPET) web site and reproduced in Figure 17, show that along portions of the floodwall that did not fail, water flowing over the top of the floodwall eroded trenches on the protected side of the levee. It is likely that this could have removed enough support on the protected side that the floodwalls and their underlying sheet piling eventually toppled into the protected side of the canal sending a huge surge of water into the Lower 9<sup>th</sup> Ward.

**Figure 17.** Looking North along the floodwall of the Industrial Canal levee showing trenches eroded by water from the Industrial Canal that overtopped the floodwall. Breached section is just beyond the barge and barely discernable in this view. Florida Avenue Bridge (blue) in upper center. Photo from U.S. Army Corps of Engineers IPET web site, taken October 4, 2005.

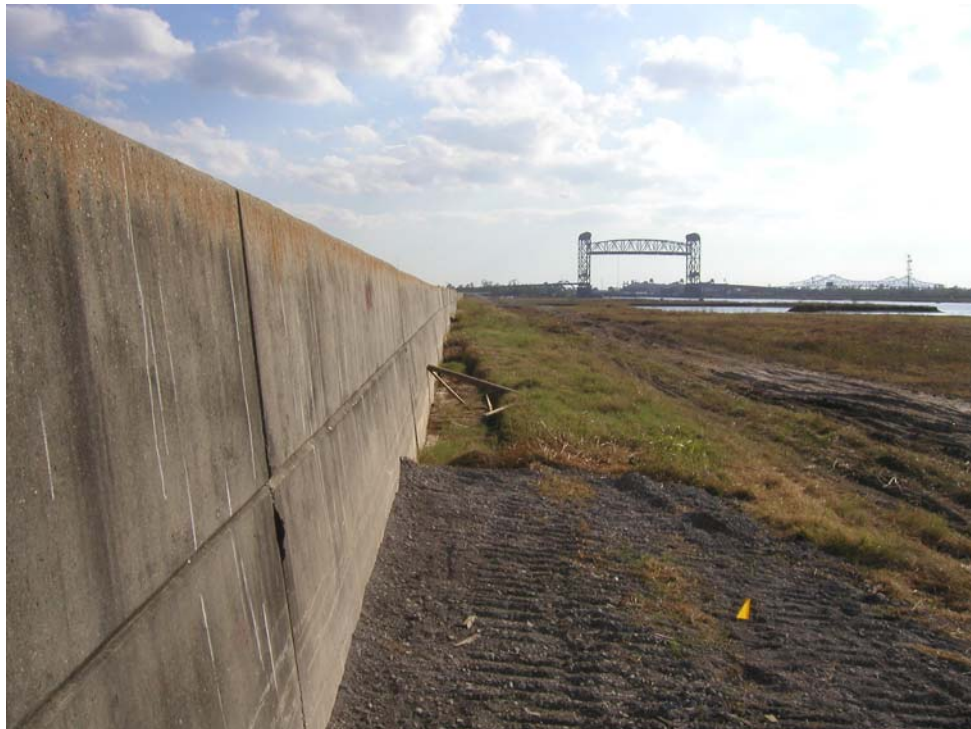
**Figure 18.** Looking South along the floodwall of the Industrial Canal on the inside of the floodwall between the two breaches showing the floodwall leaning toward the left (east) with a block of the levee next to the floodwall dropped down (near center of picture). Claiborne Ave. Bridge in right center. Photo from U.S. Army Corps of Engineers IPET web site, taken October 4, 2005.

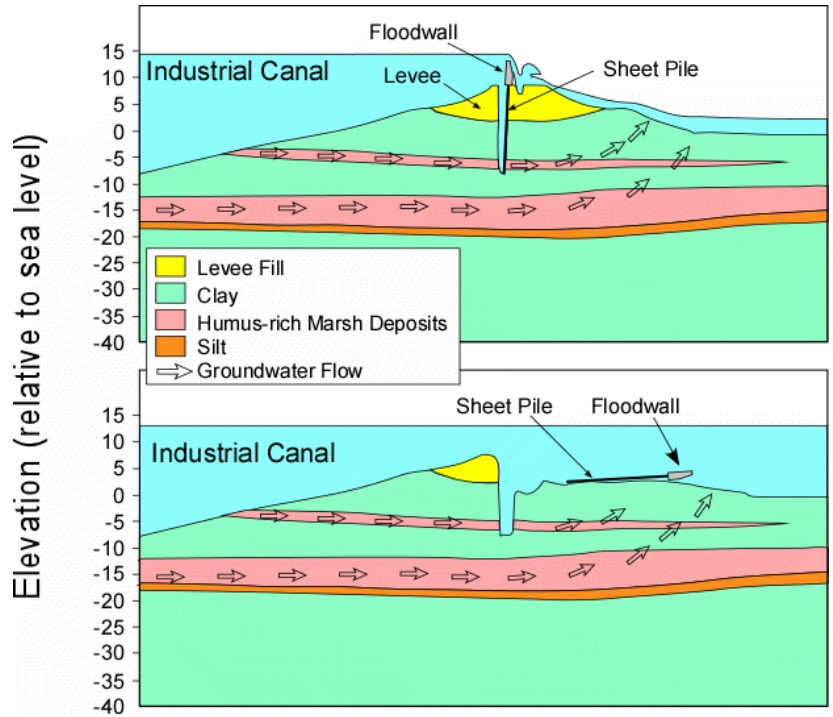
The Interagency Performance Evaluation Task Force (IPET, 2006) agreed that the main cause of failure here was the result of the surge waters in the Industrial Canal overtopping the floodwall and eroding away the levee on the protected side, but the Independent Levee Investigation Team (ILIT, 2006) suggests another cause. They do agree that erosion of the levee on the protected side could have contributed, but their analysis indicates that the geological conditions present in the subsurface along with the shallow depth to the tip of the sheet pilings resulted in hydraulic piping beneath the sheet pilings which undermined the levee and caused it and the floodwall to collapse. Two layers of highly permeable marsh deposits occur at a shallow depth below the levee (Fig. 21). According to the analysis of ILIT (2006), the added pressure in the canal forced water through these permeable layers and out at the toe of the levee on the protected side, thus removing support for the floodwall and levee.

**Figure 21.** Possible failure mechanism at the Industrial Canal Levee breach in near the Lower 9<sup>th</sup> Ward

At Stop 1 in the Lower 9<sup>th</sup> Ward, one now sees that the entire floodwall between the two bridges (Claiborne to the south and Florida Avenue to the North – the blue colored bridge) has been replaced with a T-wall with a top elevation at 14.5 feet above sea level, the level it was supposed to have attained prior to Katrina. This new floodwall was completed in mid-June, 2006. The original I-wall is still present along the other side of the Industrial Canal as well as to the south and north of the new T-wall. The only improvement made to the levees where the I-walls still exist is concrete armoring has been added to the base of the I-wall to prevent the erosion of the levee should water come over the top of the wall again.

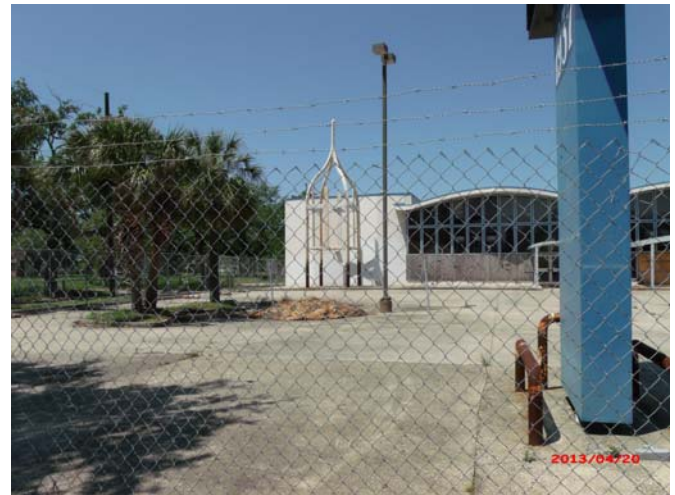
**Figure 26.** Church at the corner of St. Anthony and Mirabeau showing the standing water line and rusted church steeple.

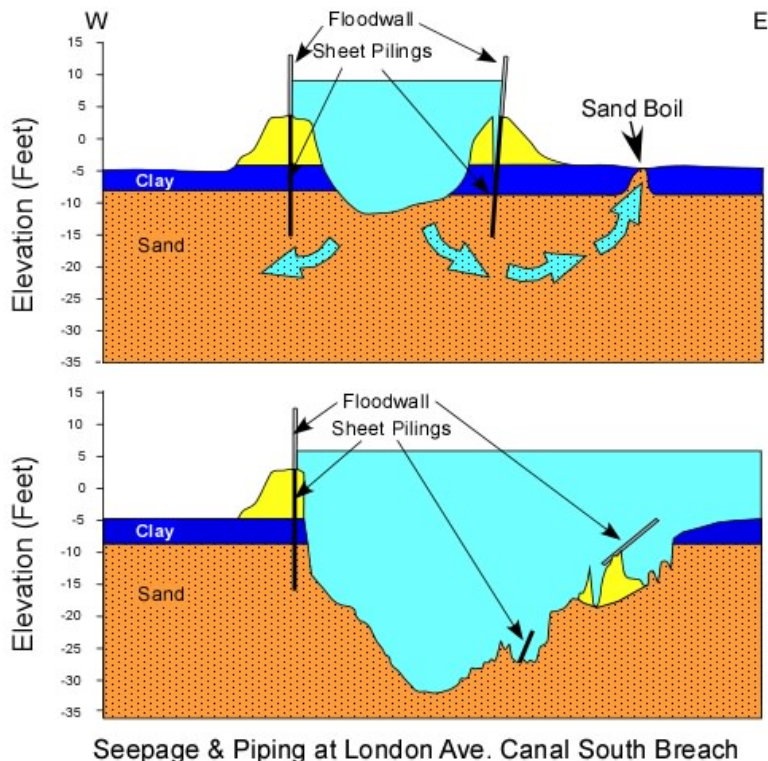
**Figure 32.** Geological cross section across the London Ave. Canal based on borings 16 and 51 (Figs. 29 and 36), shown at time of estimated high water during Katrina’s storm surge. The sands form a permeable layer through which groundwater originating in the canal can penetrate and move below the sheet pilings and up to the surface (top diagram), eventually undermining the levee and causing a blowout completely removing a section of levee and carrying sand into the neighborhood. The shape of the canal bottom is based on depth soundings undertaken by the U.S. Army Corps of Engineers on September 5, 2005.

The repair operation has only been done in the area of the breach. The operation involved digging out the material used in the initial emergency repair, filling it with clay and construction a T-wall to replace the missing I-wall. Fortunately, the Corps of Engineers has now completed removable floodgates near the mouths of the London Ave, Orleans, and 17<sup>th</sup> St. canals near Lake Pontchartrain (Stop 6). These floodgates are closed in the event of a hurricane and prevent storm surge from reaching onto the floodwalls in the canals. If the gates are closed, however, the pumps at the southern end of the canals cannot be used to pump rainwater out of the city. Thus, the Corps has built pumping stations near the Lake (where they should have been built in the first place), but full pumping capacity is not yet available. Still rainwater flooding is better than having Lake Pontchartrain drain into the city. The Corps has also driven additional sheet piles along the canal banks to further stabilize the floodwalls and prevent any underseepage.

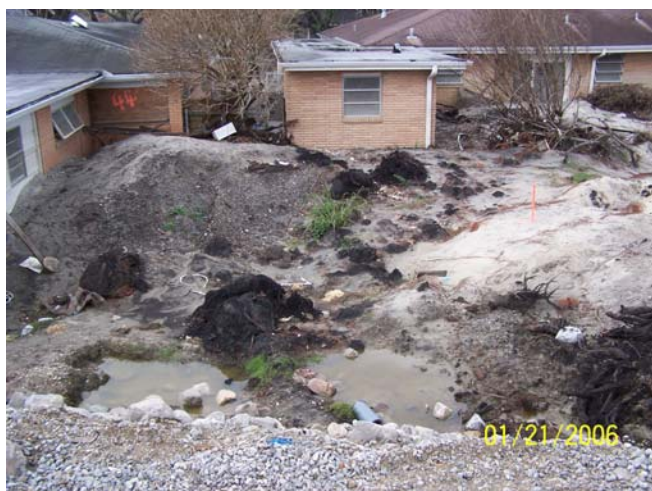
After the water was drained from the area, deposits of sand along with blocks of peat were observed to have filled the street and the backyards of houses along Pratt Drive (Figs. 39 and 40). The sand deposits were similar to the ones observed at the Mirabeau Ave. breach, but also contain blocks of peat as expected from the geologic cross section shown in Figure 36. The sand was not as extensive as the deposits at the southern Mirabeau breach, only reaching a thickness of about 3 feet, and only filling the street in front of the breach, but not extending into the back yards of houses on the other side of the street.

**Figure 39.** Sand deposits and peat blocks (black) behind homes on Pratt Drive at the North breach of the London Ave. Canal. Note the sand boil on the right. Gray material in the foreground is gravel used in the repair of the breach.

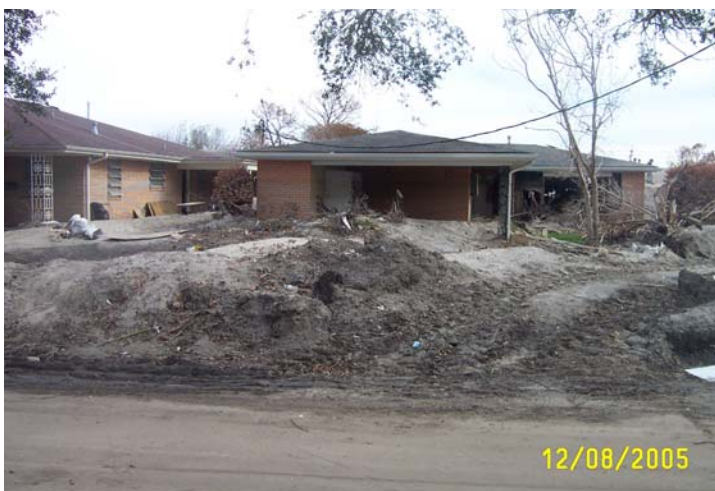
**Figure 40.** Sand deposits in front of houses on Pratt Drive at the North breach of the London Ave. Canal.

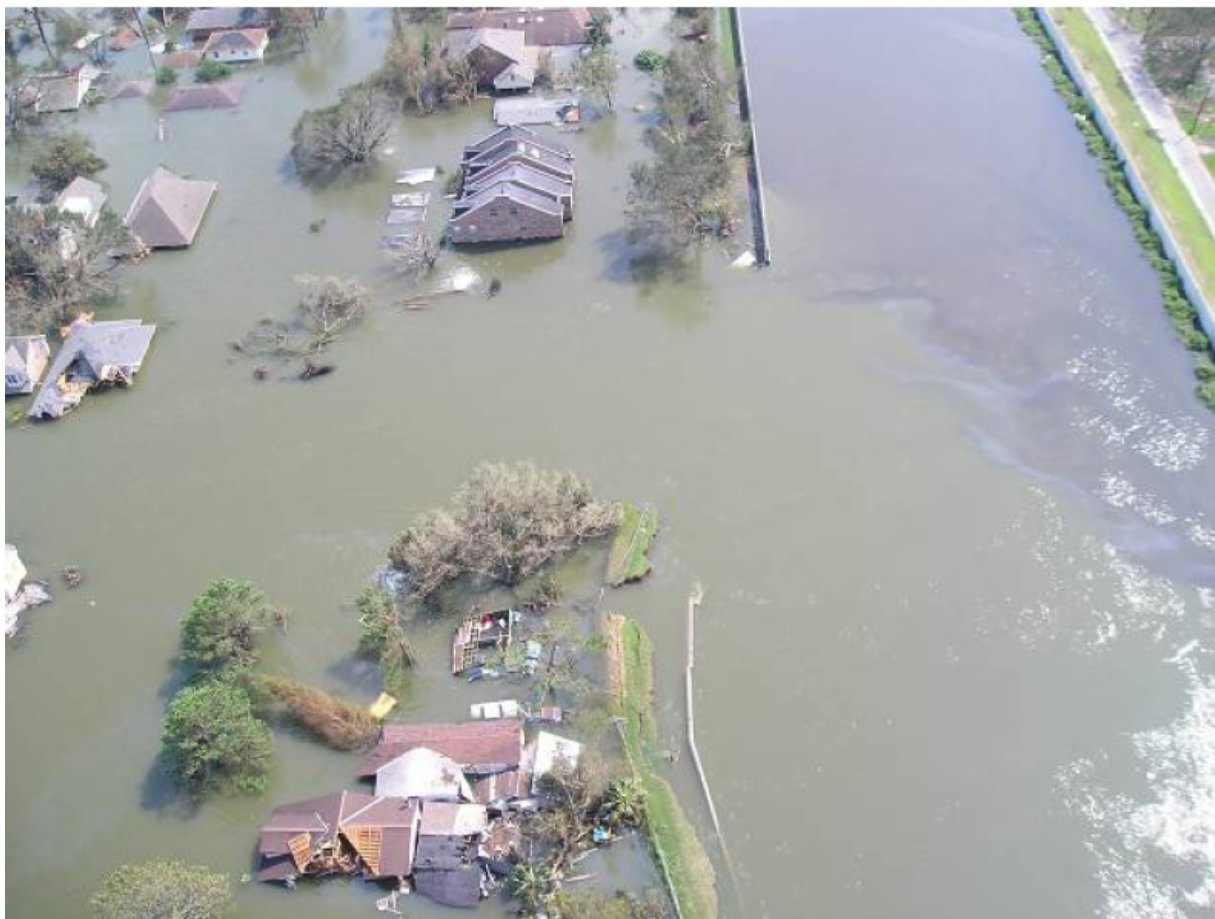
**Figure 43.** View of 17<sup>th</sup> St. Canal breach looking toward south. Note displaced floodwall and levee just below the missing section of the levee. Photo from IPET Report .

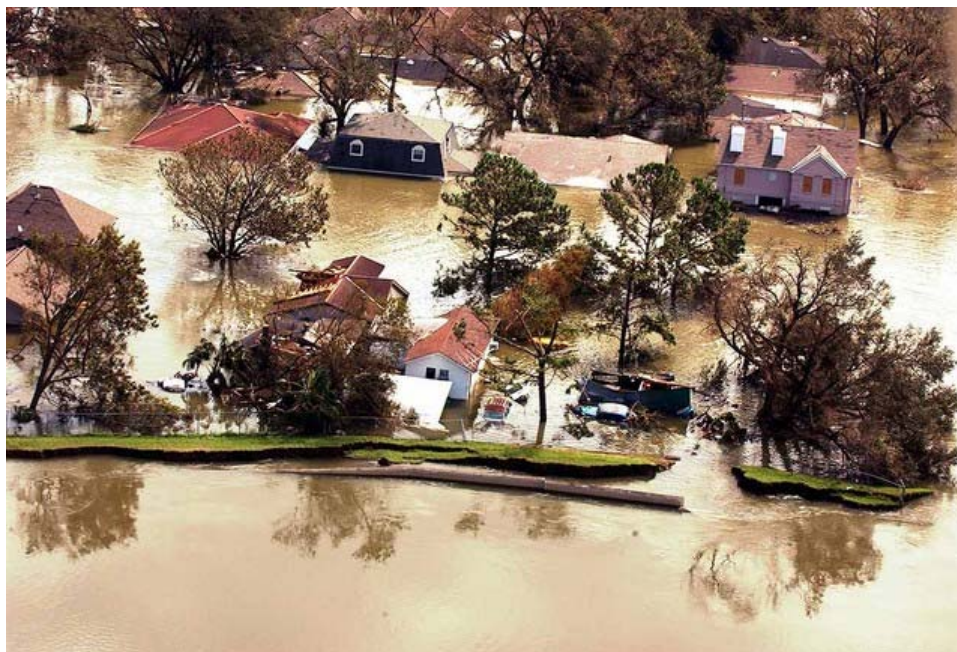
**Figure 44.** View of 17<sup>th</sup> St. Canal breach looking toward east. Note fractures in the displaced part of the levee. Photo by J. Augustino FEMA.

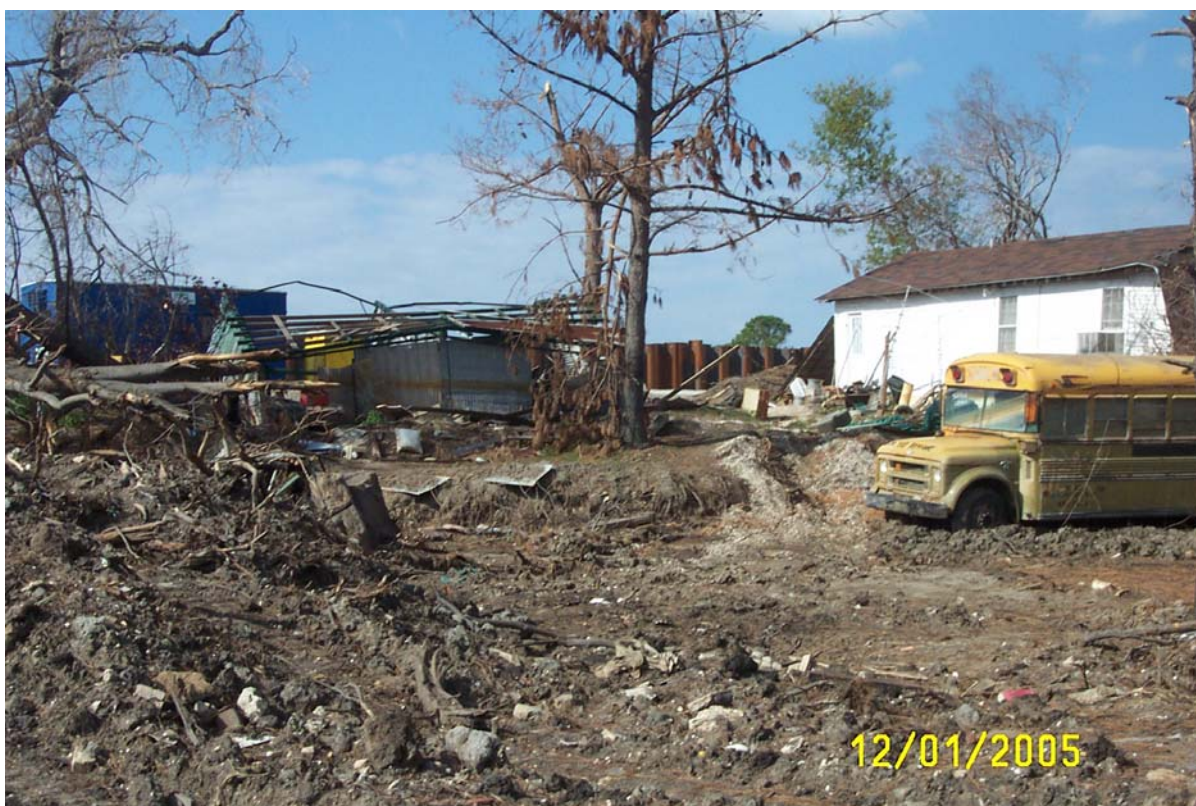
**Figure 45.** Slide toe (at abrupt change in slope in front of school bus) where levee and neighborhood were displaced about 45 feet toward the viewer.

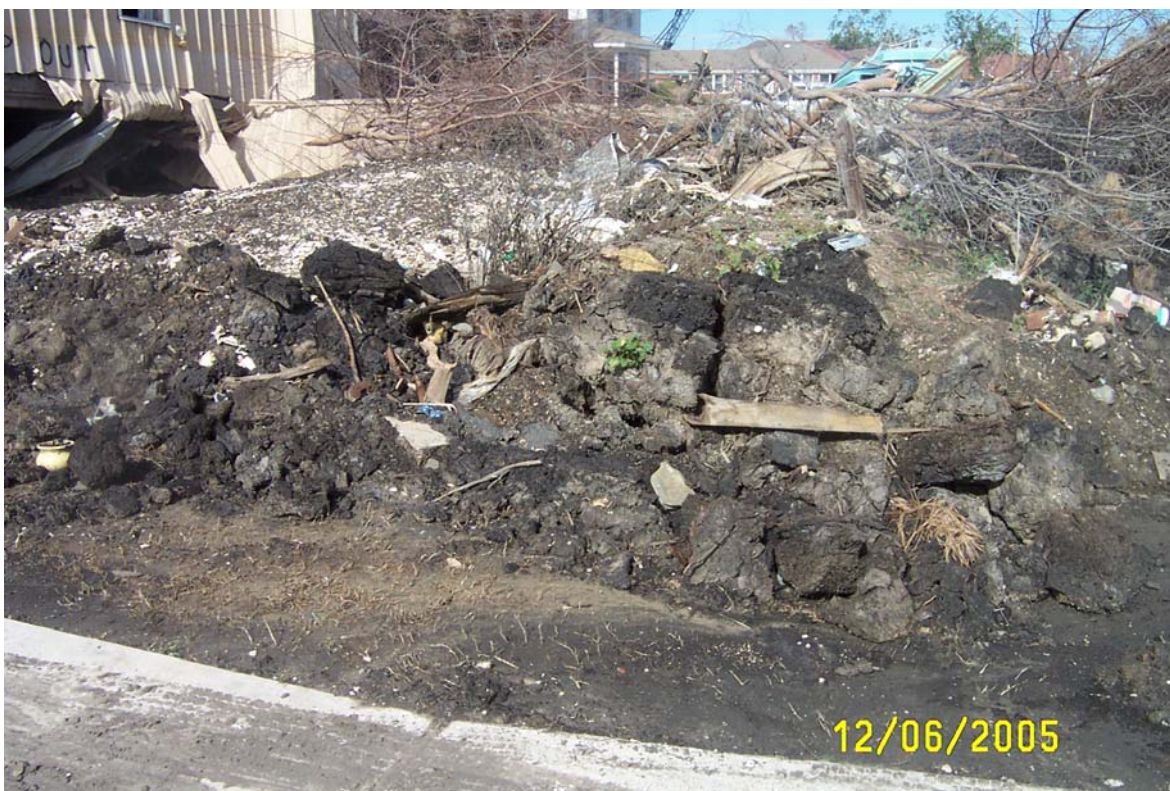
Before the debris was completely removed, large blocks of peat were present throughout the neighborhood, some of which could be found a block away to the east near Fleur de Lis Blvd. Examples of the peat blocks before their removal can be seen in Figure 46 and the upper right photograph in Figure 51.

**Figure 46.** Blocks of Peat along Belaire Drive near the 17<sup>th</sup> St. Canal levee breach

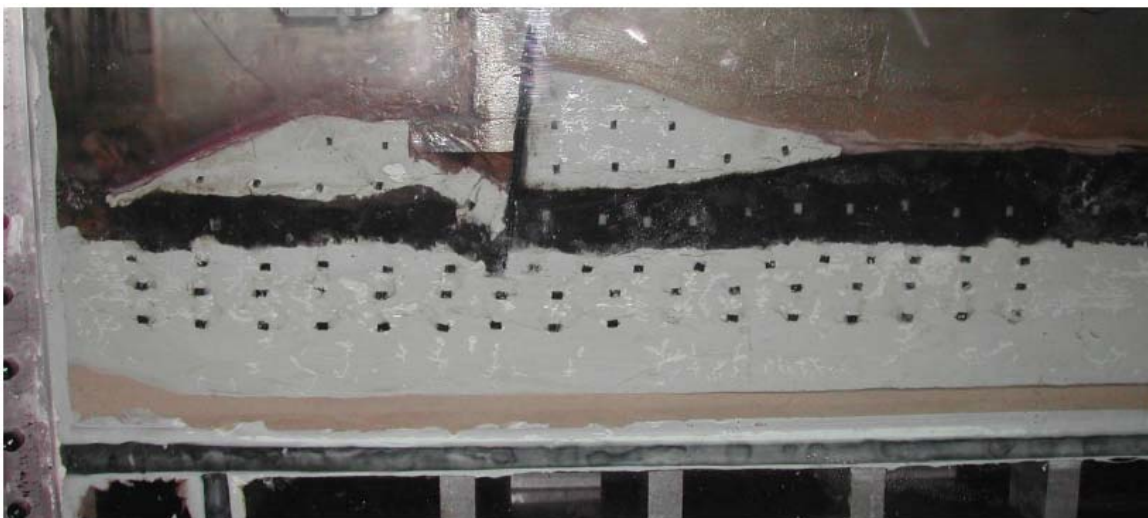
**Figure 49.** Photograph of failed levee and floodwall in IPET's scale model centrifuge experiment representing the 17<sup>th</sup> St. Canal. The white at the top is clay and represents the levee. This overlies the dark peat layer, which in turn overlies another white clay layer meant to represent the estuary deposits beneath the peaty marsh deposits. Small rectangles were initially laid out in a rectangular grid and can be used to determine how much deformation has occurred during the experiment. (IPET, 2006).

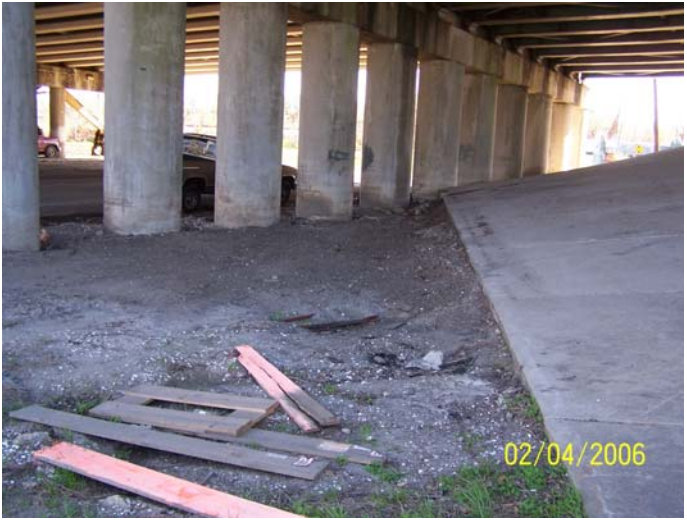
**Figure 54.** Erosion around the support structures for I-610 near Orleans Canal on Marconi Ave (Stop 9).
