Hurricane Katrina - What Happened?

Tulane University
Field Trip
1 Year Anniversary Edition
August 29, 2006

Levee Breaches in New Orleans during Hurricane Katrina

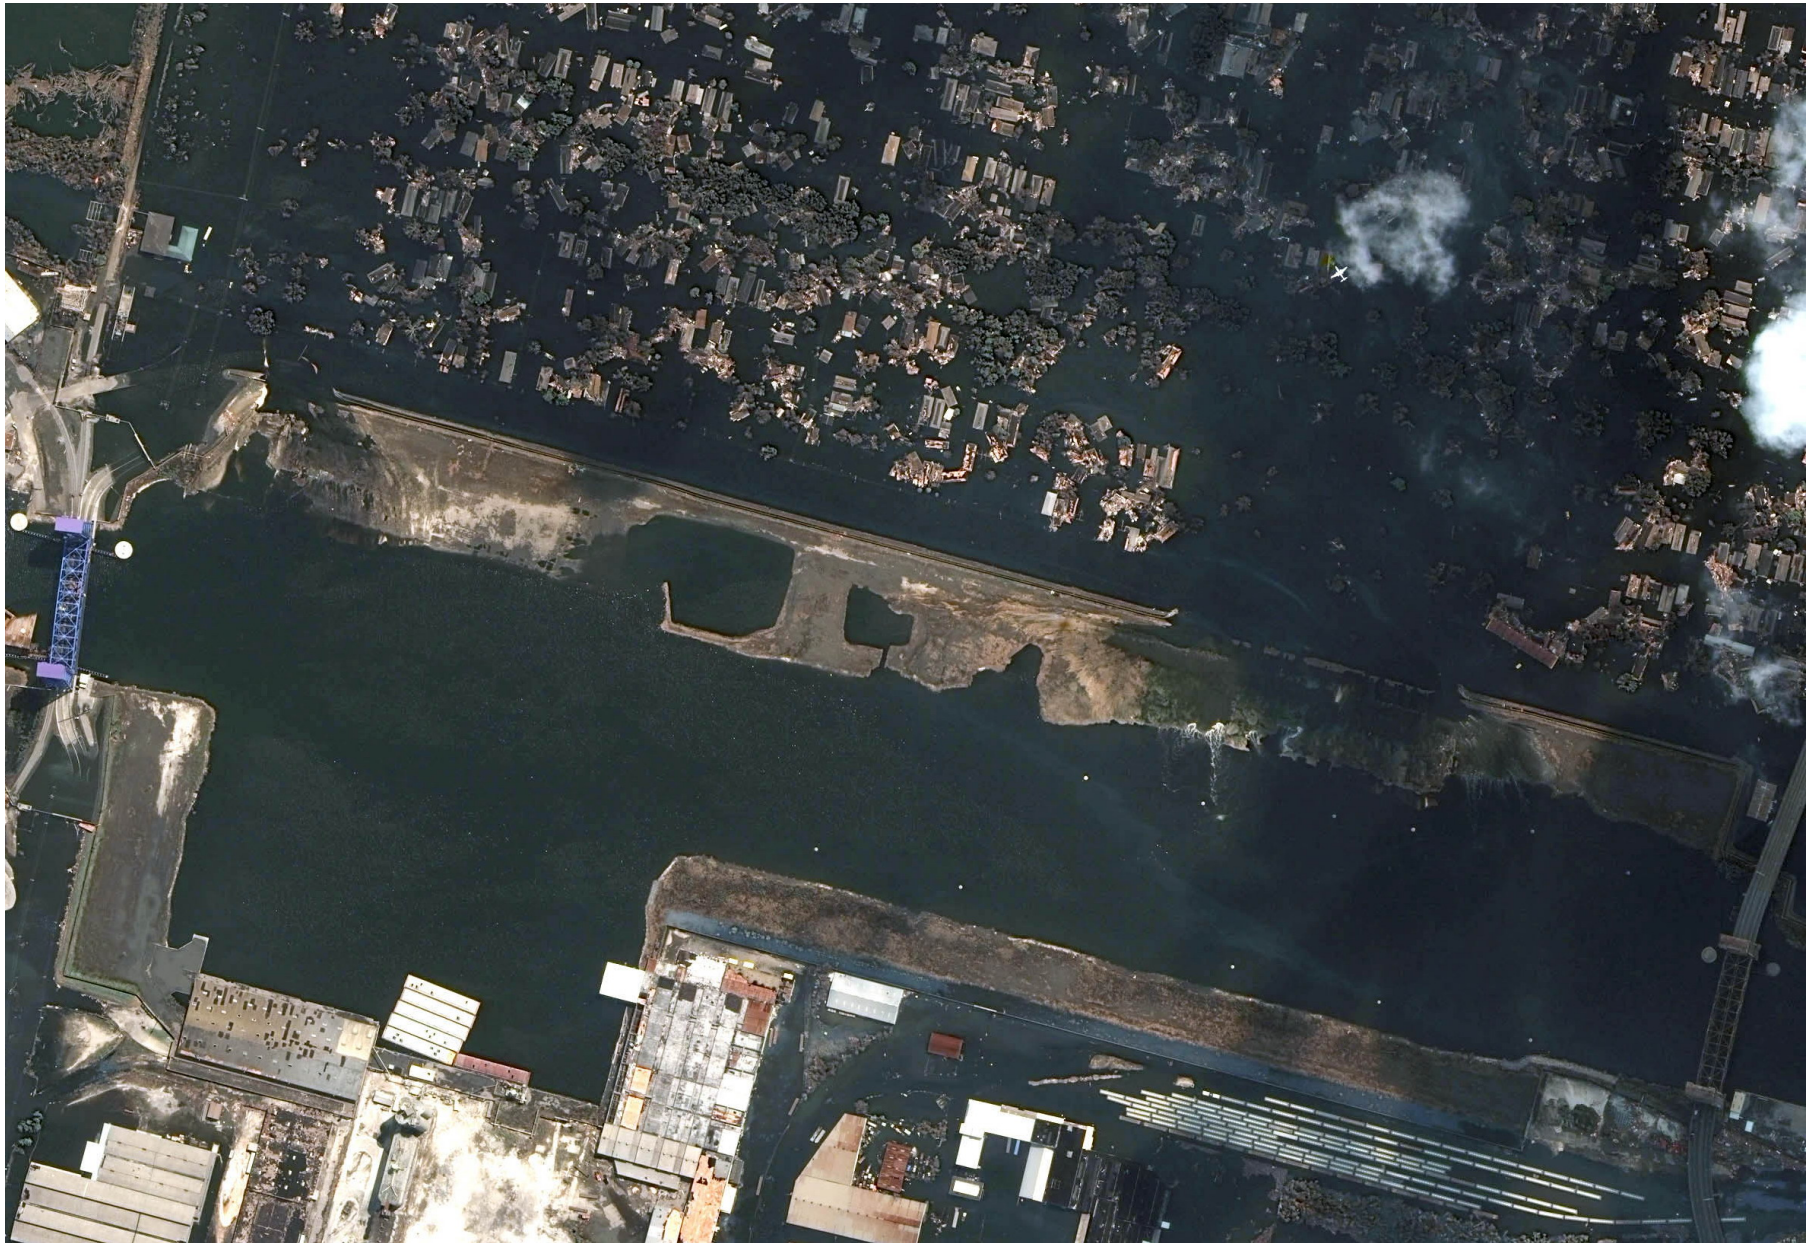
Photographs available on the U.S. Army Corps of Engineers, Interagency Performance Evaluation Task Force (IPET) web site and reproduced in Figure 11, show that along portions of the floodwall that did not fail, water flowing over the top of the floodwall eroded trenches on the protected side of the levee. It is likely that this erosion could have removed enough support on the protected side that the floodwalls and their underlying sheet piling eventually toppled into the protected side of the canal sending a huge surge of water into the Lower 9th Ward. Levee/Floodwall failures occurred at two places along the Industrial Canal levee. The longer breach (approximately 1,000 feet long) occurred between N. Galvez and N. Roman Streets (Figures 8, 10, & 13). The shorter (about 200 foot-long) breach occurred just to the south of Florida Avenue (Figures 10 & 14).

In both cases, all houses were removed in the areas immediately in front of the breaches (Figures 10, 12, 13 & 15) and in areas between the breaches the rush of water was forceful enough to lift houses off their foundations and float them around until they collided with other houses and either came to rest or broke apart to form piles of rubble (Figure 10). The floodwall and underlying sheet pilings were strewn into the first few blocks of the Lower 9th Ward like a ribbon (Figures 12, 13, and 14).

Figure 10. Air photograph of the area where the Industrial Canal Levee was breached to flood the Lower Ninth Ward. Image acquired Sept. 3, 2005
Source: National Oceanic and Atmospheric Administration's National Geodetic Survey, Katrina Images - <http://ngs.woc.noaa.gov/katrina/>

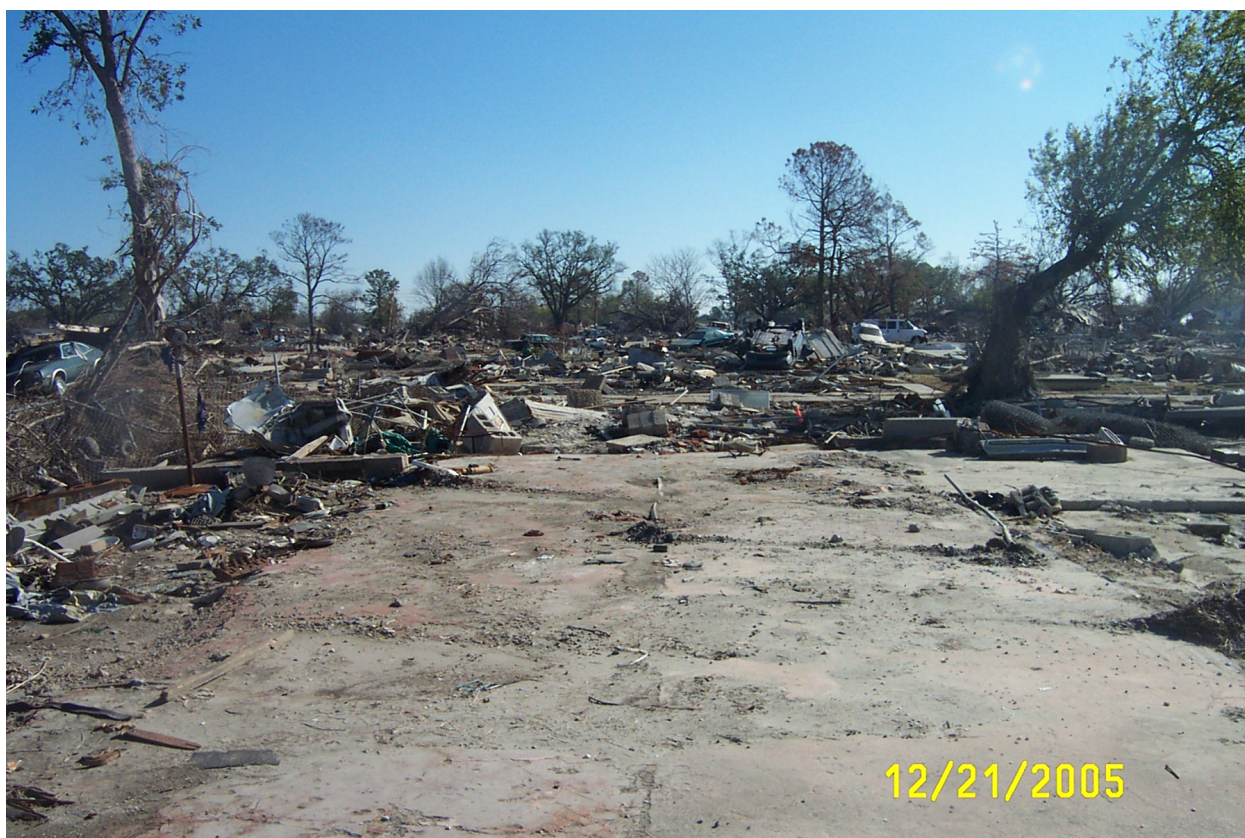
Figure 15. View of Lower Ninth Ward looking East as it appeared in December, 2005.

From Stop 1, we will proceed to the North passing through the part of the Lower Ninth Ward between the two levee breaches. Note that in general, homes built on slab foundations were not moved by the force of the flood waters in this part of the neighborhood. Homes built on pier foundations, however, were, in almost all cases lifted off their foundations and floated around the neighborhood. Note also that debris deposited on the roofs of single story homes indicates that the maximum of depth of the flood water was in excess of the roof line. This contrasts with the standing water line left on the houses, which was at a much lower. At the north end of the neighborhood, note that nearly all structures were removed from the area to the east of the northern breach.

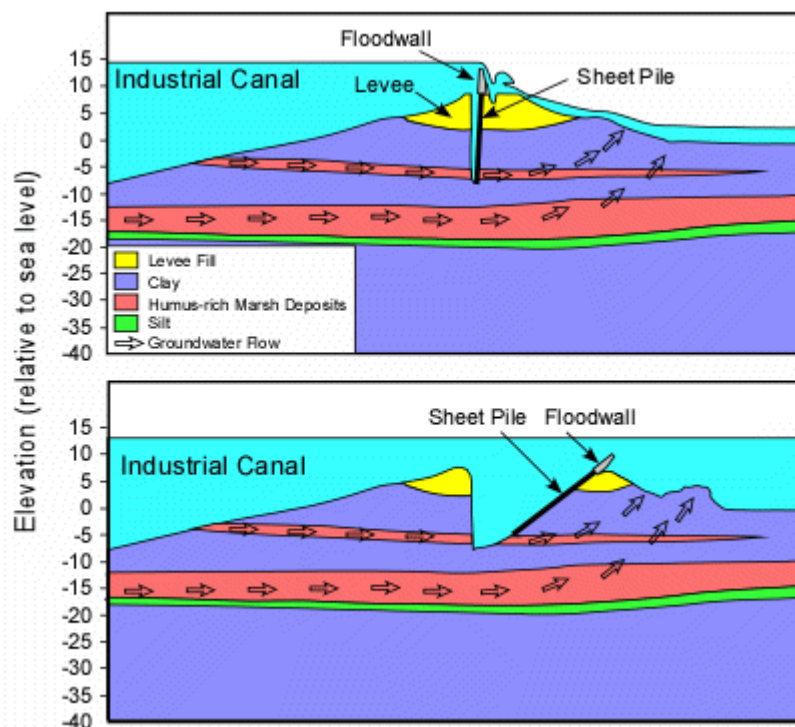
Although the Interagency Performance Evaluation Task Force (IPET, 2006) suggested that the main cause of failure here was the result of the surge waters in the Industrial Canal overtopping the floodwall and eroding away the levee on the protected side, the Independent Levee Investigation Team (ILIT, 2006) disputes this. They do agree that erosion of the levee on the protected side could have contributed, but their analysis indicates that the geological conditions present in the subsurface along with the shallow depth to the tip of the sheet pilings resulted in hydraulic piping beneath the sheet pilings which undermined the levee and caused it and the floodwall to collapse. Two layers of highly permeable marsh deposits occur at a shallow depth below the levee (Figure 16). According to the analysis of ILIT (2006), the added pressure in the canal forced water through these permeable layers and out at the toe of the levee on the protected side, thus removing support for the floodwall and levee.

Figure 16. Possible failure mechanism at the Industrial Canal Levee breach in near the Lower 9th Ward

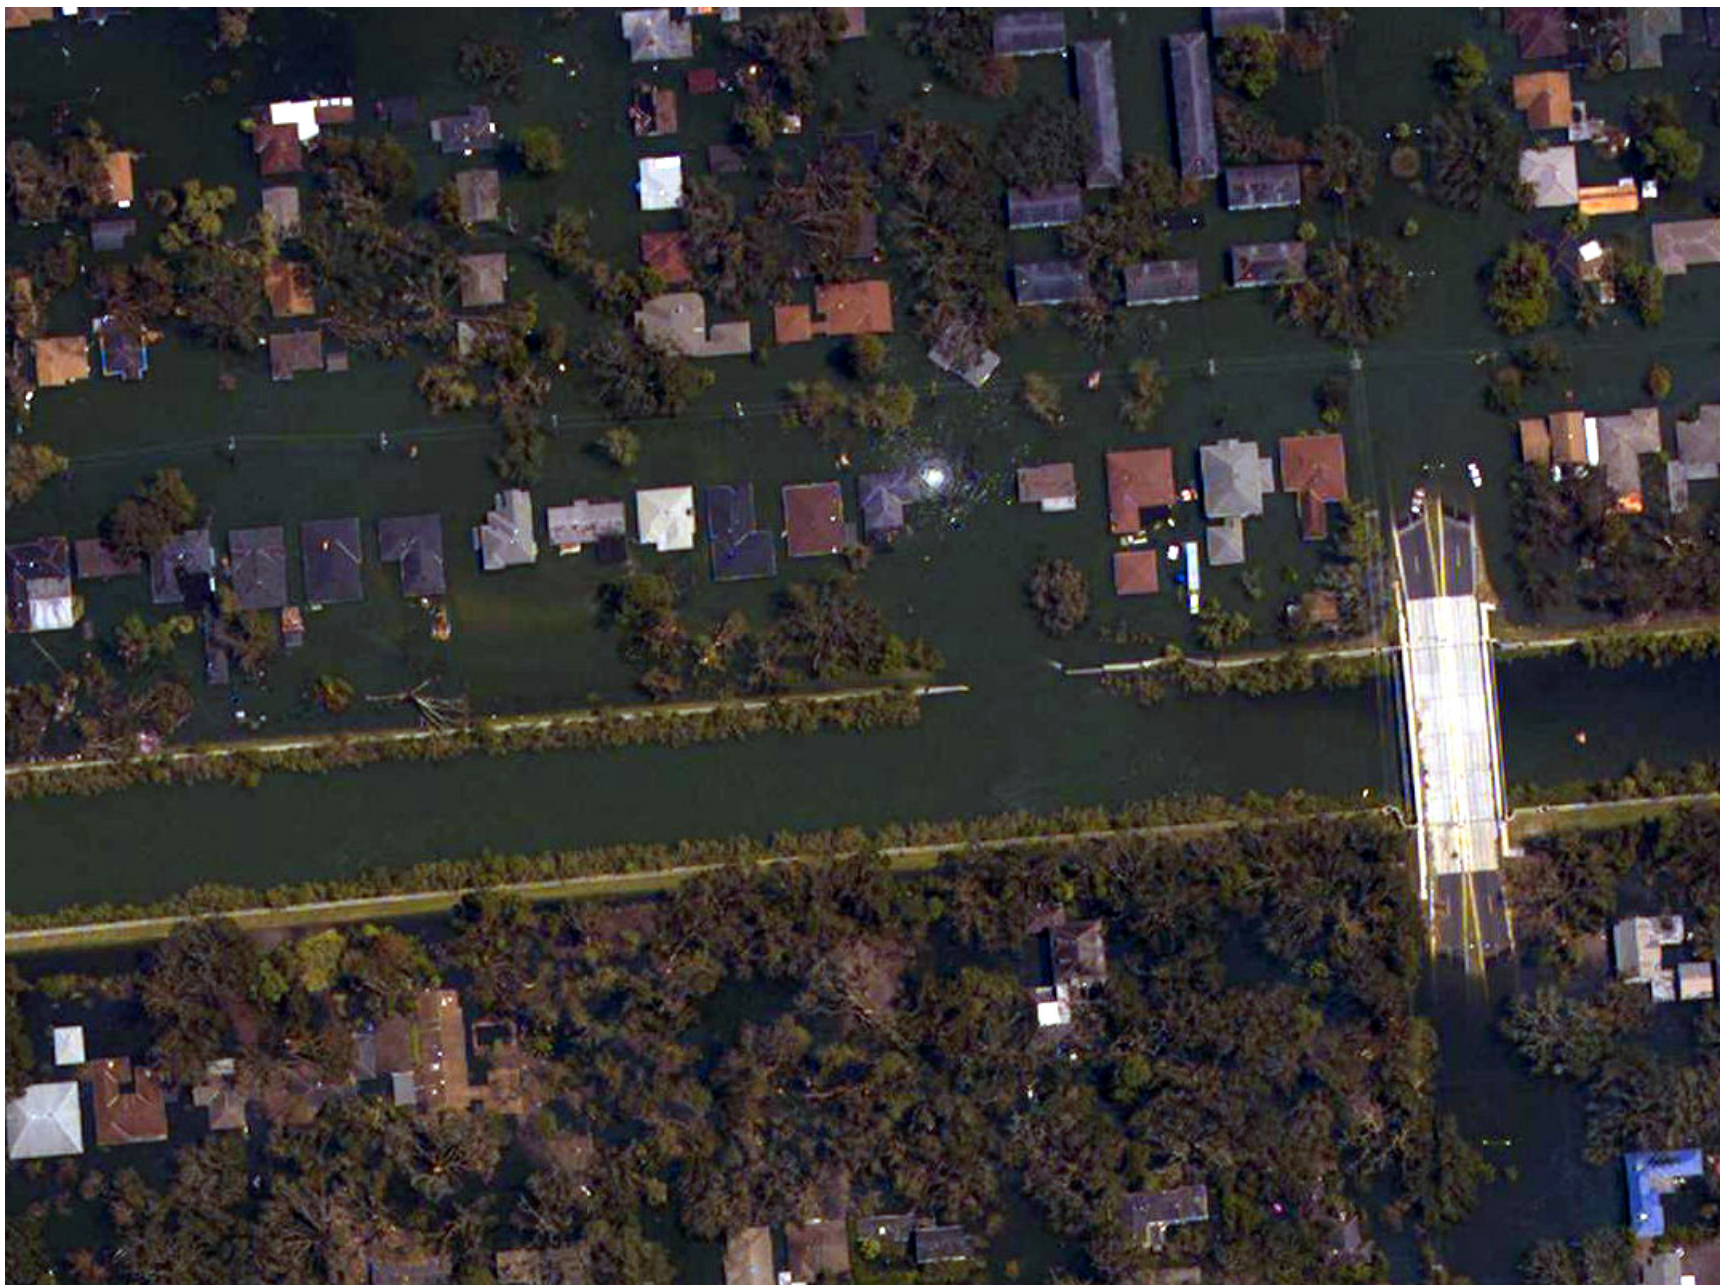
the area of the breach before Katrina and Figure 18 shows approximately the same view on August 31 when the breach was still active. A house in the center of the breach was moved out onto Warrington Drive (this house was demolished on about March 10, 2006). In Figure 18, natural gas can be seen bubbling up through the flood waters at the location of the now displaced house. The breach here is about 200 feet wide and is currently under repair. Like at the Industrial Canal, the new floodwall that will be constructed here will be a T-wall instead of the I-wall that was present before Katrina.

Figure 18. Air photograph of the area where the London Avenue Canal levee was breached near Mirabeau Ave. and Warrington Drive (Stop 1). Image acquired Aug. 31, 2005. Source: National Oceanic and Atmospheric Administration's National Geodetic Survey, Katrina Images - <http://ngs.woc.noaa.gov/katrina/>

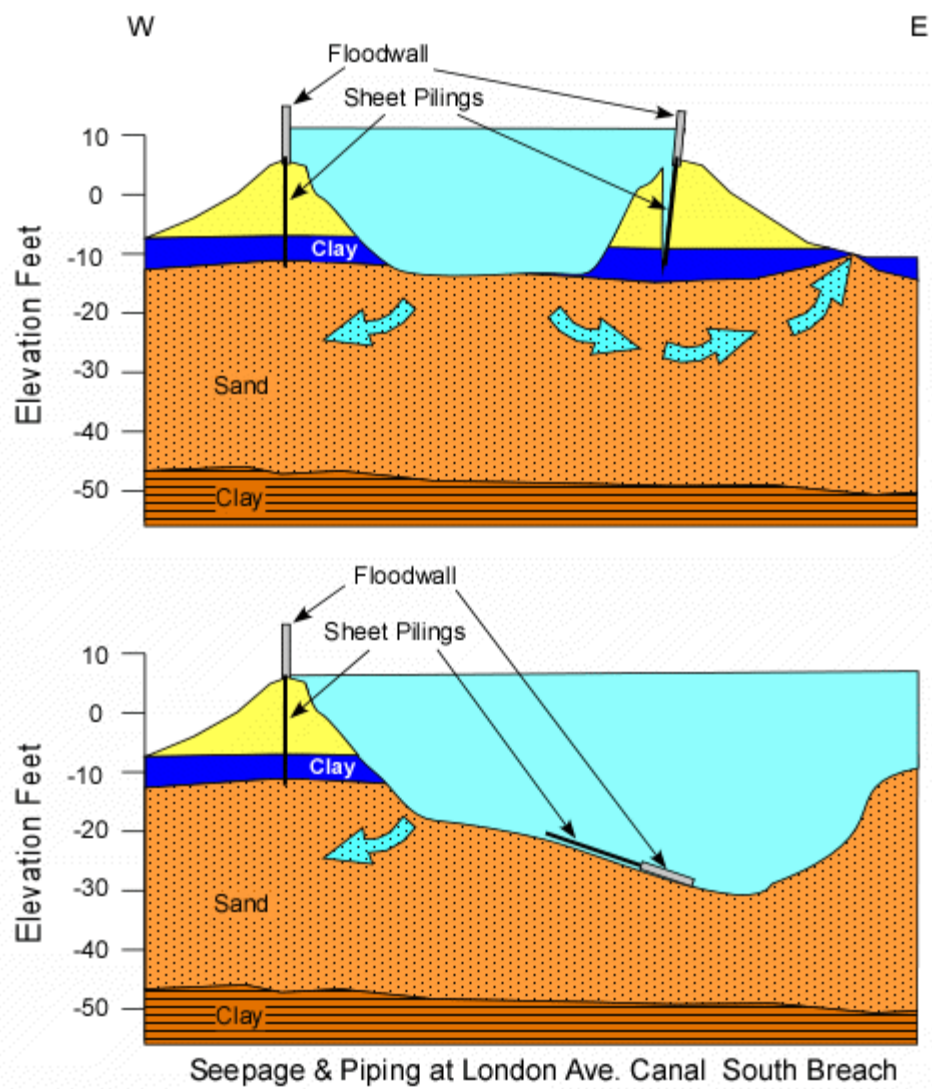
Sand is a highly permeable material. This means that water can easily be transported between the sand grains, especially when the weight due to overlying water is increased due to the added height of the water column during a storm surge. This increases the pressure and could force the water through the pore spaces in the sand and back up to the surface on the other side of the levee. If enough flow takes place the sand will be picked up by the flowing groundwater and eventually form an underground channel. This could undermine the levee and cause it to collapse. The principle is illustrated in Figure 20 with a simple thought experiment. The underflow (called seepage or siphoning) is the apparent cause of the collapse at this section of the London Ave. Canal. The "As built" design specifications indicate that the sheet pilings (which should form an impermeable barrier to pressure induced flow in the sand) were placed to a depth of 14 feet below sea level (U.S. Army Corps of Engineers, 1994), one can see from the cross section in Figure 21, that the water still has a path back to the surface if it flows as groundwater beneath the sheet pilings. Note that in order to prevent such siphoning, the sheet pilings would need to be placed to a depth of about 50 feet below sea-level where they would penetrate a layer of clay. Clay, because the individual mineral grains stick together and thus reduce pore space and interconnection between pores, is much more impermeable than is sand.

Figure 21. Geological cross section across the London Ave. Canal based on borings 16 and 51 (Figs. 19 and 26), shown at time of estimated high water during Katrina's storm surge. The sands form a permeable layer through which groundwater originating in the canal can penetrate and move below the sheet piling and up to the surface (top diagram), eventually undermining the levee and causing a blowout completely removing a section of levee and carrying sand into the neighborhood.

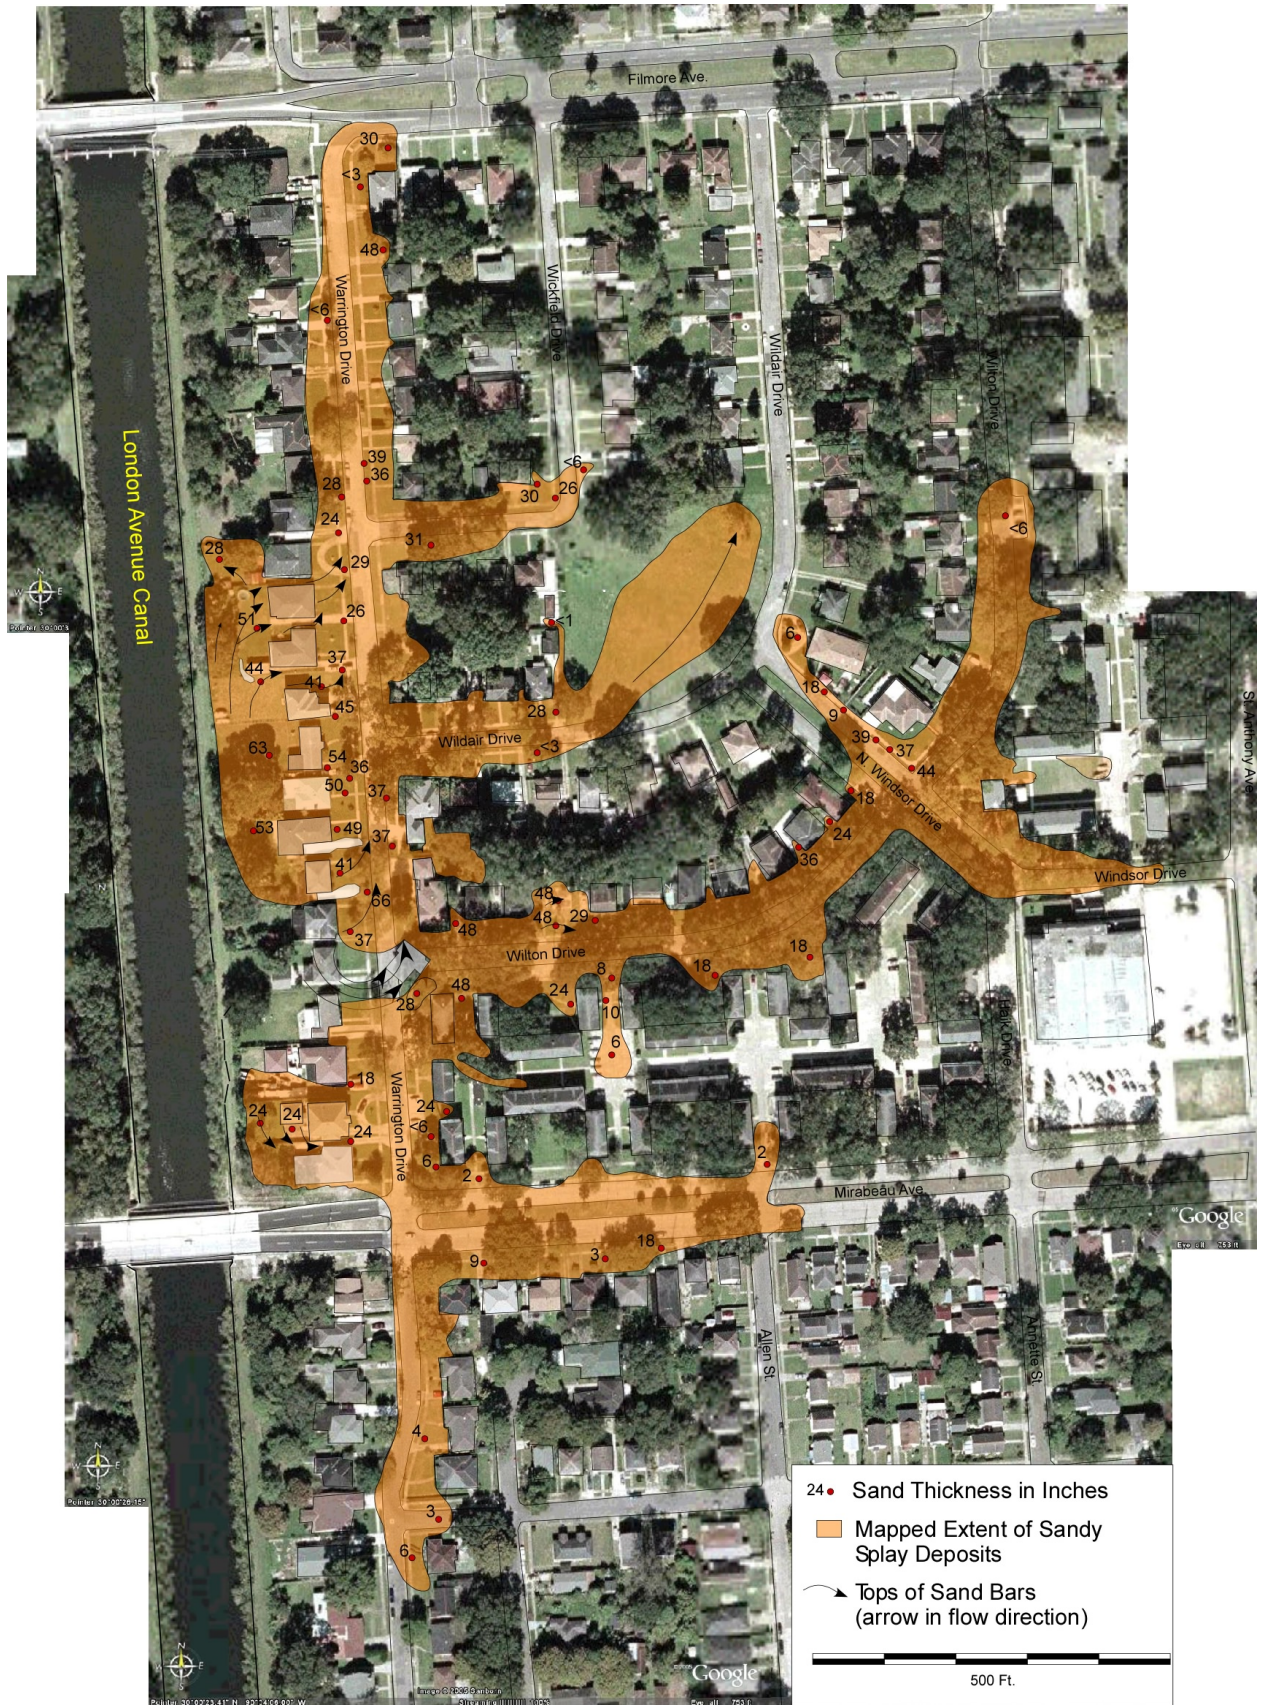
Our estimate of the volume of sand deposited in the neighborhood is about 932,000 ft³. Such a volume would cover a football field, from end to end (including the end zones) with over 16 feet of sand. Engineers working on the breach repair have reported that they had to dig to a depth of 30 feet below sea level to completely remove gravel and sand bags used to plug the breach in the first few days after Katrina. A conservative estimate of the volume of this hole is about 330,000 ft³. This only accounts for about 35% of the volume of sand found in the neighborhood, and implies that the canal bottom, both upstream and downstream from the breach, was scoured to an unknown depth. This raises questions about the stability of the levee/floodwall system outside the breach area if the canal bottom is now in permeable sand in these areas.

Figure 23. Preliminary map of sand deposits (by S. A. Nelson) from the Mirabeau Ave. Breach on the London Ave. Canal. Underlying image is a composite from Google Earth.

The repair operation is only taking place in the area of the breach. The operation has involved digging out the material used in the initial emergency repair, filling it with clay and constructing a T-wall to replace the missing I-wall. Fortunately, the Corps of Engineers is now completing removable floodgates near the mouths of the London Ave, Orleans, and 17th St. canals near Lake Pontchartrain. These floodgates will be closed in the event of a hurricane and should prevent storm surge from reaching onto the floodwalls in the canals. If the gates are closed, however, the pumps at the southern end of the canals cannot be used to pump rainwater out of the city. Thus, the Corps is in the process of building pumping stations at the Lake (where they should have been built in the first place), but full pumping capacity will not be available for the 2006 hurricane season. Still rainwater flooding is better than having Lake Pontchartrain drain into the city.

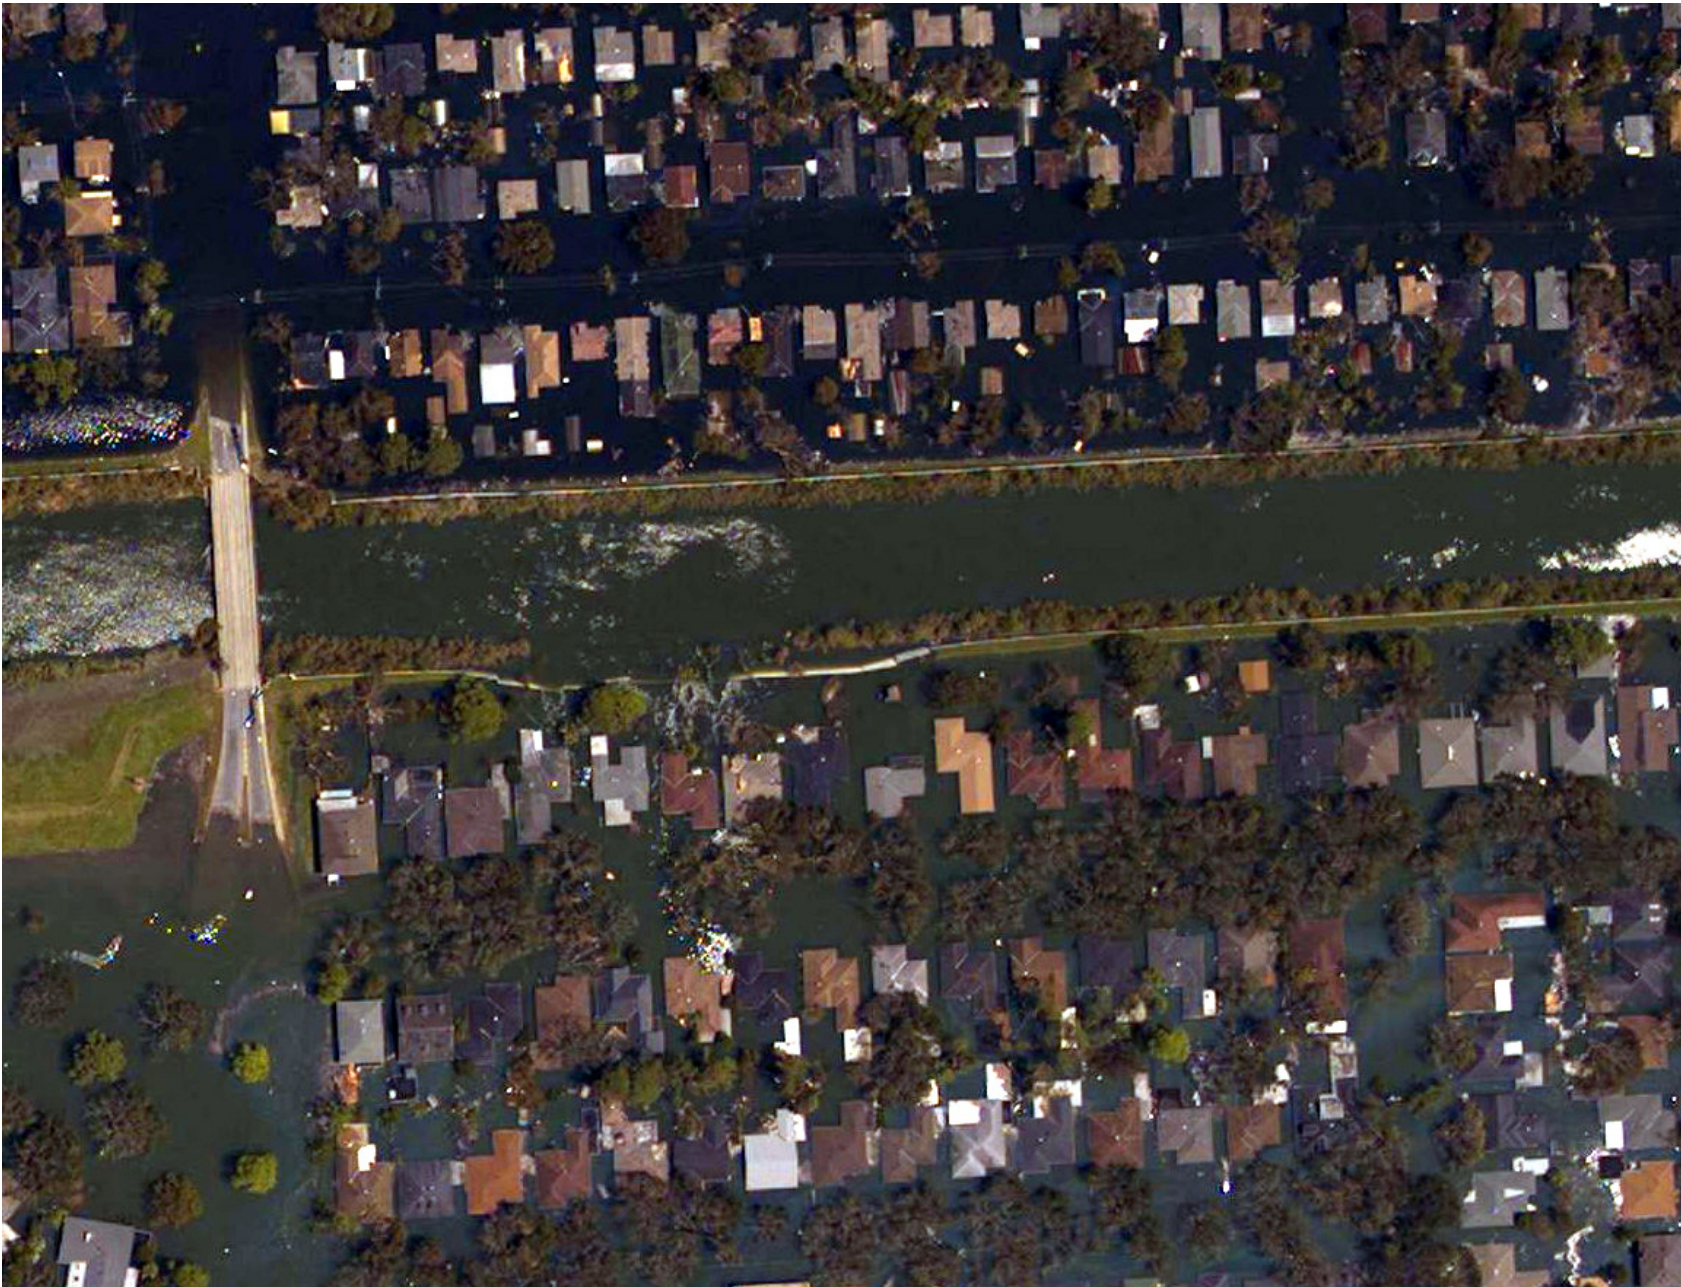
Figure 25. Air photograph of the area where the London Avenue Canal levee was breached near Robert E. Lee Ave. and Pratt Drive (Stop 2). Drive. Image acquired Aug. 31, 2005. Source: National Oceanic and Atmospheric Administration's National Geodetic Survey, Katrina Images - <http://ngs.woc.noaa.gov/katrina/>

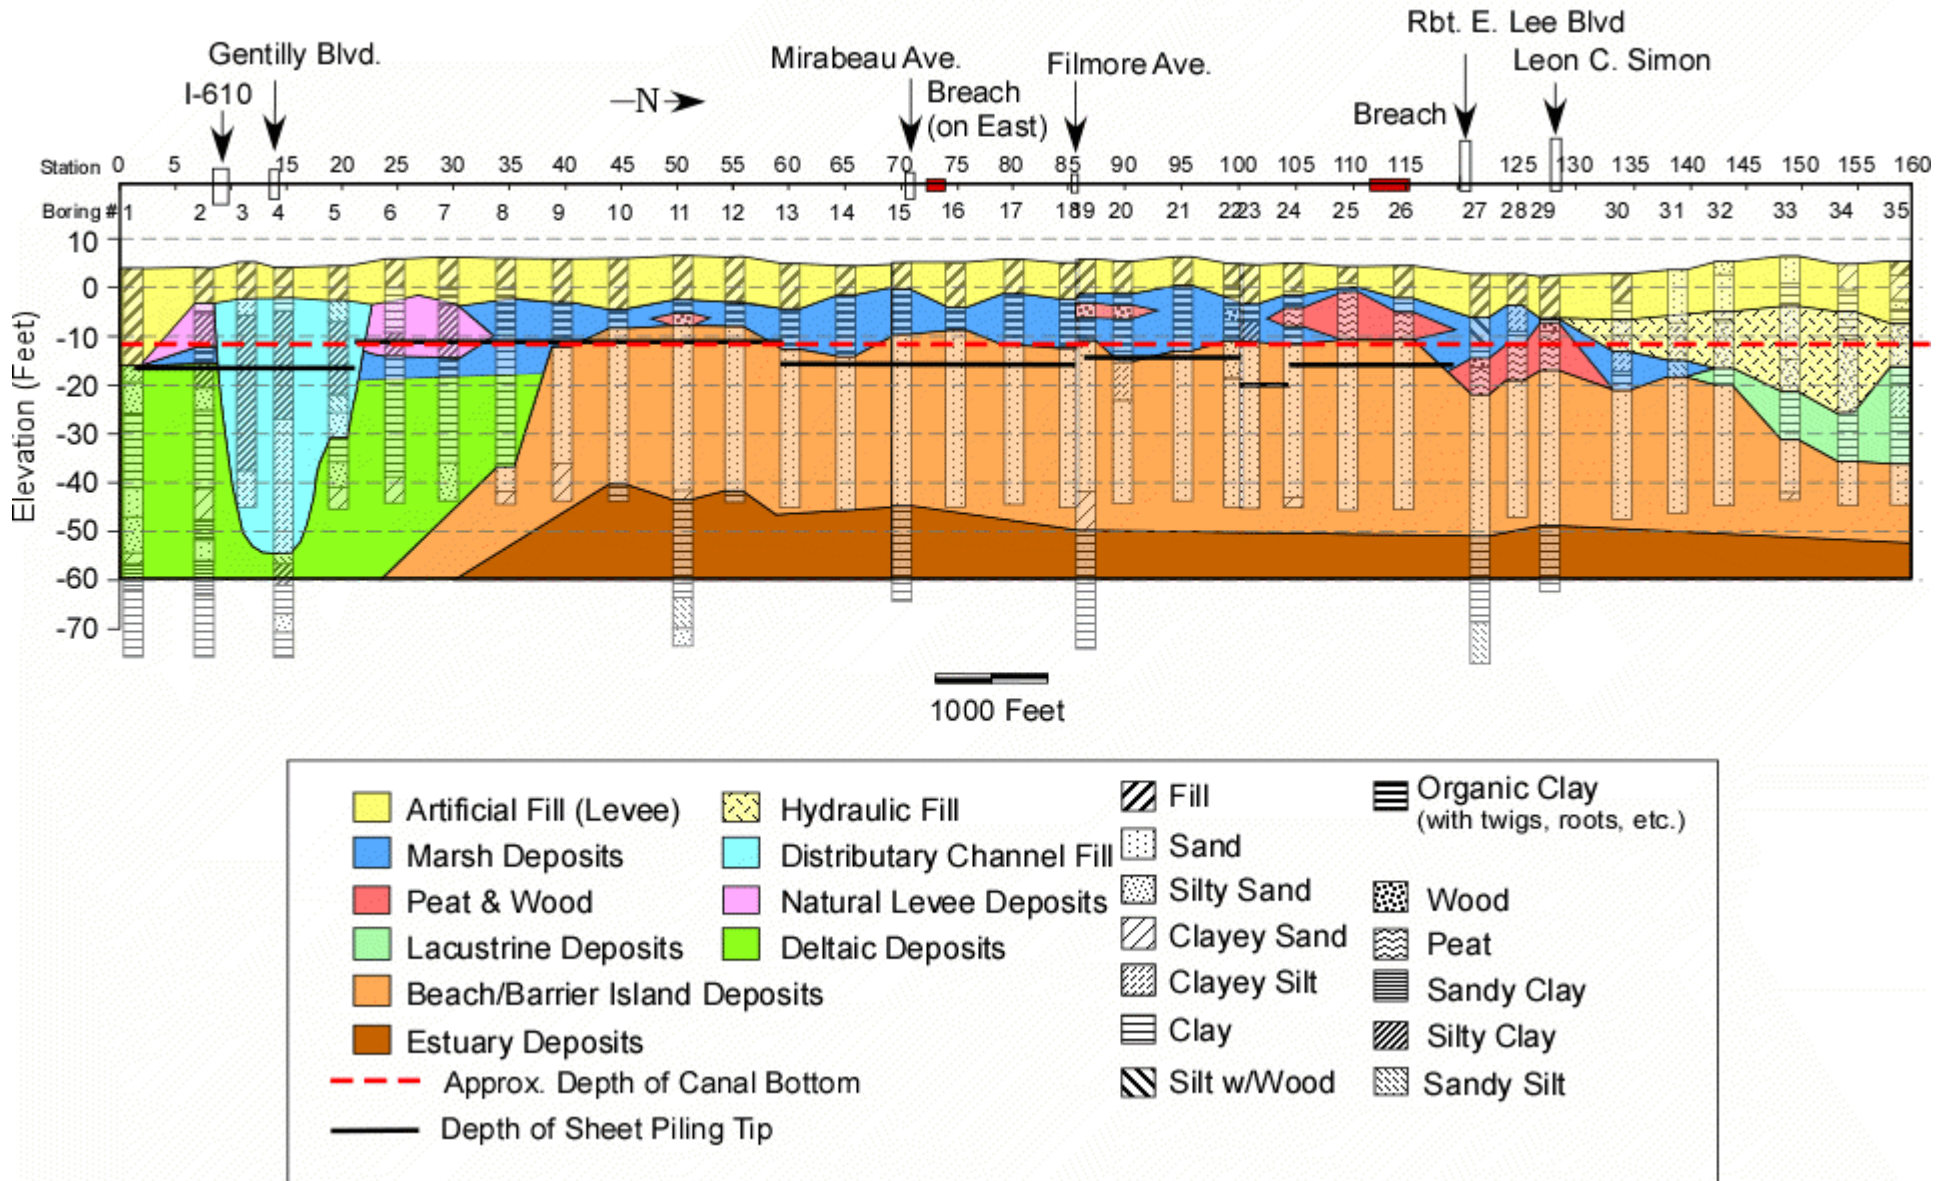
Due to changes in construction activity at the breach, we may or may not be able to walk into the breach. The breach is about 400 feet wide. A geologic cross section of the west side of the levee is shown in Figure 26. Note that the conditions beneath the surface are similar to those at the Mirabeau Ave. breach, with a sand layer about 12 feet below sea-level. Here a peat layer is also observed. Peat is organic matter (vegetation that is in the process of decay). It represents material accumulated in swampy areas and indicates that this area was a swamp in the not too distant past. Peat is very porous and has the additional property that it shrinks when it is dried out and expands when water is added. The presence of peat can make for very unstable soil conditions.

Although the “as built” design documents (U.S. Army Corps of Engineers, 1994) show that the depth of the sheet pilings were at 14 feet below sea-level, water still had access to the peat layer and thus the peat layer could have played a role in the collapse of the levee. Another phenomenon that was observed here was that of ground heave in the area of collapse. Water, and perhaps expanding peat, apparently pushed up the levee and land surface on the west side of the canal prior to collapse of the levee. This is illustrated in Figures 27 and 28. Although the clubhouse shown in figure 27 has been removed during the repair of the levee, the house (with the mispositioned air conditioner compressor) is the 5th house south of Robert E. Lee Blvd. on Pratt Drive.

A short walk down Pratt Drive or along the levee breach reveals the presence of thick bodies of sand scoured from the bottom of the canal. These deposits are similar to the ones observed at the Mirabeau Ave. breach, but also contain blocks of peat as expected from the geologic cross sections shown in Figure 26.

Figure 26. Geological cross-section along the west side of the London Avenue Canal constructed from data in U.S. Army Corps of Engineers (1989).

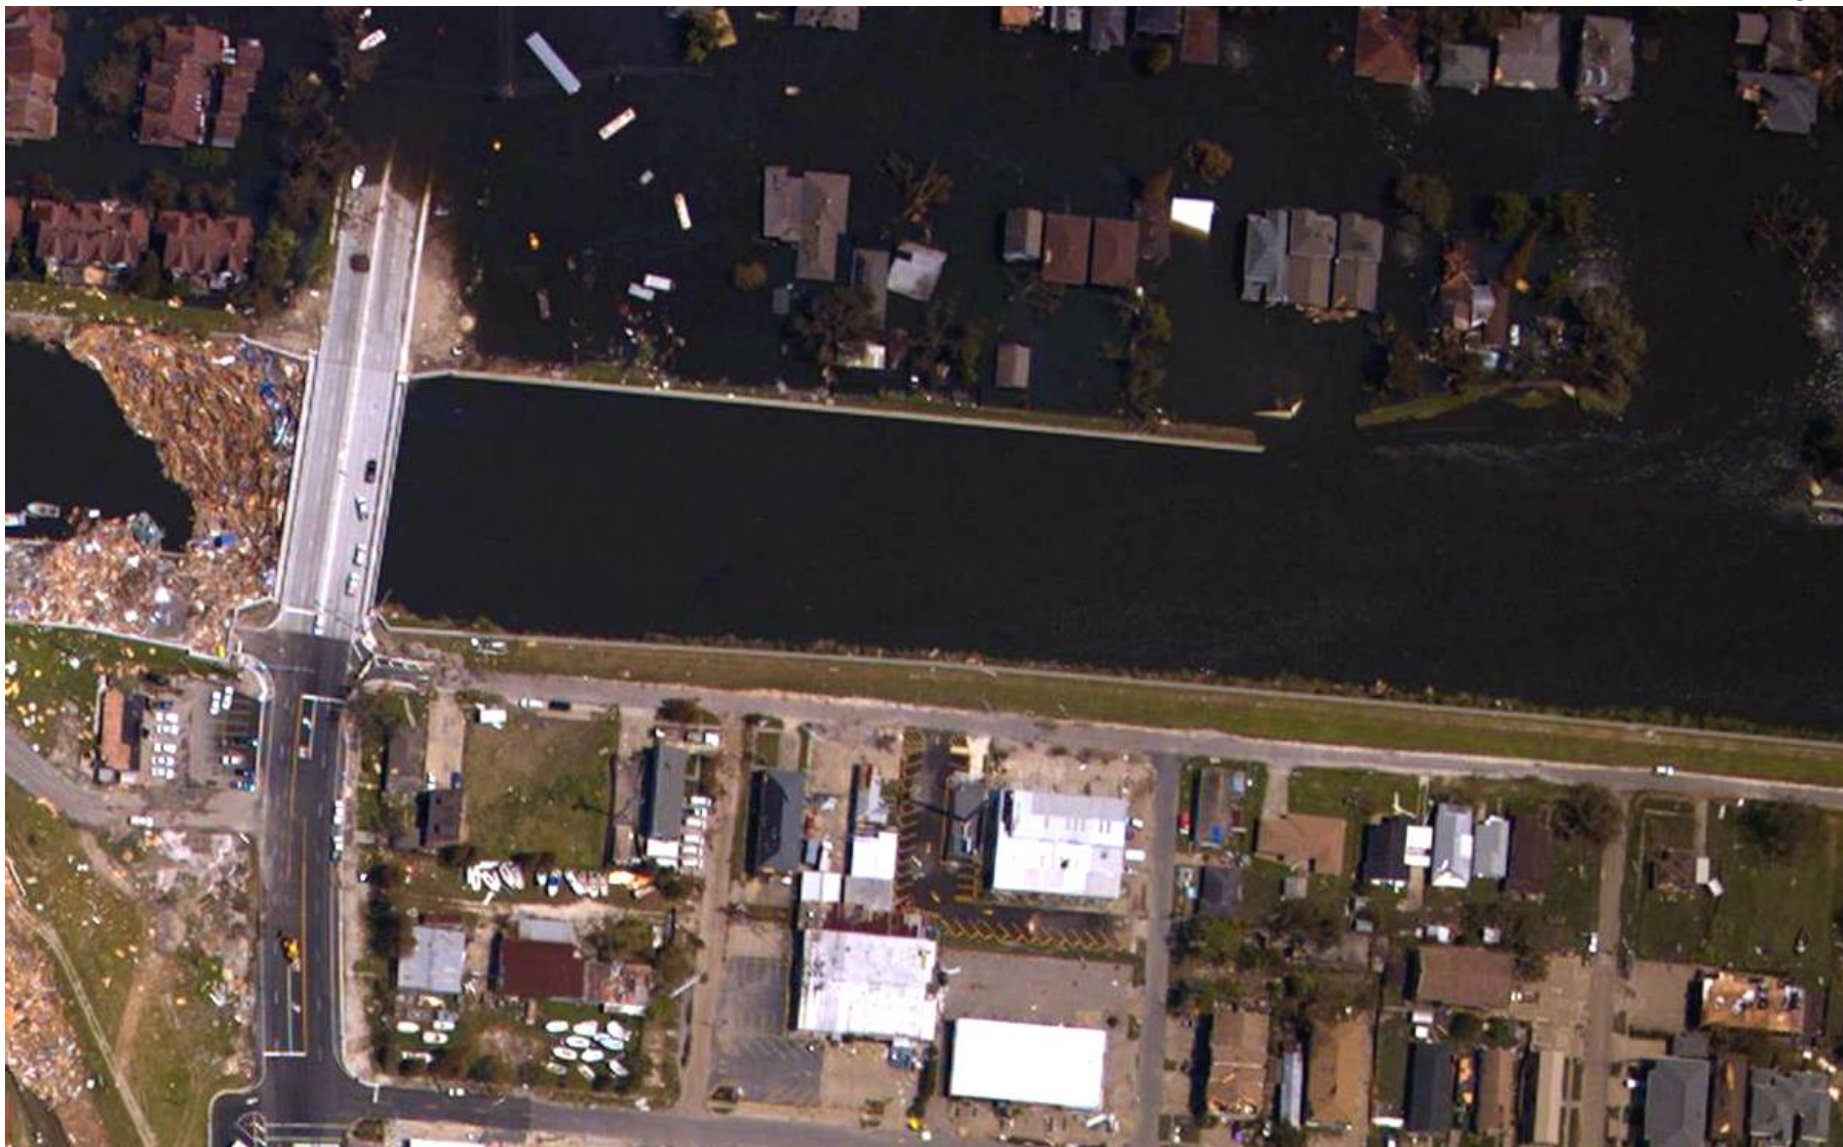
Note that the breach occurred along Belaire Drive where, like the along the London Avenue Canal, houses are backed up against the levee. Here, the main part of the breach occurred in a recently cleared empty lot. A house to the south of the main part of the breach, built on a chain wall foundation, was completely removed (see also the photo in the lower right of Figure 38). Natural gas from a line that fed the house can be seen bubbling up through the floodwater. Another house to the north of the empty lot was built on a slab. The house was destroyed, but the slab remains.

Figure 30. Air photograph of the area where the 17th Street Canal Levee was breached near Belaire Drive (stop 5). Image acquired Aug. 31, 2005. Source: National Oceanic and Atmospheric Administration's National Geodetic Survey, Katrina Images - <http://ngs.woc.noaa.gov/katrina/>

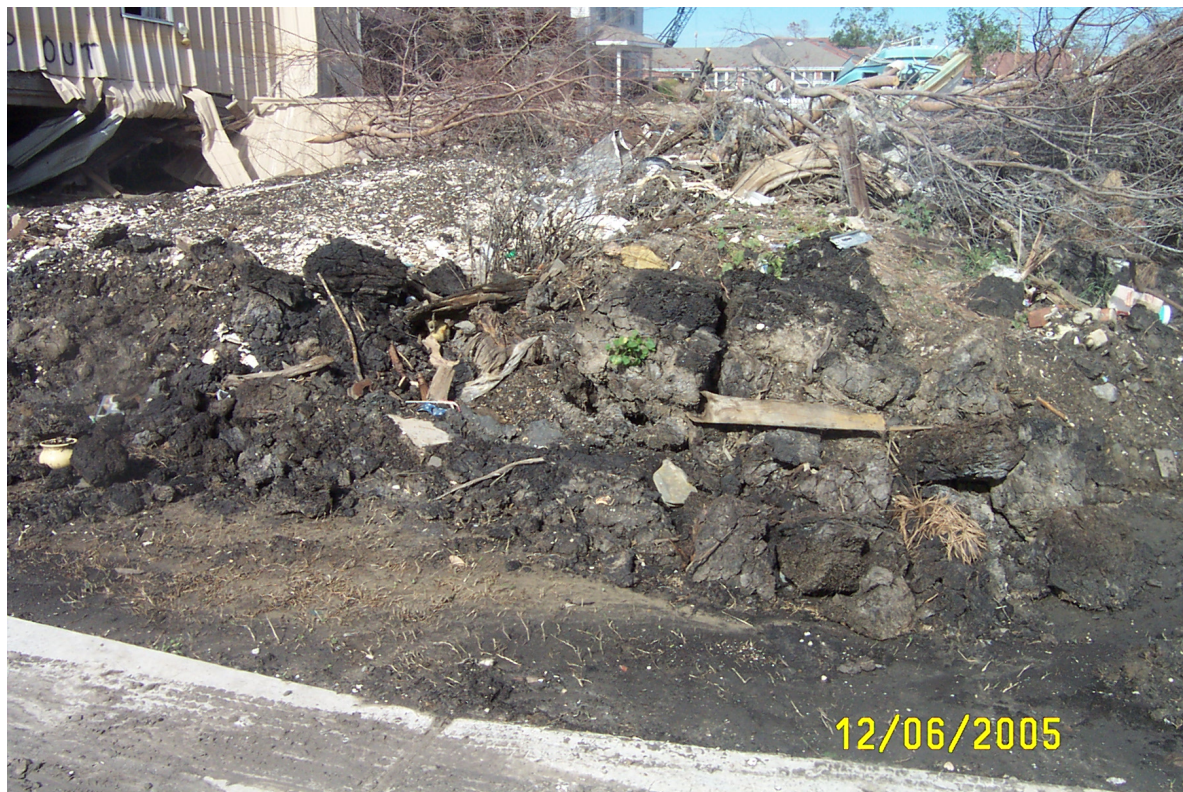
Before the debris was completely removed from the neighborhood, large blocks of peat were present throughout the neighborhood, some of which could be found a block away to the east near Fleur de Lis Blvd. Examples of the peat blocks before their removal can be seen in Figures 34 and the lower right of Figure 38.

Figure 34. Blocks of Peat along Belaire Drive near the 17th St. Canal levee breach

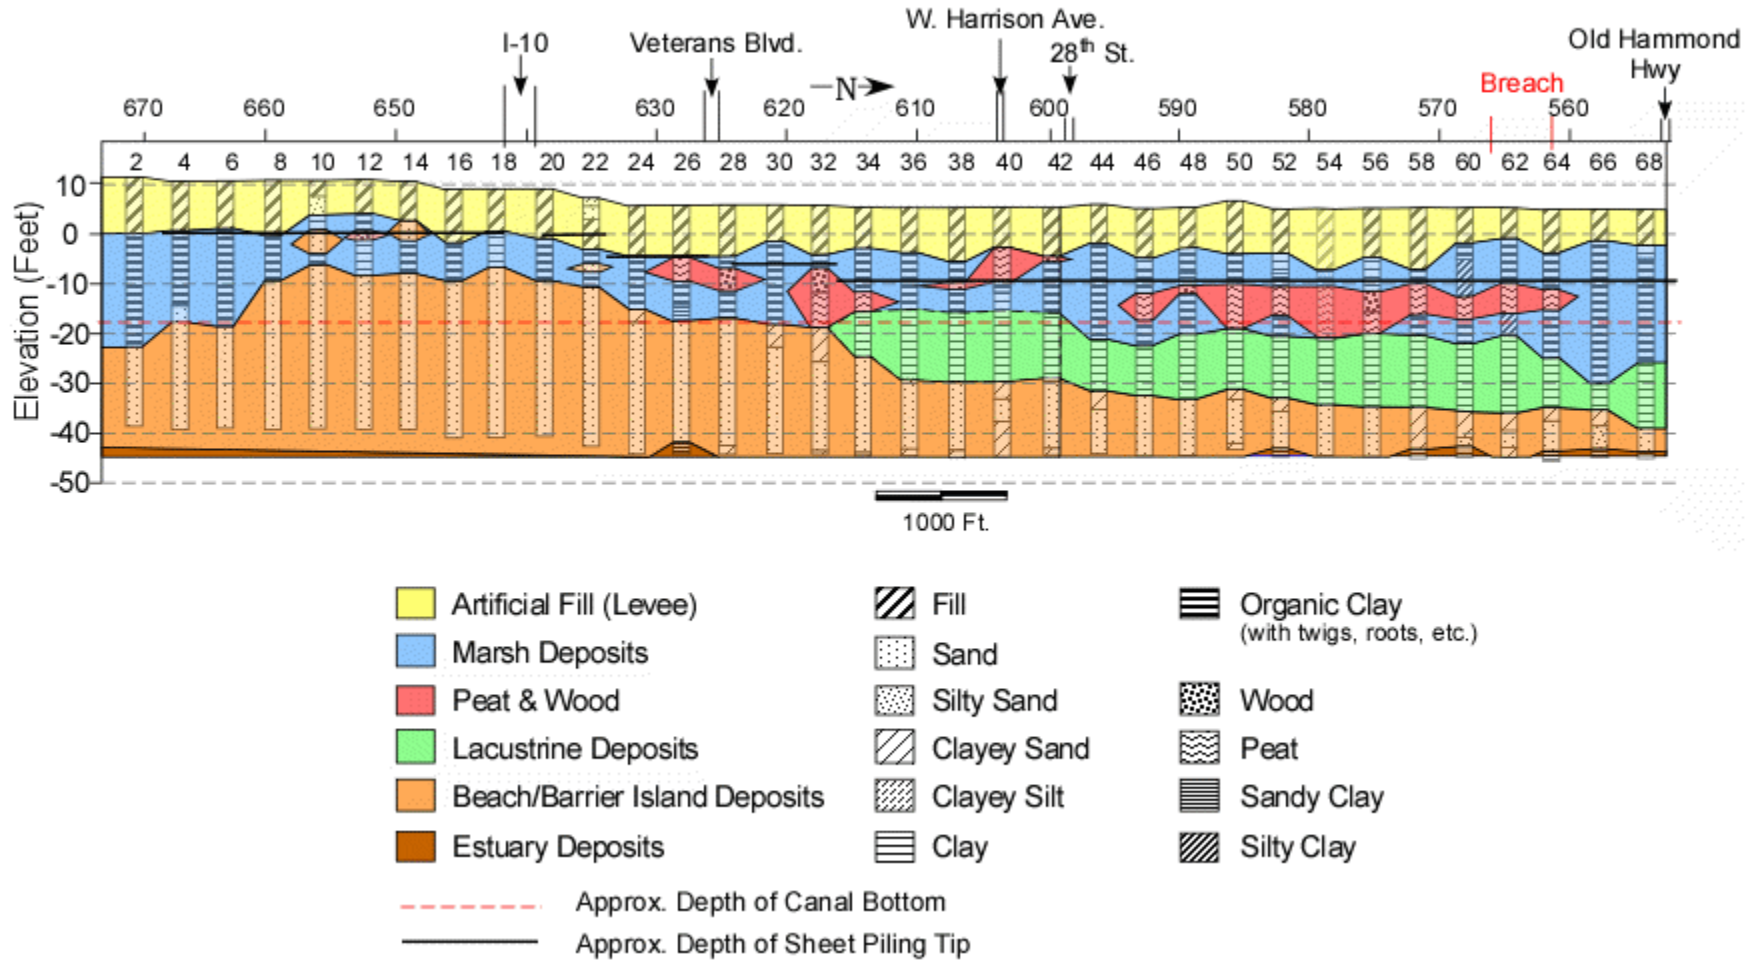
Figure 35 shows a geological cross section along the levee of the 17th street canal. The most notable feature of the cross section is the peat layer observed at depths between about 8 and 15 feet below sea level in the area of and to the south of the breach.

A series of articles in the Times Picayune, by John McQuaid, Bob Marshall, and Mark Schleifstein, and Sheila Grissett (see references section) discuss the role of the peat layer, the possible design flaws, and the possible mistakes made during the construction of the 17th St. Canal levee and floodwall system. Figure 36 summarizes the possible cause of failure. Although initial seismic tests performed on the sheet pilings suggested that they were only driven to a depth of 10 feet below sea level (Marshall, November 9, 2005; Olson Engineering, 2005), when sheet piles immediately adjacent to the breach were pulled they were shown to be at the design specification of 17 feet below sea level (Schleifstein, December 13, 2005); Schleifstein and Marshall, December 14, 2005; Marshall, December 19, 2005). Even at this depth, the sheet pilings would not have been deep enough to prevent failure (Marshall, November 30, 2005 & December 30, 2005), and were not even as deep as the bottom of the canal.

Figure 35. Geological cross-section along the eastern side of the 17th St. Canal (based on data in the U.S. Army Corps of Engineers design documents (1990). Notable in the cross-section is the peat layer that occurs in the area of the breach.
