Hurricane Katrina - What Happened?

Tulane University
Field Trip
1 Year Anniversary Edition
August 29, 2006

Levee Breaches in New Orleans during Hurricane Katrina

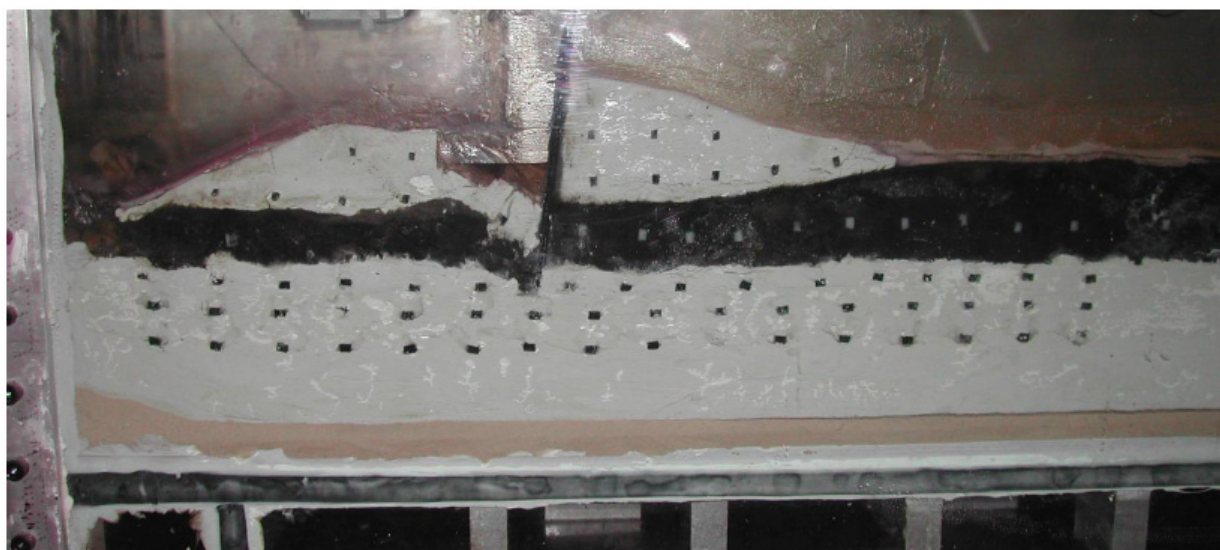
A photograph of the end result of IPET's scale model centrifuge experiment is shown in Figure 37. The canal side (on the left in the photograph) next to the sheet piling is seen to have dropped down as a result of the floodwall moving toward the right (toward the protected side). Indeed in the end result of the experiment, the levee, peat layer, and upper part of the underlying clay layer all have moved to the protected side. Viewing the complete video of the experimental run (<https://ipet.wes.army.mil/>), however, shows that the initial failure occurred either in the peat layer or at the peat – clay interface, and only when the sheet pile started to move to the right, away from the canal, did the upper part of the clay layer also move. Furthermore, the only part of the clay layer that moved was the part immediately in front of the tip of the sheet pile, and it only moved because it was being pushed along by the sheet pile.

Figure 37. Photograph of failed levee and floodwall in IPET's scale model centrifuge experiment representing the 17th St. Canal. The white at the top is clay and represents the levee. This overlies the dark peat layer, which in turn overlies another white clay layer meant to represent the estuary deposits beneath the peaty marsh deposits. Small rectangles were initially laid out in a rectangular grid and can be used to determine how much deformation has occurred during the experiment. (IPET, 2006).

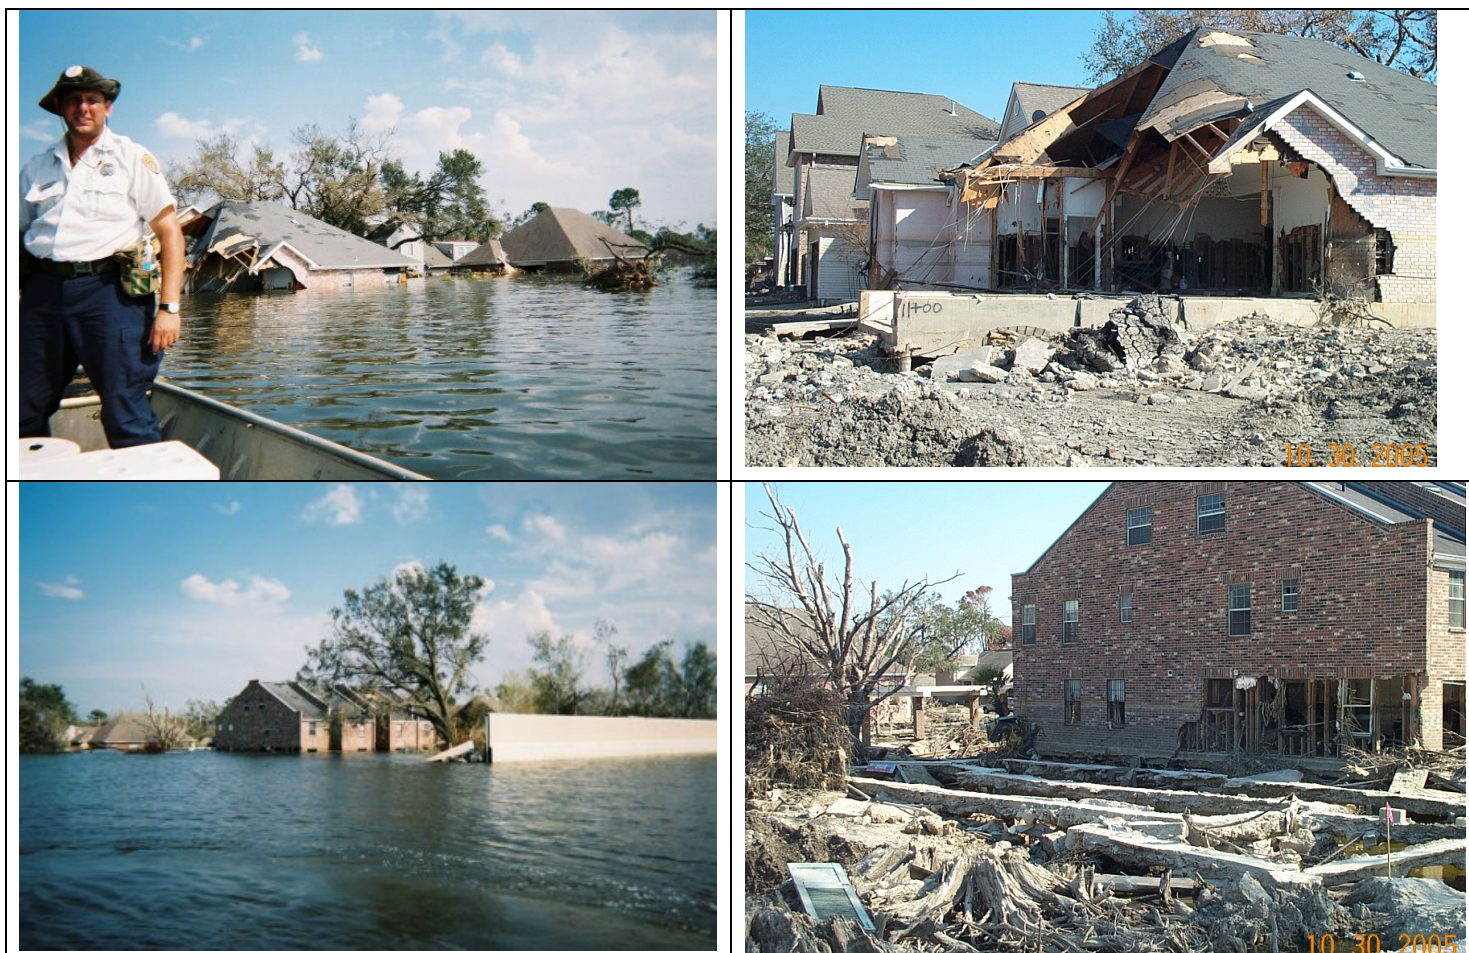
Figure 38. Comparison of water levels on Sept.1, 2005 (photos on left by Kevin Himmel), with water lines on same structures indicate lines left by standing water are about 1.5 to 2 feet lower than the maximum water level. Note large block of peat in photo at the upper right. In photo at lower right, note the chainwall foundation of a house that was removed by the burst of water when the levee was breached and the cypress stump from a tree that was probably cut down 100 years ago when this Lakeview neighborhood was reclaimed from the cypress swamp.

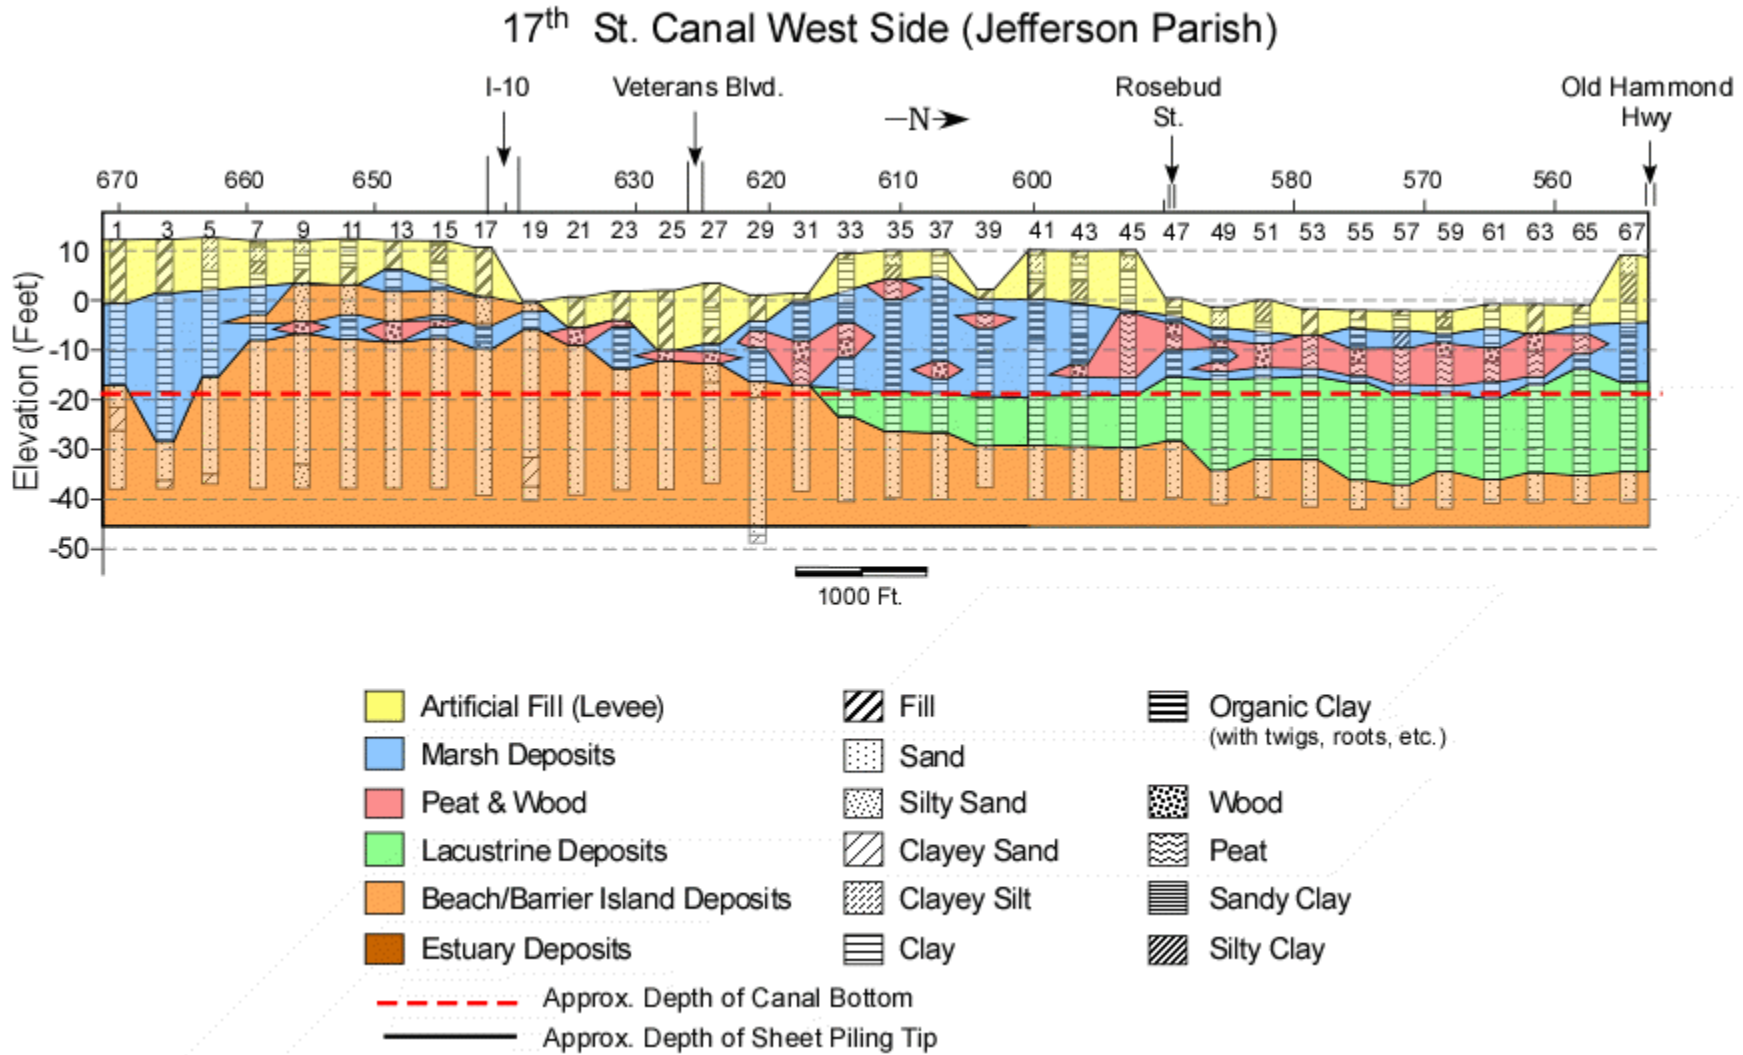
It is notable that the same peat layer and the same levee design and construction are present on the Jefferson Parish side of the canal, which by luck or the path of the storm, did not breach on August 29. Figures 39 shows a geological cross section of the west bank (Jefferson Parish side) of the 17th St. Canal constructed from data provided on the Army Corps of Engineers IPET web site - <https://ipet.wes.army.mil/> where it can be seen that the same geologic materials are present beneath the Jefferson Parish side as are found on the Orleans Parish side (compare with Figure 35). One major difference on the Jefferson Parish side is that a street occupies the area next to the levee and there are no trees, houses or swimming pools abutting the levee on that side.

Figure 39 Geologic cross section of the west bank of the 17th St. Canal constructed from data provided to the U.S. Army Corps of Engineers (1990).
