# Hurricane Katrina - What Happened? The Geology of the Katrina Disaster in New Orleans Field Trip Guide

August 2015

Stephen A. Nelson  
Department of Earth &  
Environmental Sciences  
Tulane University  
New Orleans, LA  
[snelson@tulane.edu](mailto:snelson@tulane.edu)

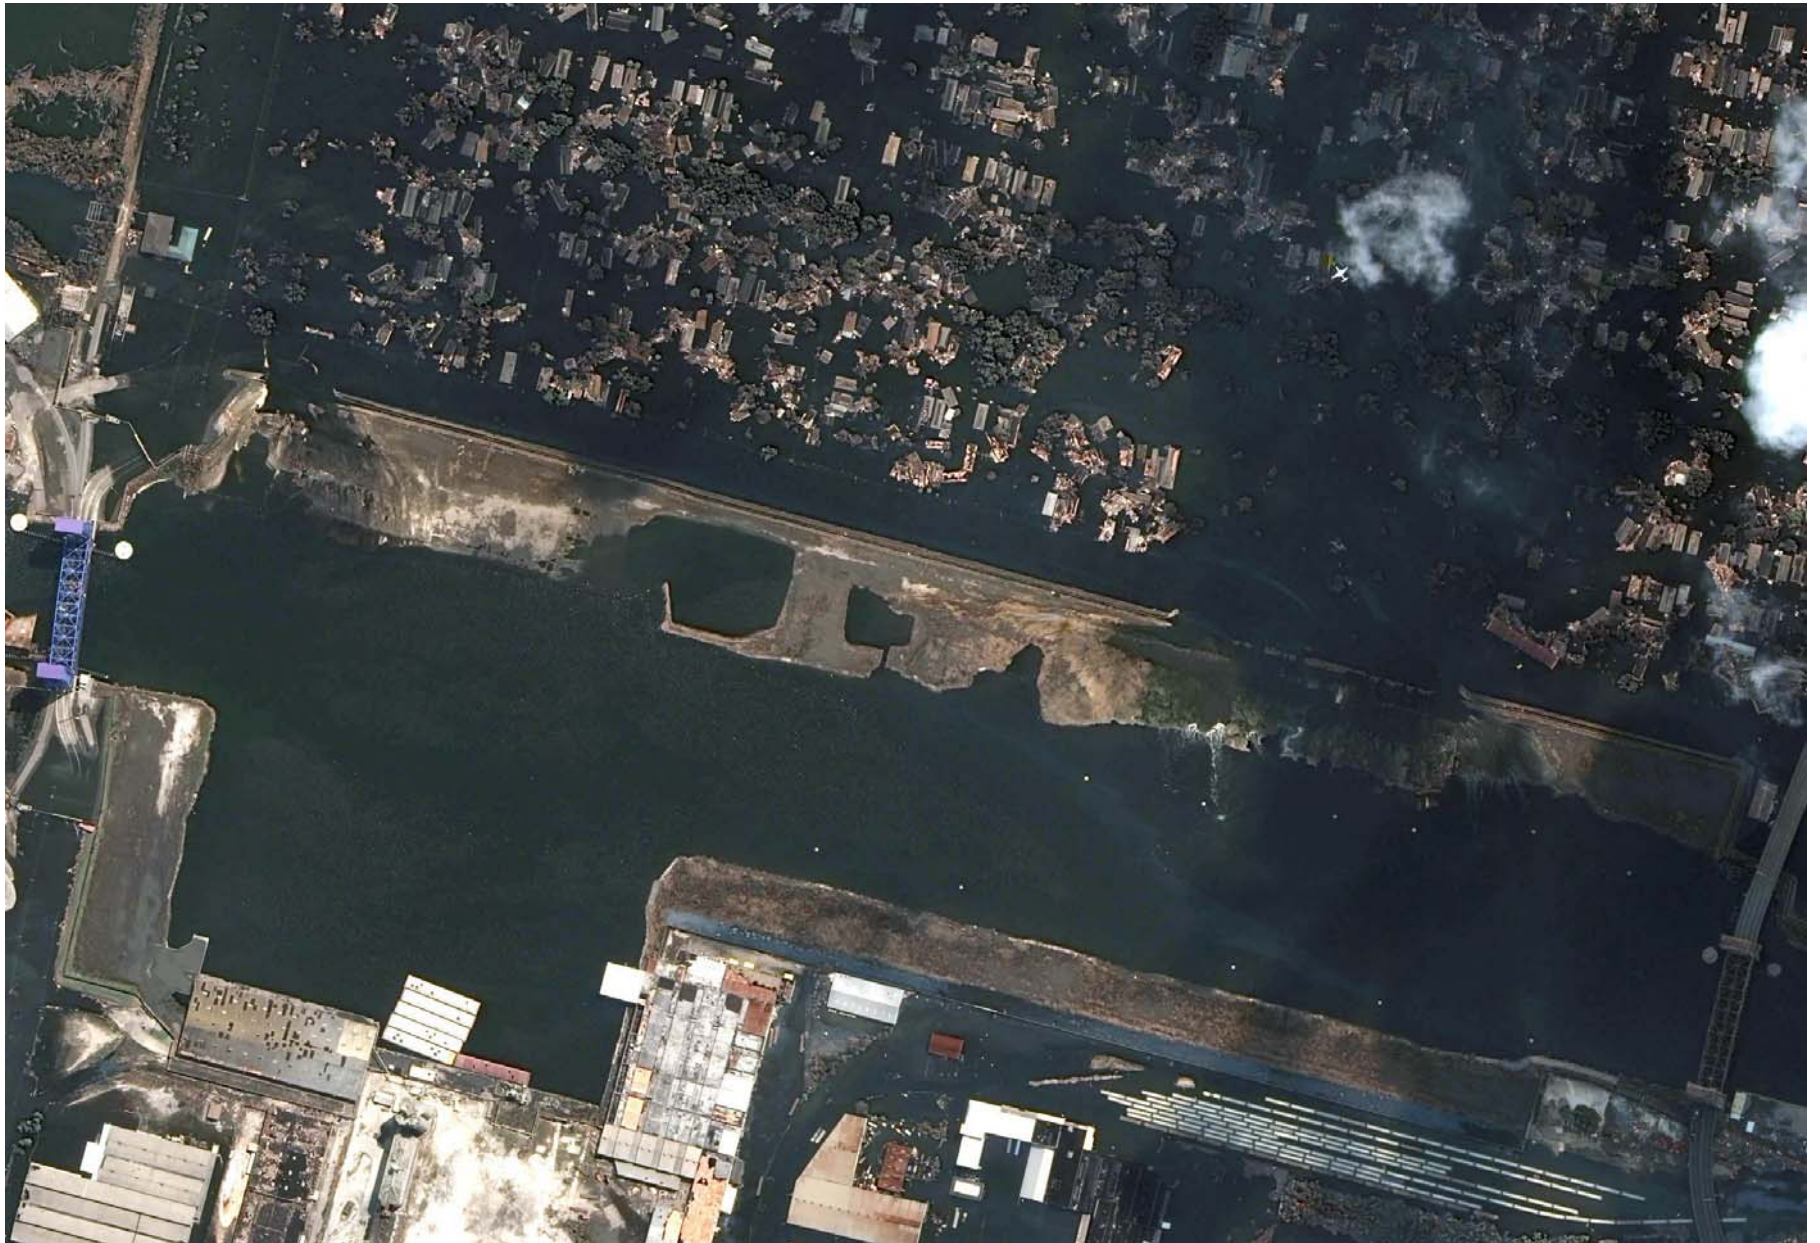
All houses and most trees were removed by the incoming water in the areas immediately in front of the breaches (Figs. 11, 12, 13, & 14) and in areas between the breaches the rush of water was forceful enough to lift houses off their foundations and float them around until they collided with other houses and either came to rest or broke apart to form piles of rubble (Fig. 11). The floodwall and underlying sheet pilings were strewn into the first few blocks of the Lower 9<sup>th</sup> Ward like a ribbon (Figures 14, 15, and 16).

**Figure 11.** Air photograph of the area where the Industrial Canal Levee was breached to flood the Lower Ninth Ward. Image acquired Sept. 3, 2005 Source: National Oceanic and Atmospheric Administration's National Geodetic Survey, Katrina Images - <http://ngs.woc.noaa.gov/katrina/>

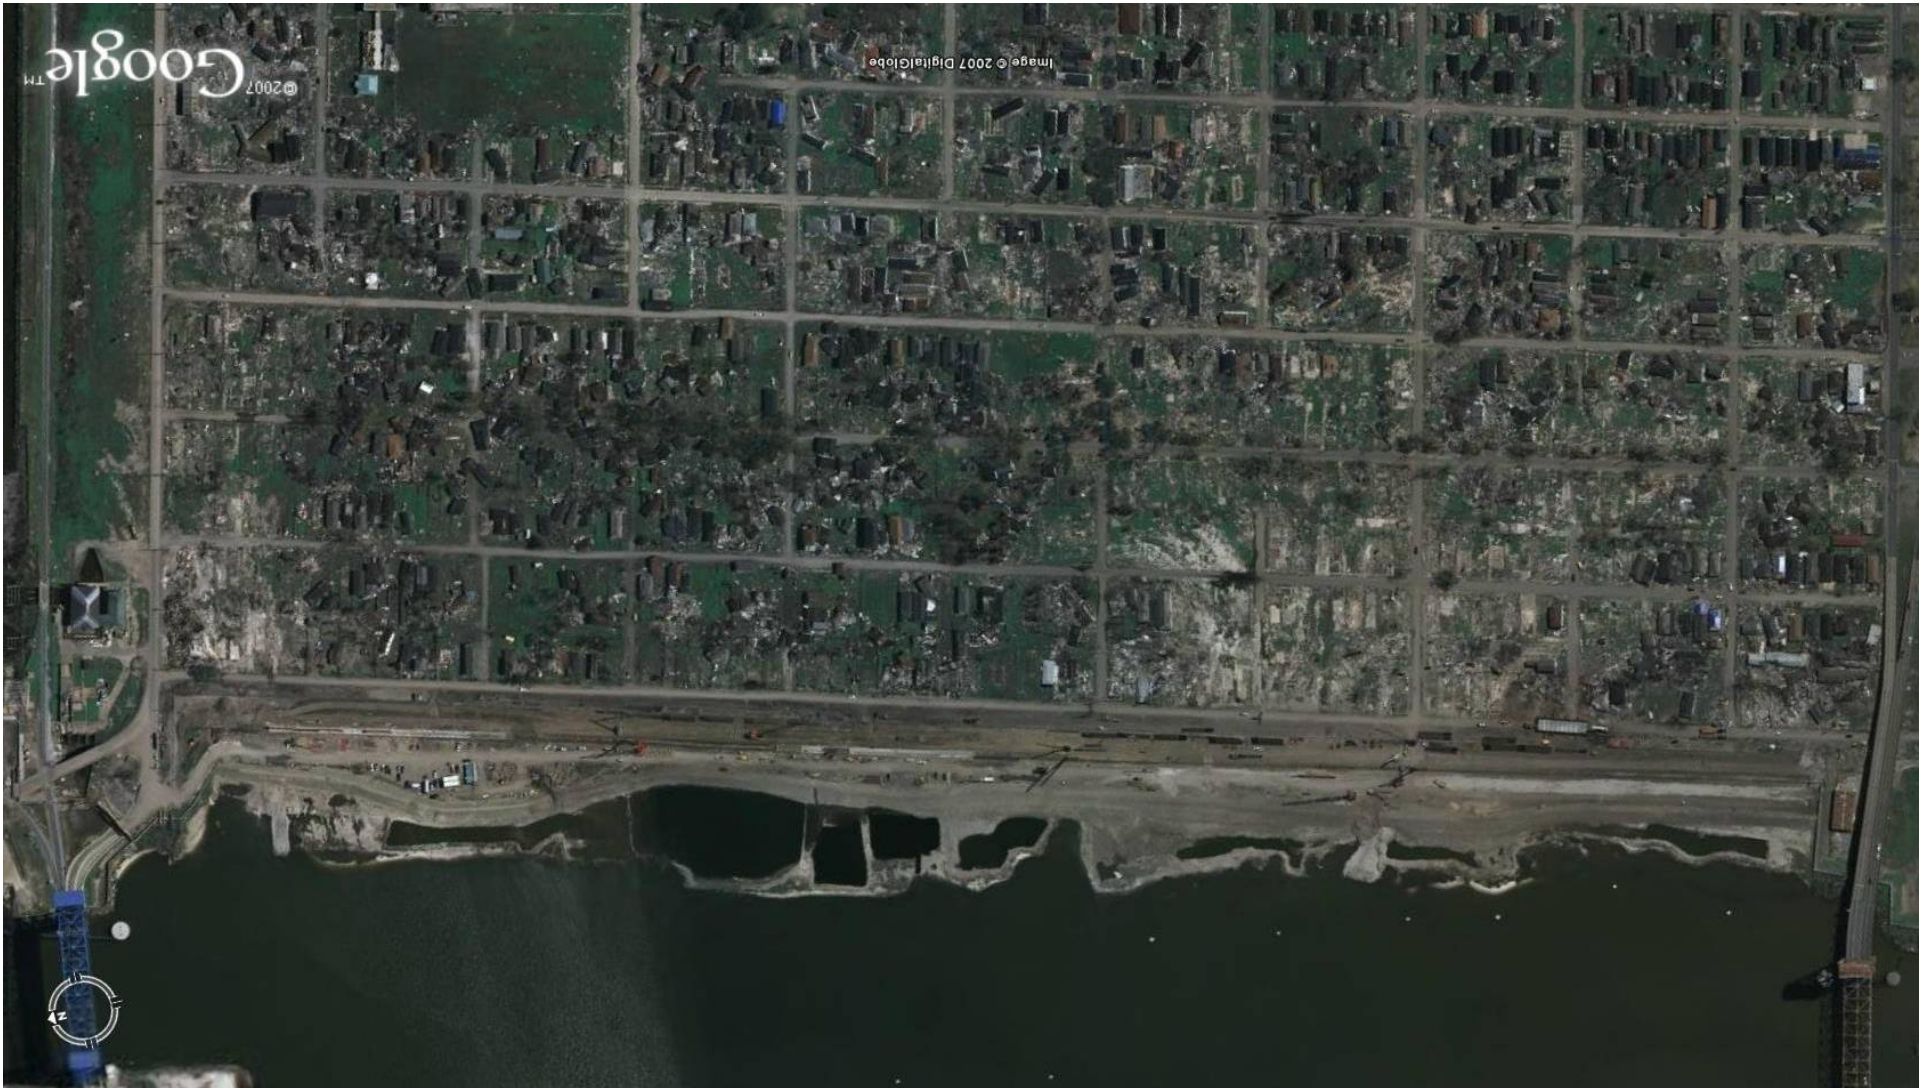
**Figure 12.** Google Earth image of the area where the Industrial Canal Levee was breached to flood the Lower Ninth Ward. Image acquired around mid-March, 2006.

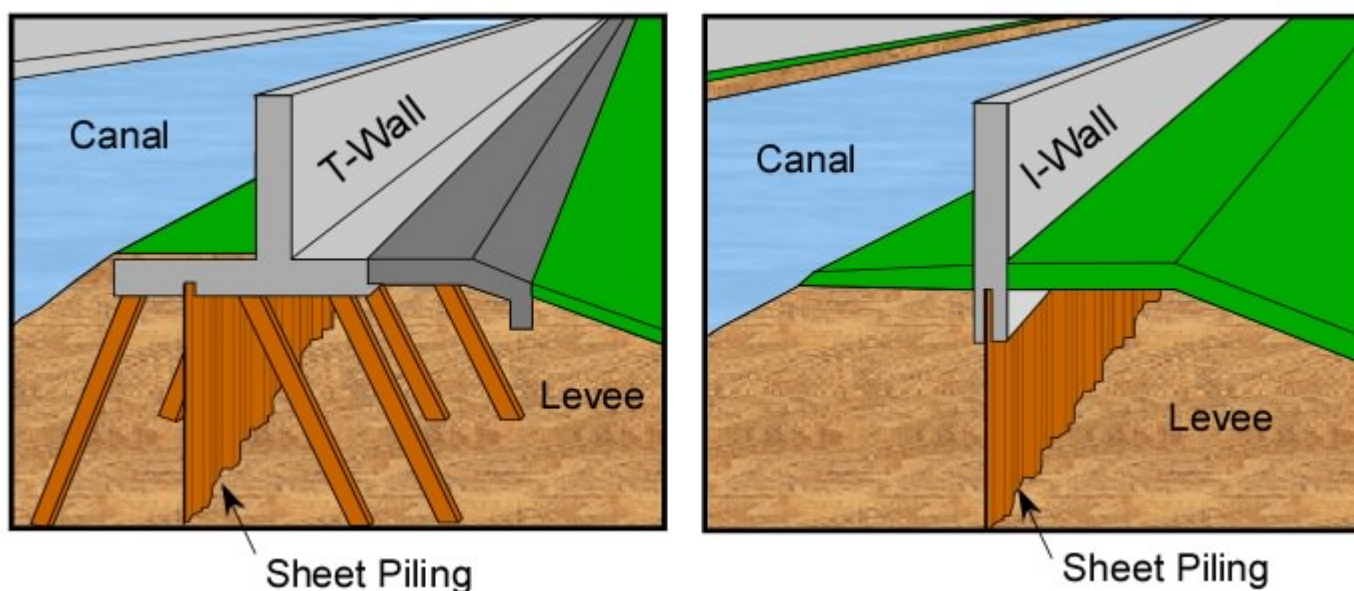
**Figure 19.** Most pre-Katrina floodwalls in New Orleans were built with the I-wall design (right). In repairing failed floodwall sections after Katrina, the T-wall design (left) was used.

At Stop 1 in the Lower 9<sup>th</sup> Ward, one now sees that the entire floodwall between the two bridges (Claiborne to the south and Florida Avenue to the North – the blue colored bridge) has been replaced with a T-wall with a top elevation at 14.5 feet above sea level, the level it was supposed to have attained prior to Katrina. This new floodwall was completed in mid-June, 2006. The original I-wall is still present along the other side of the Industrial Canal as well as to the south and north of the new T-wall. The only improvement made to the levees where the I-walls still exist is concrete armoring has been added to the base of the I-wall to prevent the erosion of the levee should water come over the top of the wall again.

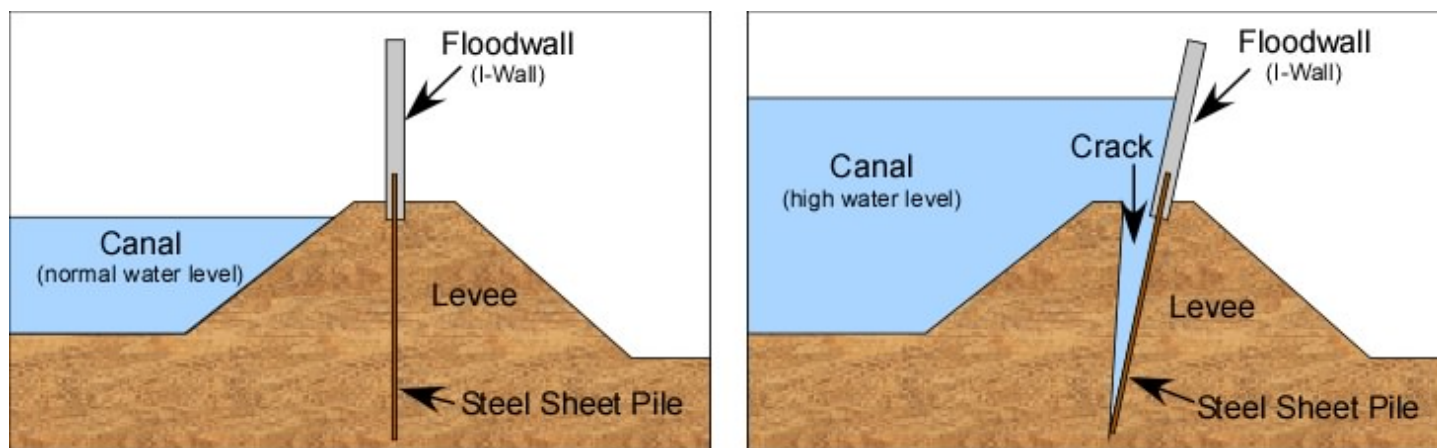
Although the floodwalls along the Industrial Canal were built in the 1970s, in 1985, the research branch of the Army Corps of Engineers conducted experiments on the I-wall design. They constructed a levee and enclosure in the Atchafalaya Basin (to the southwest of New Orleans) and began filling the area next to the levee and sheet pile floodwall with water. As the water rose against the floodwall, deflections of the floodwall began to occur and a gap opened on the water side of the floodwall which allowed the full hydrostatic force of the water to penetrate to the tip of the sheet piling (Jackson, 1988, Oner and others, 1997). This type of floodwall failure is illustrated in Figure 20. These findings were apparently never communicated to those in the Corps responsible for the design and construction of floodwalls in New Orleans (Marshall, March 14, 2006). The leaning floodwall seen in Figure 18 clearly shows that this also happened on the Industrial Canal floodwall during Hurricane Katrina. The force of the water pushing the wall outward toward the protected side coupled with removal of support by erosion caused by the water pouring over the top of the floodwall was the most likely cause of the catastrophic failures on the east side of the Industrial Canal (Fig. 21).

**Figure 20.** Illustration of crack development as water in a canal rises on the floodwall and pushes outward on the floodwall as observed in 1985 experiments by U.S. Army Corps of Engineers.

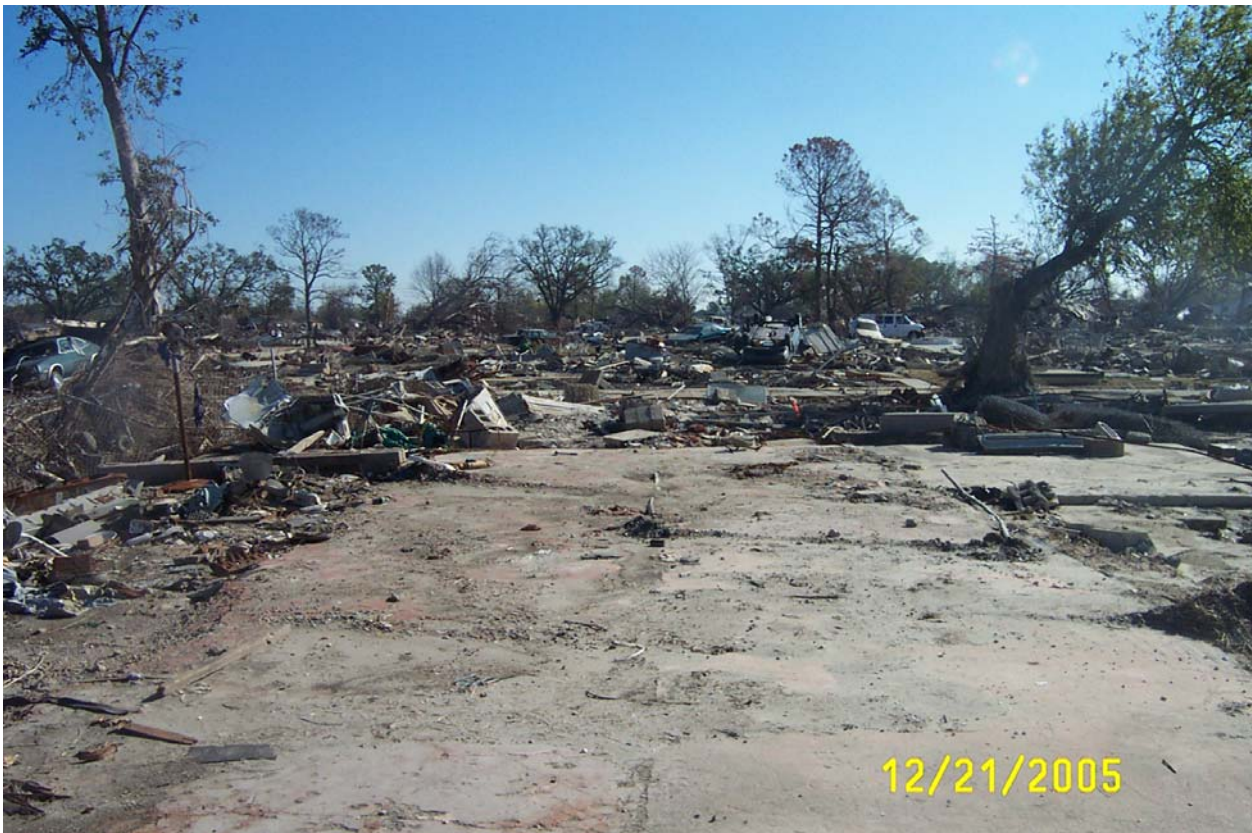
**Figure 22.** View of Lower Ninth Ward looking East as it appeared in December, 2005.

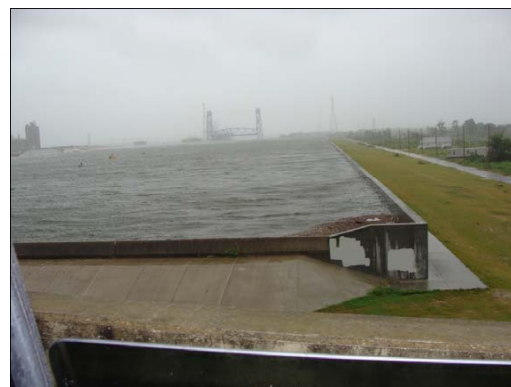
**Figure 23.** View of the Industrial Canal from the Claiborne Ave. Bridge looking North toward Stop 7 with the Florida Ave. Bridge (blue bridge) on the horizon. Photo as taken on the morning of Sept. 1, 2008 during the passage of Hurricane Gustav. Note the elevation drop from the post-Katrina floodwall (on the right) to the original floodwall to the left. Photo from U.S. Army Corps of Engineers.

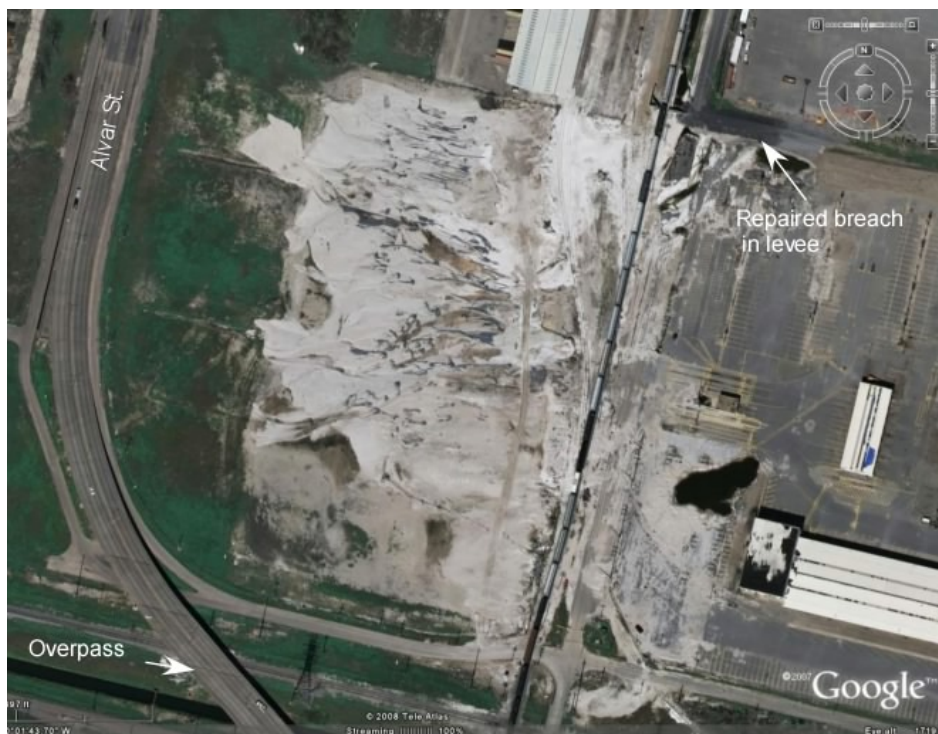
Before reaching the underpass, turn right on France Road and then left after crossing the railroad tracks. Along here immediately after Katrina there were deposits of white shells that were emplaced during the breach of a levee constructed mostly of shells on the west side of the Industrial Canal (one of two breaches on this side). Figure 25 is a Google Earth Image of these deposits.

**Figure 25.** Google Earth Image (acquired around May, 2006) of area near overpass to Alvar St. (point A in Figure 1) showing location of breached levee and deposits of shells (white material in center of image) that resulted from the breach. Industrial Canal is off the image to the right (east).

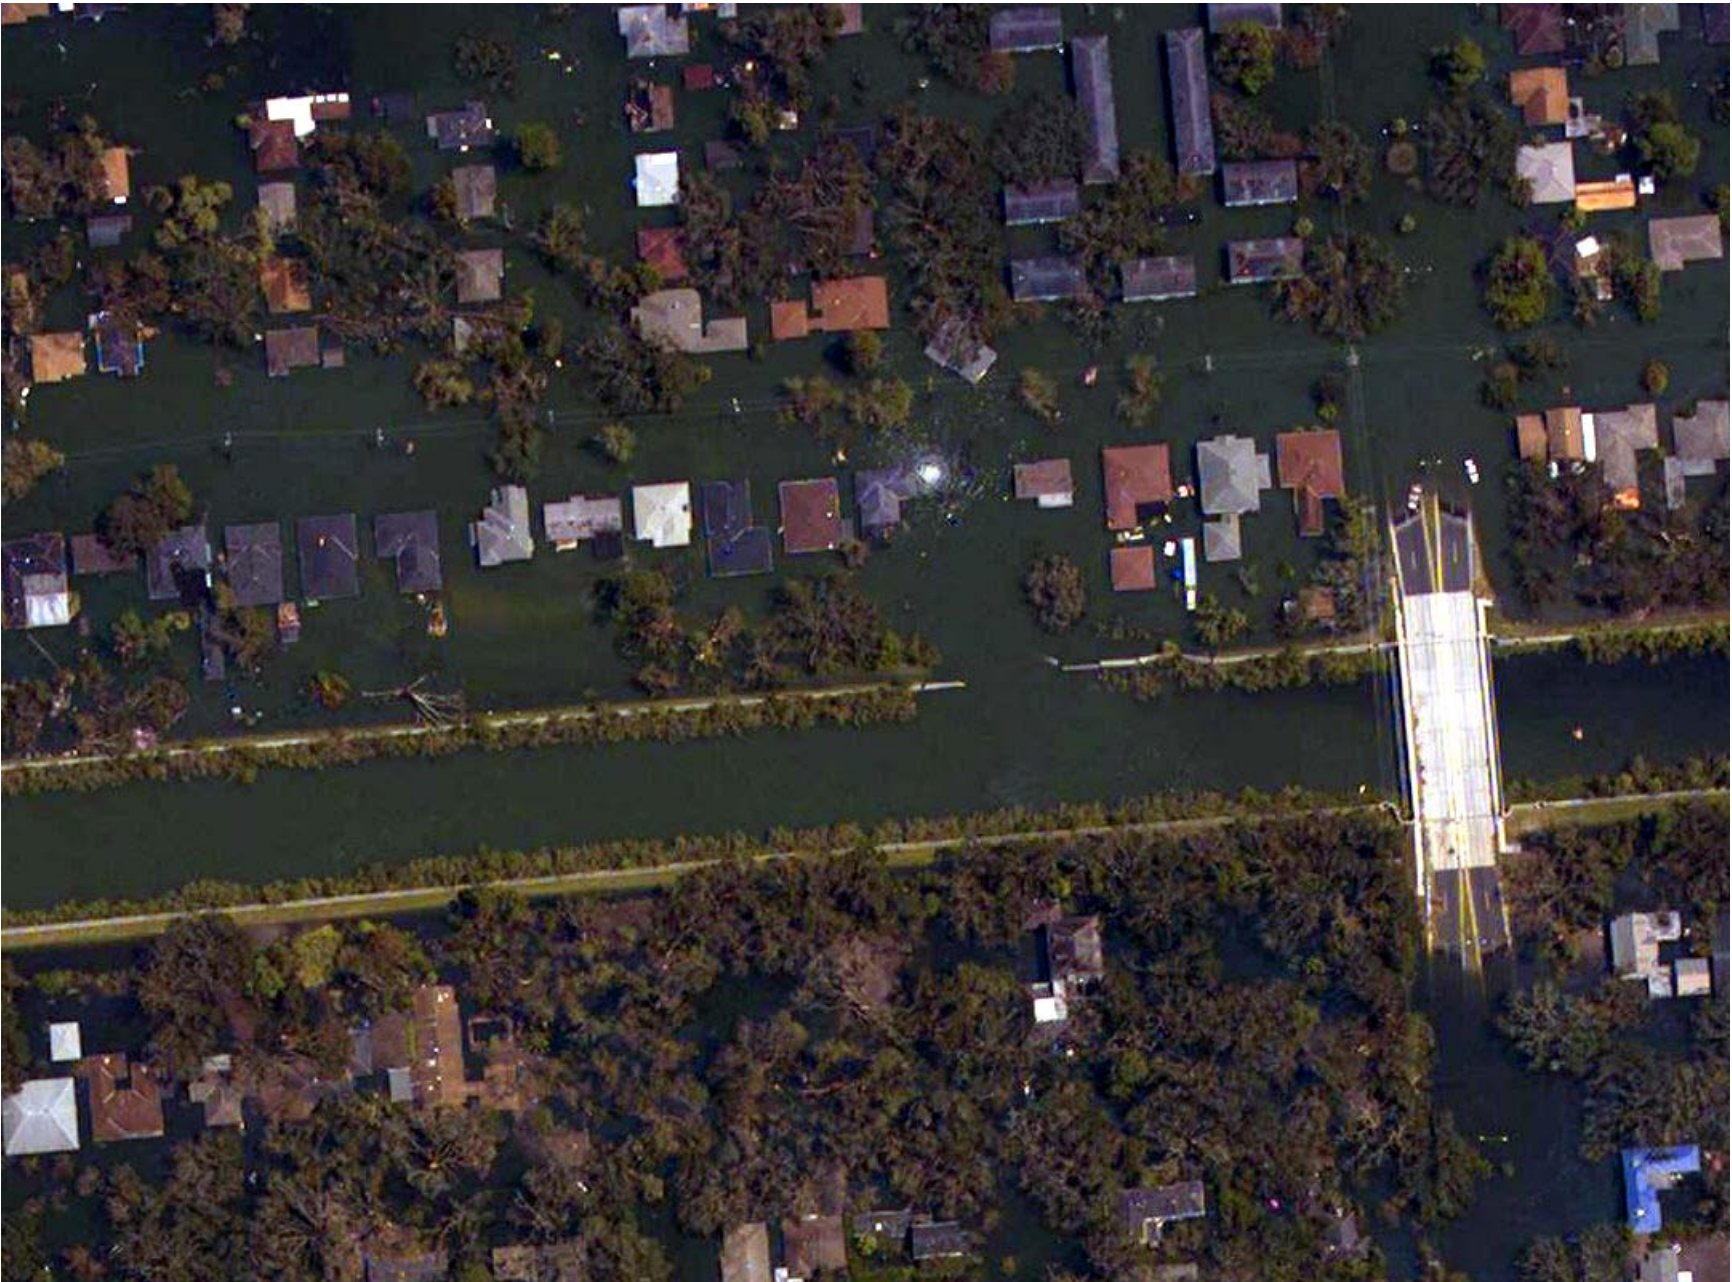
Comparing Figures 27 and 28 one sees that before Katrina a tree stood at the toe of the levee adjacent to the part that breached. That tree is laying on its side in the image taken on August 31, 2005 (Fig. 28). It is notable that many trees in the New Orleans area were blown over by the hurricane force winds on the morning of August 29 and when they are blown over they bring up a large root ball leaving a large hole in the ground. If this tree was one of those that were blown over, it is entirely possible that because of its location at the toe of the levee, it could have destabilized the levee and been

**Figure 28.** Air photograph of the area where the London Avenue Canal levee was breached near Mirabeau Ave. and Warrington Drive (Stop 4). Image acquired Aug. 31, 2005. Source: National Oceanic and Atmospheric Administration's National Geodetic Survey, Katrina Images - <http://ngs.woc.noaa.gov/katrina/>

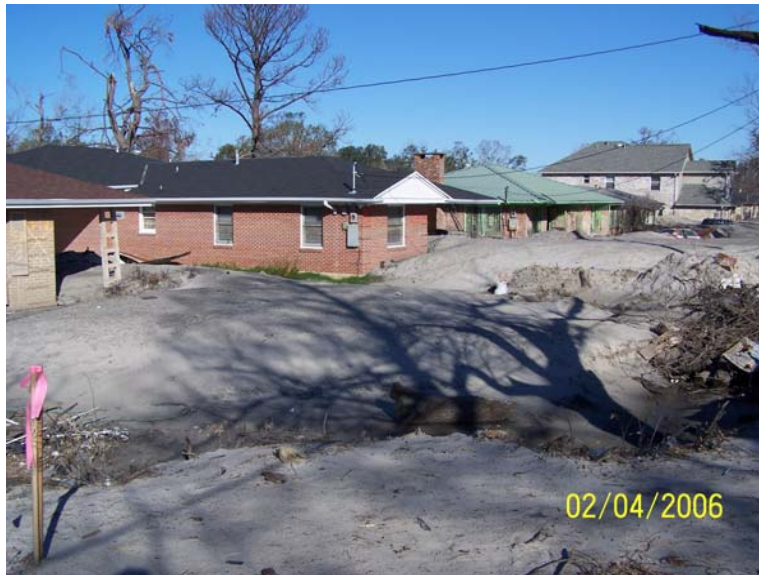
After the flood waters were pumped out, large deposits of sand were seen throughout the neighborhood. As of March 1, 2006 most of the sand had been removed from in front of the houses, and the back yards were cleared by January, 2007. Fig. 29 shows the sand deposits as they appeared before removal.

The sand did not originate from the canal water or lake water that was pushed into the canal during Katrina. Instead, it originated from beneath the levee. A geologic cross-section constructed from data on soil borings (done in 1986) (U.S. Army Corps of Engineers, 1989) from the banks of the London Avenue Canal is shown Figure 30. The cross-sections clearly show the presence of sand at a depth beginning between 10 and 15 feet below sea level. This sand is the same Pine Island beach sand that was deposited in the area between 4,000 and 5,000 years ago as shown in Figures. 2, 5 and 6.

**Figure 29.** Sand deposits near the south breach of the London Avenue canal. (a) sand ridges deposited in the wake of houses as the currents flowed down the driveways between the houses. (b) Sand deposits that buried two cars in front of house on Warrington Drive. (c) Ridges of sand filling the back yards of houses along Warrington Drive, just north of the breach. As of March 1, 2006, most of the sand in the front yards had been removed and as of mid January, 2007 most of the sand in the backyards had been removed.(d) one of the cars buried by sand in (b) during excavation.

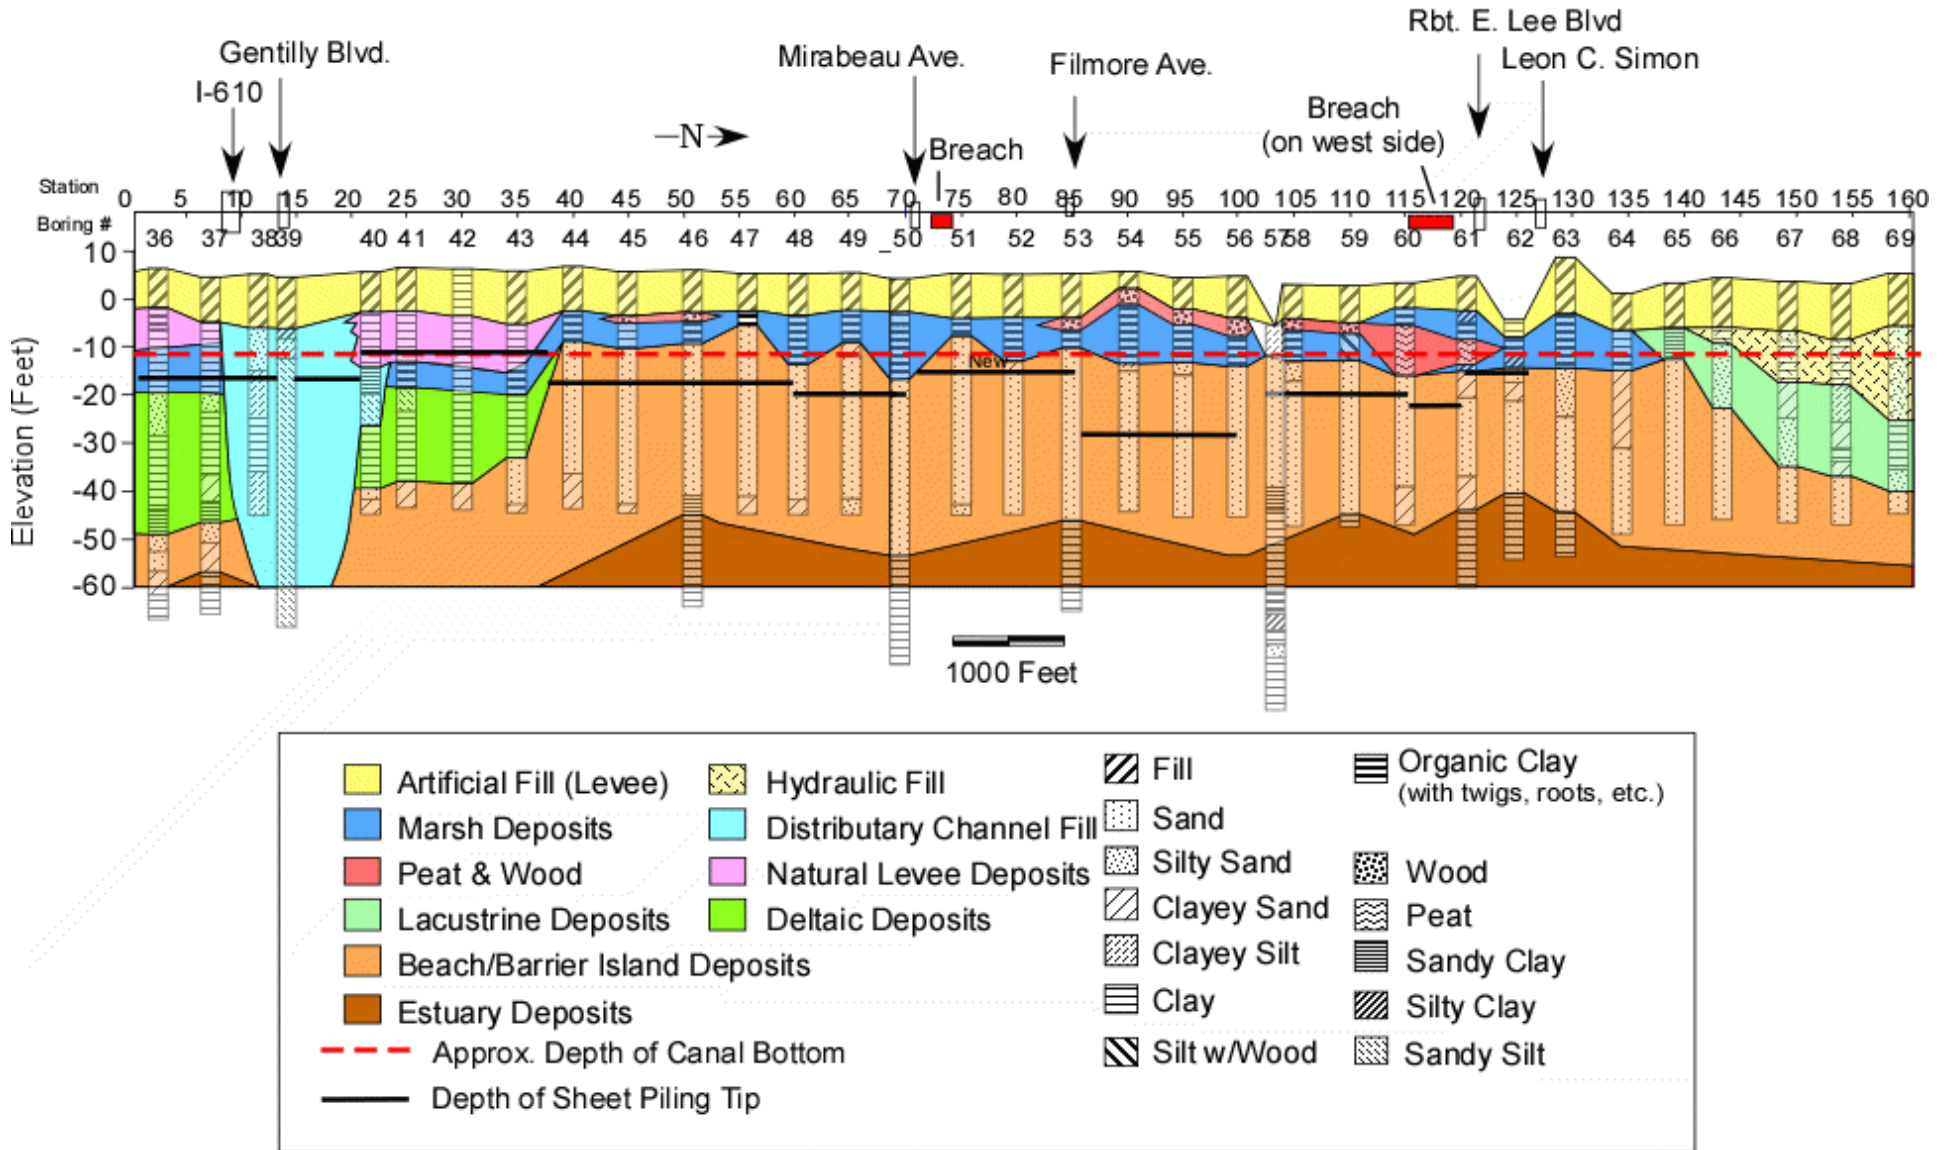
Figure 30. Geological cross-section along the east side of the London Avenue Canal constructed from data in U.S. Army Corps of Engineers (1989).

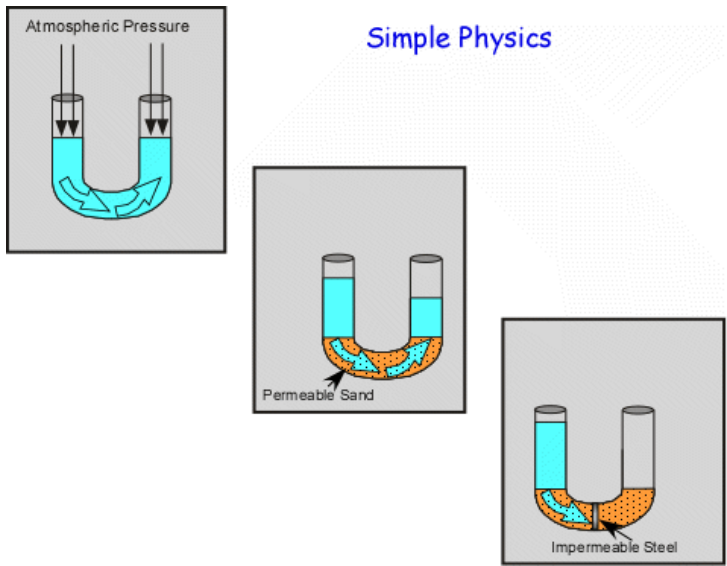
**Figure 31.** A simple thought experiment illustrates the principle of hydrostatic pressure by imagining a U-shaped glass tube. The water levels in each side of the tube rise to the same level because both sides of the tube are subject to the same pressure (atmospheric pressure). If a permeable material like sand is placed in the bottom of the tube and water is poured into one side, the water will find its way through the intricate pathways between the sand grains and will eventually, although not instantaneously rise to the same level on the other side of the tube. If an impermeable barrier is placed in the sand in the bottom of the tube, then the water will not get from one side to the other.

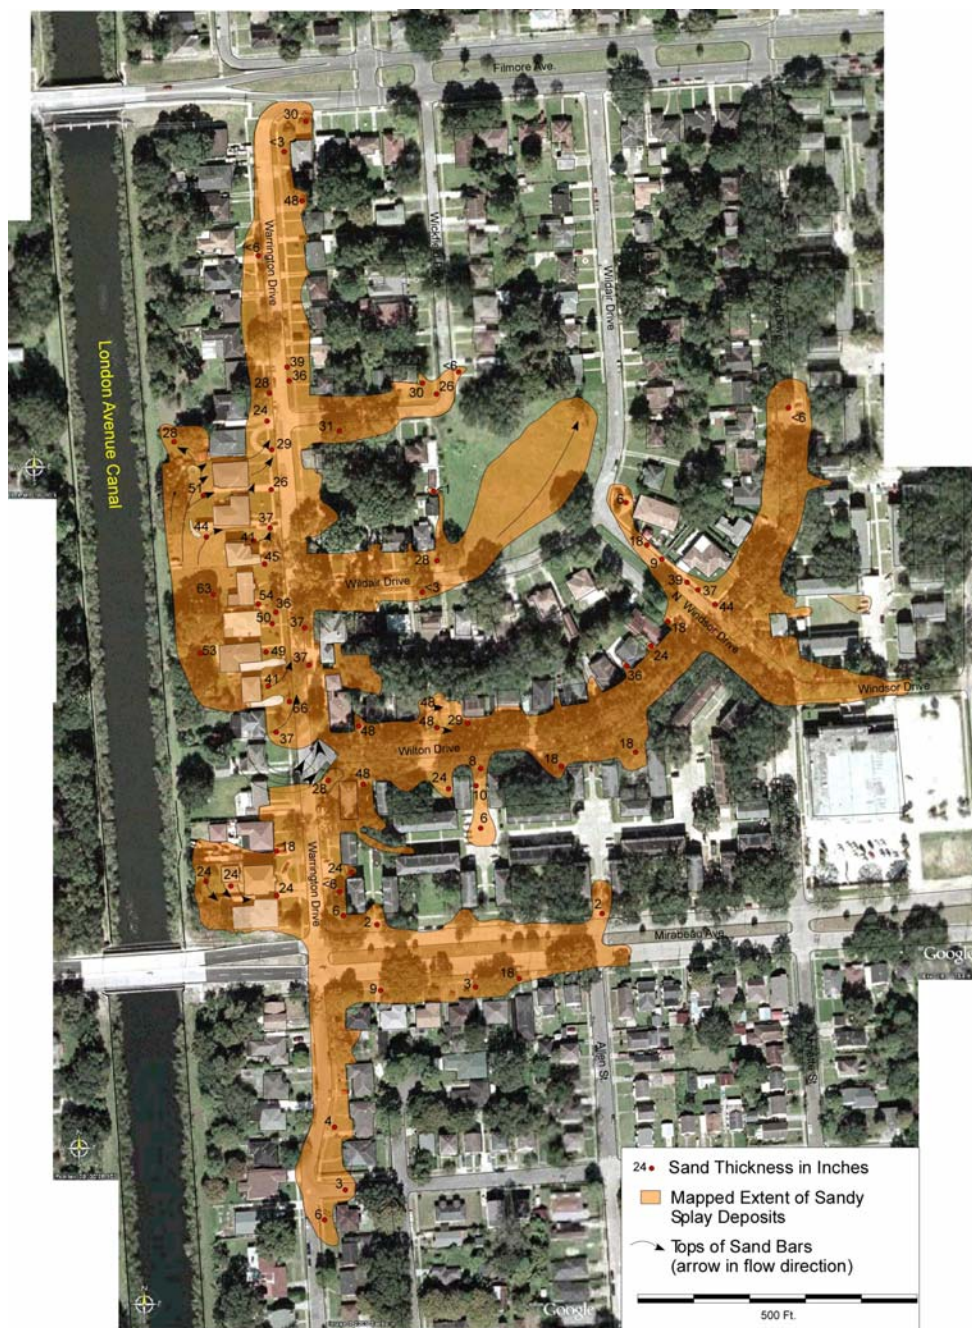
**Figure 33.** Preliminary map of sand deposits (by S. A. Nelson) from the Mirabeau Ave. breach on the London Ave. Canal. Underlying image is a composite from Google Earth.

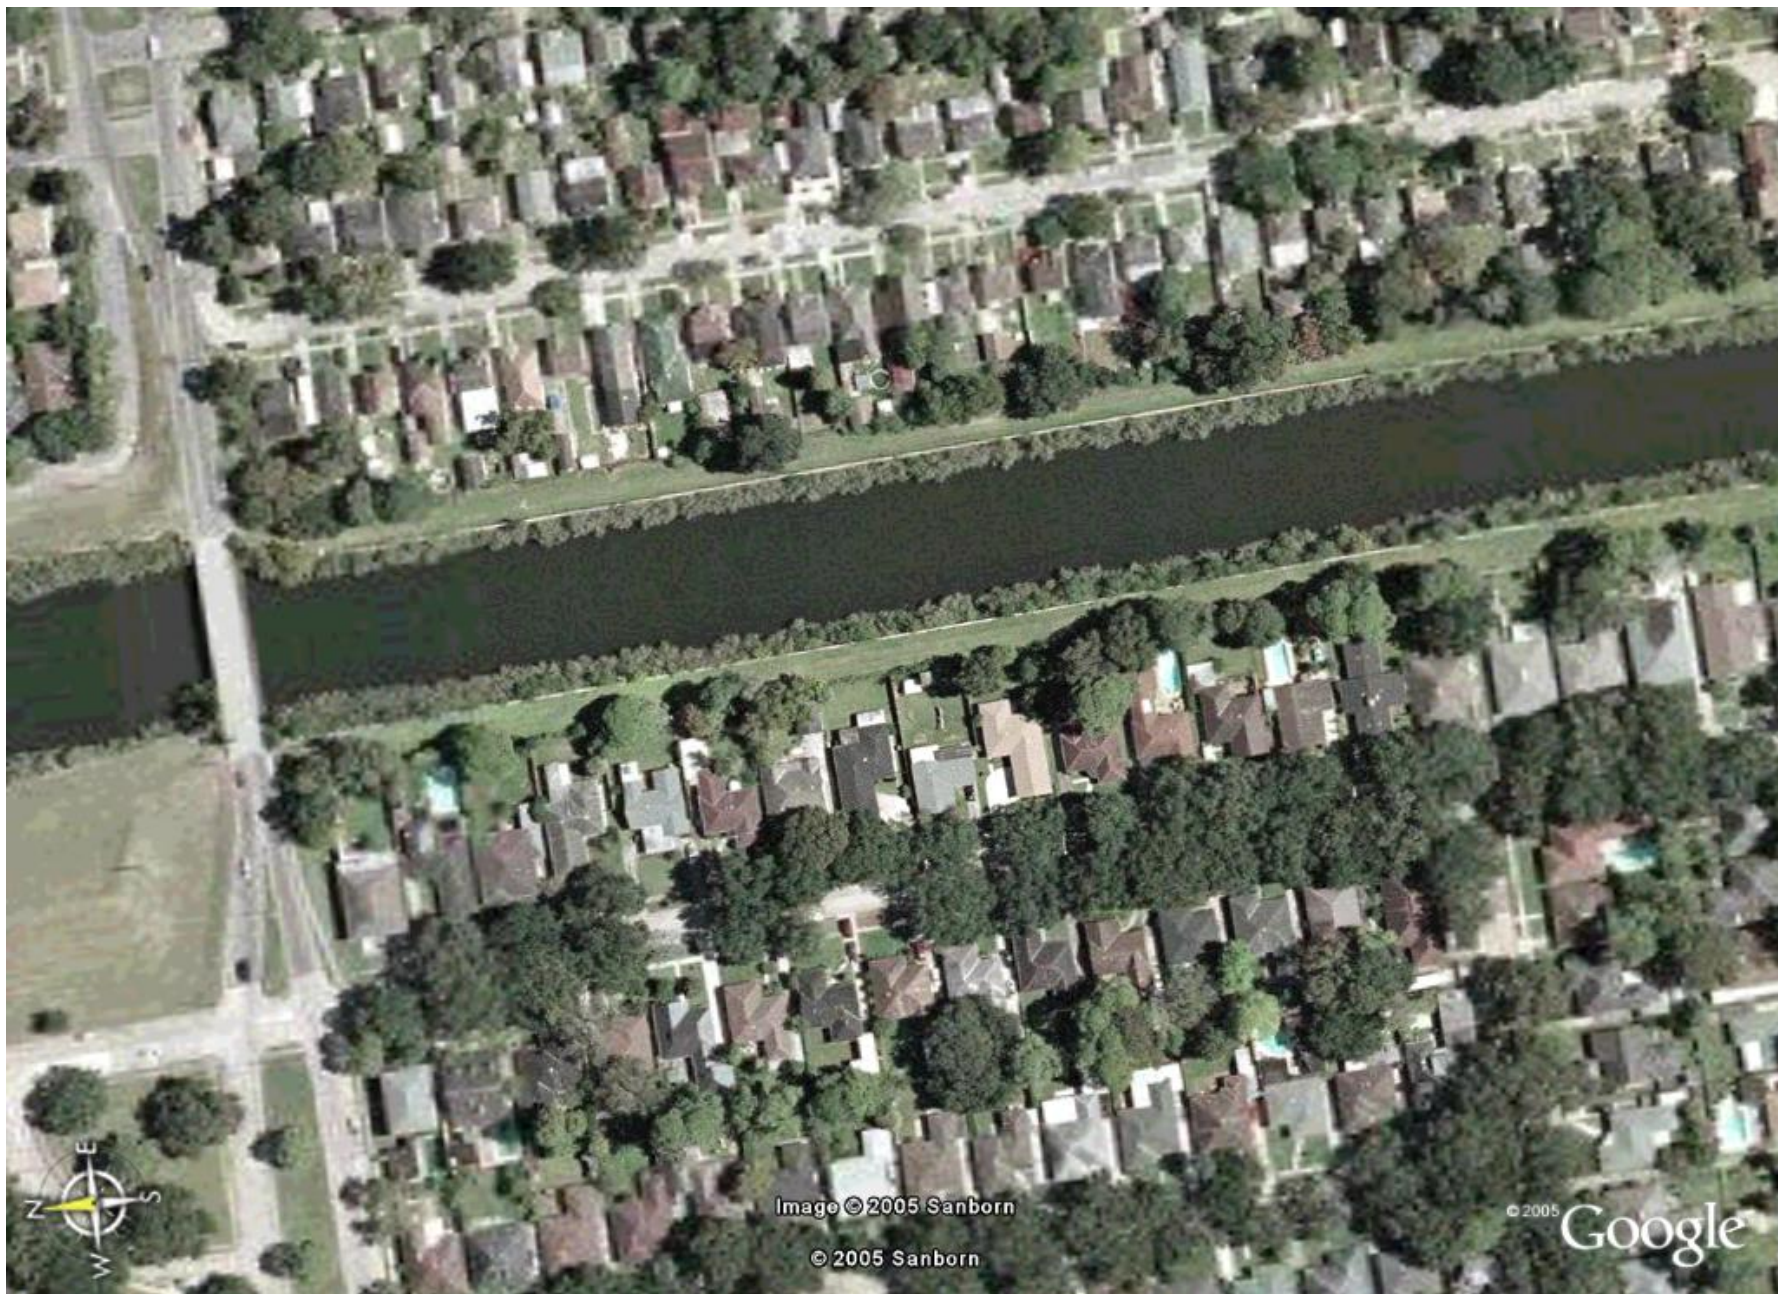
Stop 5 is on Pratt Drive near the intersection with Robert E. Lee Blvd. where the London Avenue Canal levee was breached on the west side of the canal. The estimated chronology determined by IPET (2006) suggests that this breach occurred sometime before 9:00 AM on August 29, 2005. Figure 34 shows an image of this area before Katrina. Figure 35 shows approximately the same area in an image taken on August 31, 2005 after the breach occurred and before the floodwaters had been pumped out.

**Figure 34.** Satellite image of the area along the London Avenue Canal near Robert E. Lee Blvd. and Pratt Drive (Stop 5), where the levee was later breached during Hurricane Katrina. (Source - Google Earth)

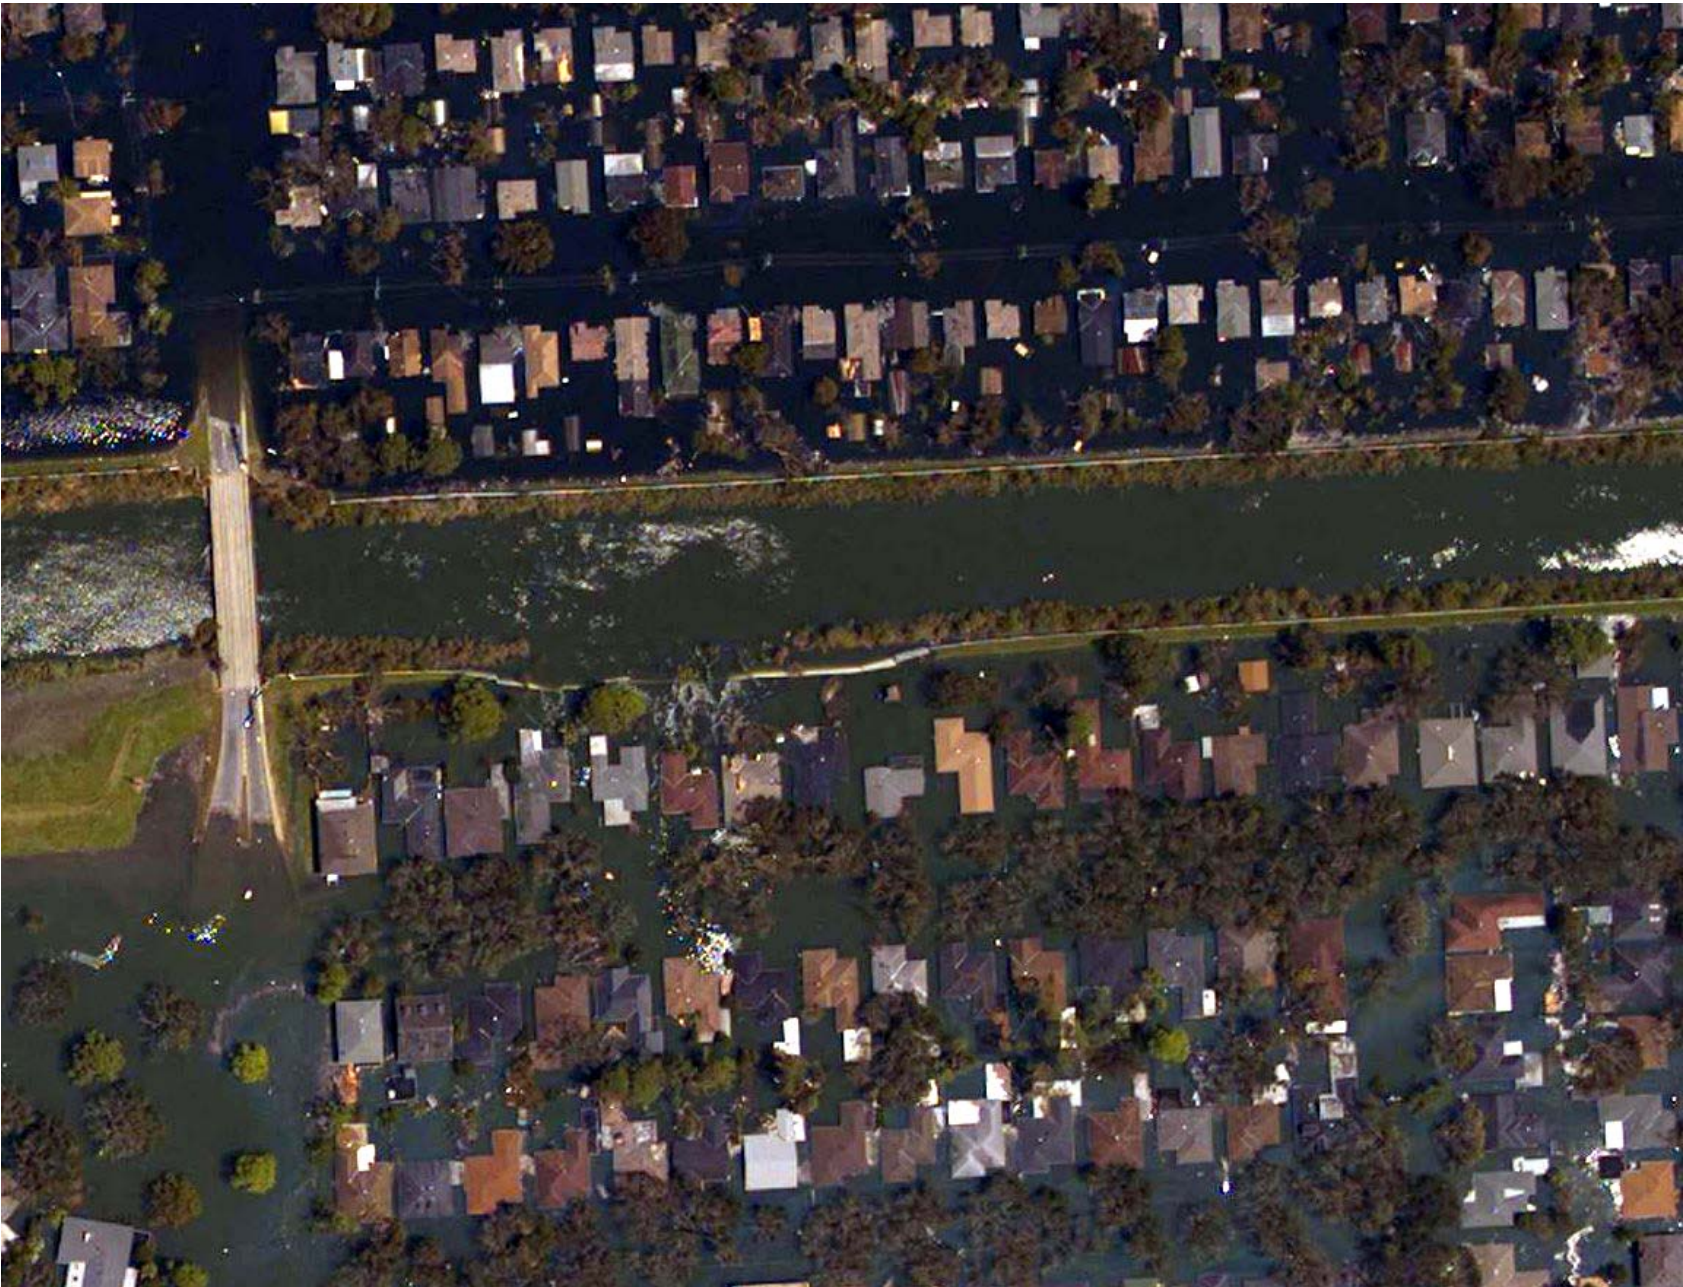
Note in Figures 34 and 35 that there is abundant vegetation along the banks of the canal inside the floodwalls. During the surge event in the canal, this vegetation trapped debris flowing in the canal and the height of this trapped debris in the vegetation could be used to estimate water level. Such evidence observed shortly after the storm indicates that the water level in the canal was no higher than about 3 feet from the top of the floodwall. Note also in Figure 35 how the vegetation along the bank of the failed floodwall shows a distinct edge marking the pre-failure position of the floodwall. During the failure, the floodwall slid away to the west as a result of the water pressure against the floodwall and sheet pilings.

**Figure 35.** Air photograph of the area where the London Avenue Canal levee was breached near Robert E. Lee Ave. and Pratt Drive (Stop 5). Drive. Image acquired Aug. 31, 2005. Source: National Oceanic and Atmospheric Administration's National Geodetic Survey, Katrina Images - <http://ngs.woc.noaa.gov/katrina/>
