# Hurricane Katrina - What Happened? The Geology of the Katrina Disaster in New Orleans Field Trip Guide

August 2015

Stephen A. Nelson  
Department of Earth &  
Environmental Sciences  
Tulane University  
New Orleans, LA  
[snelson@tulane.edu](mailto:snelson@tulane.edu)

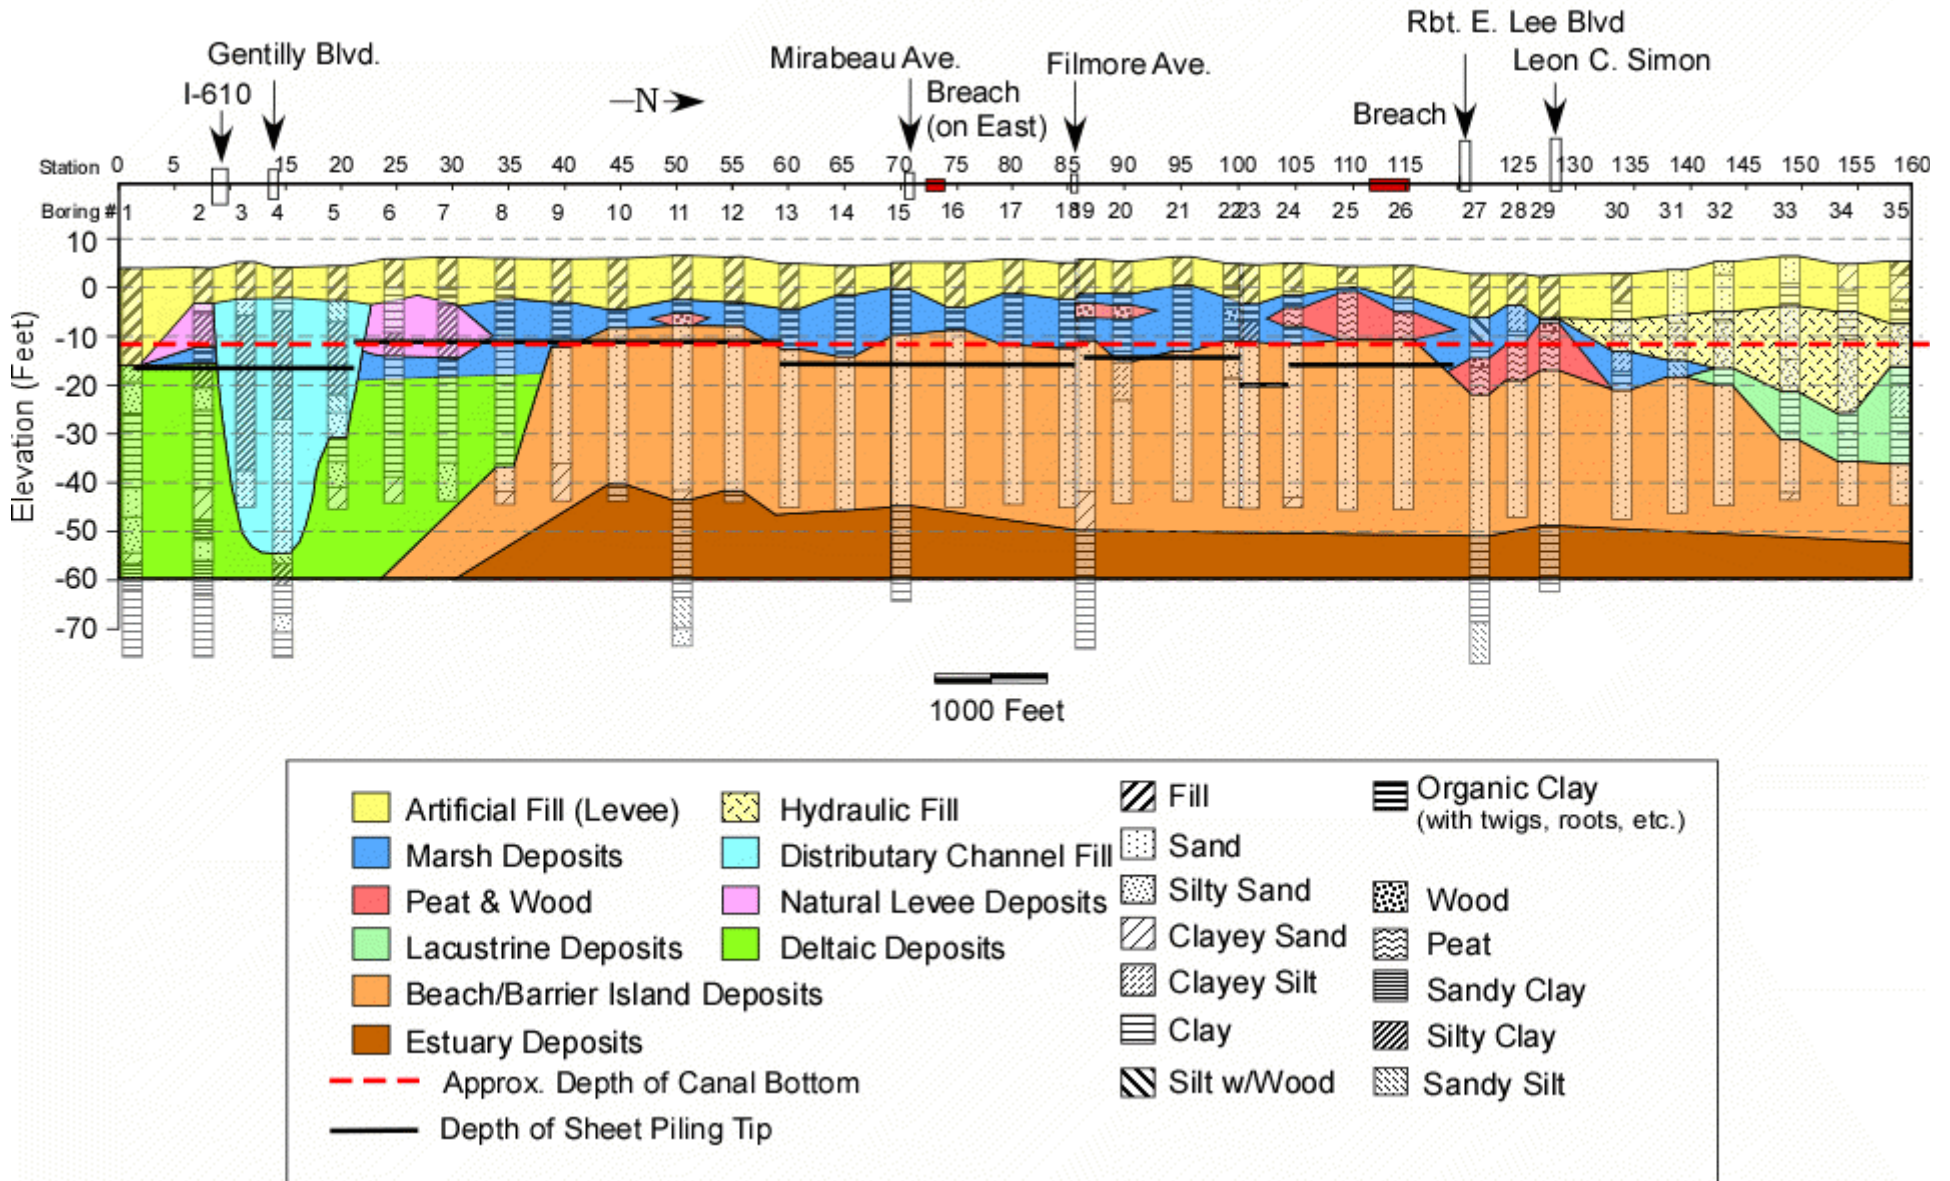
A geologic cross section of the west side of the levee is shown in Figure 36. Note that the conditions beneath the surface are similar to those at the Mirabeau Ave. breach, with a sand layer about 12 feet below sea-level. Here a peat layer is also observed. Peat is organic matter (vegetation that is in the process of decay). It represents material accumulated in swampy areas and indicates that this area was a swamp in the not too distant past. Peat is very porous and has the additional property that it shrinks when it is dried out and expands when water is added. The presence of peat can make for very unstable soil conditions.

Although the “as built” design documents (U.S. Army Corps of Engineers, 1994) show that the depth of the sheet pilings were at 14 feet below sea level, water still had access to the peat layer and thus the peat layer could have played a role in the collapse of the levee. Another phenomenon that was observed here was that of ground heave in the area of collapse. Water, and perhaps expanding peat, apparently pushed up the levee and land surface on the west side of the canal prior to collapse of the levee. This is illustrated in Figures 37 and 38. Although the clubhouse shown in Figure 37 has been removed during the repair of the levee, the house (with the mispositioned air conditioner compressor) is the 5<sup>th</sup> house south of Robert E. Lee Blvd. on Pratt Drive (this house was demolished in early November, 2006).

Figure 36. Geological cross-section along the west side of the London Avenue Canal constructed from data in U.S. Army Corps of Engineers (1989).

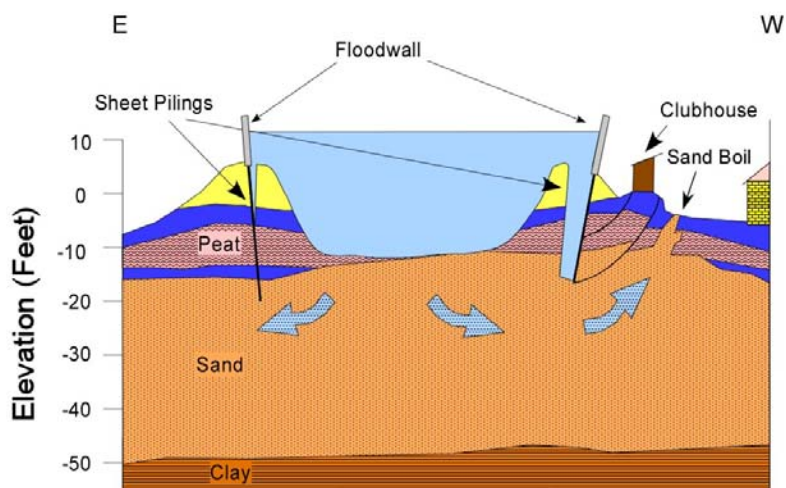
Heaving at London Ave. Canal North Breach

**Figure 38.** Water in the canal at the north breach of the London Ave. Canal puts lateral pressure on the floodwall and sheet piling along with water driven through sand under the sheet pilings (and possibly through peat, depending on the depth to which the sheet pilings actually were driven) pushes up the ground outside of the canal in a phenomenon known as heave. This would eventually provide a flow path for water which would undermine the levee and cause its collapse. This may have been responsible for the eventual collapse of the floodwall on the west side of the canal resulting in the breach. The floodwall on the east side of the canal was leaning, but did not fail to create a breach.

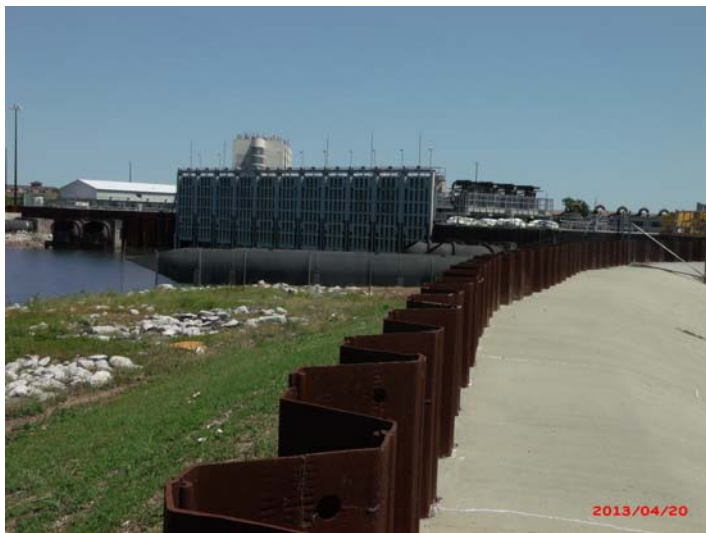
Here is a close up view of the interim gates and pumps near the Lake end of the London Avenue Canal (See Figure 41). This structure was built in 2006 to prevent storm surge from Lake Pontchartrain from entering the canal. Similar structures were also built on the Orleans and 17<sup>th</sup> Street Canals. The gray structures across the canal are the gates which are closed prior to a hurricane. Platforms on the both sides of the canal behind the gates house pumps and generators to drive the pumps. The pumps take water out of the canal and pump it around the gates where the water comes out through the black pipes on either side of the gates. The gate/pumps have been used successfully to keep storm surge out of the canals and water drained from the city during hurricanes Gustav in 2008 and Isaac in 2012.

When the gates/pumps were constructed in 2006, they were estimated to have a useful life of 5 years. They are thus scheduled to be replaced by similar more robust facilities as part of the 100-year protection plan and construction is now in progress to north here.

Although these structures will probably adequately protect the canal from storm surge, it does require coordination of pumping between the pumps at the south ends of the canals and the pumps at the gates. A safer plan would be to do away with the gates altogether by continuing the Lakefront levees across the mouths of the canals and moving the pump stations to pump over the levees directly in the Lake. This is how it works on the more recently constructed drainage canals in Jefferson Parish and Eastern New Orleans. The Corps of Engineers, however, has decided that this safer plan is too expensive.

**Figure 41.** Gate and pumps near the Lake end of the London Avenue Canal (Stop 6).

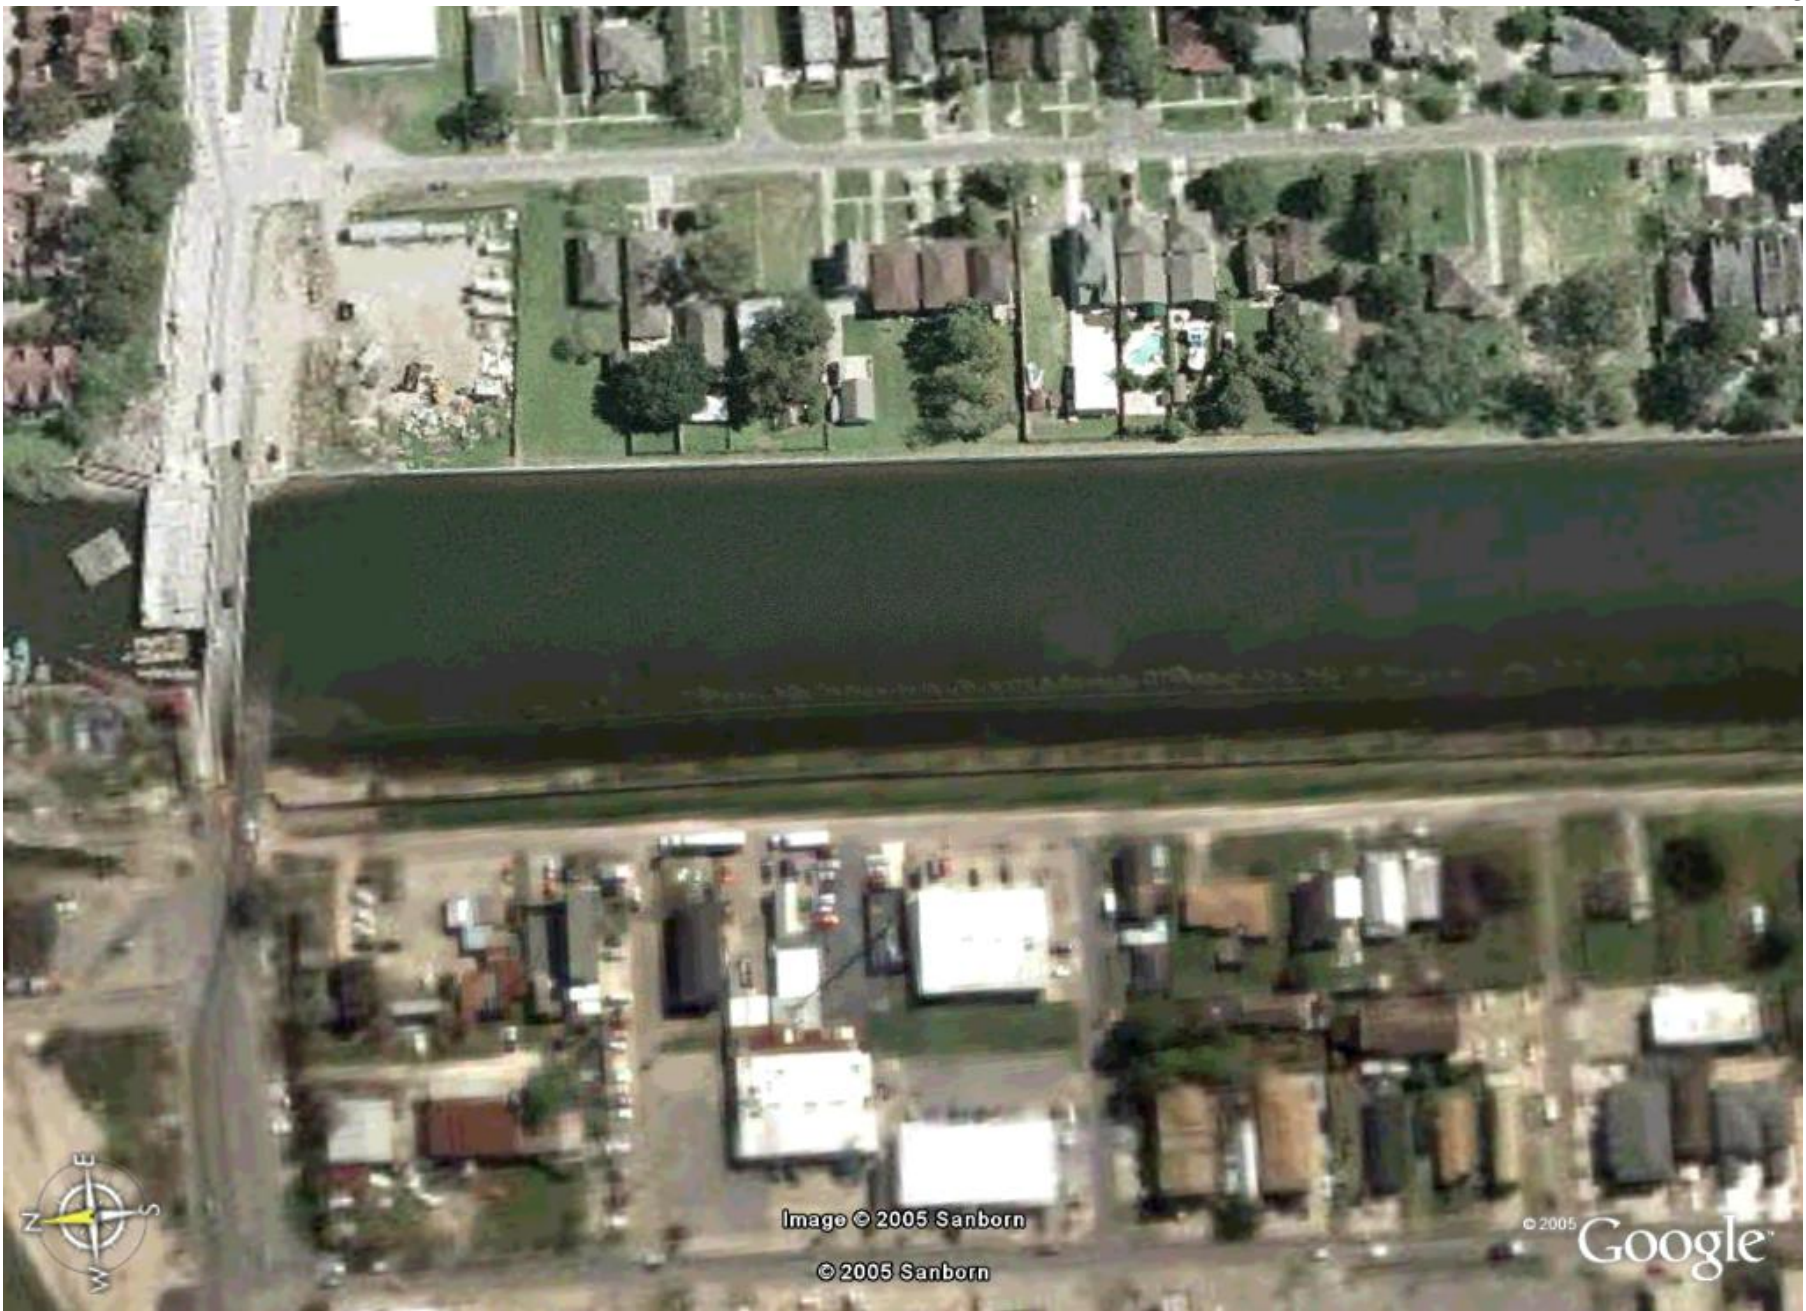
**Figure 41.** Satellite image of the area along the 17th Street Canal near the Old Hammond Highway Bridge (under construction), where the levee was later breached during Hurricane Katrina (Stop 8). (Source - Google Earth)

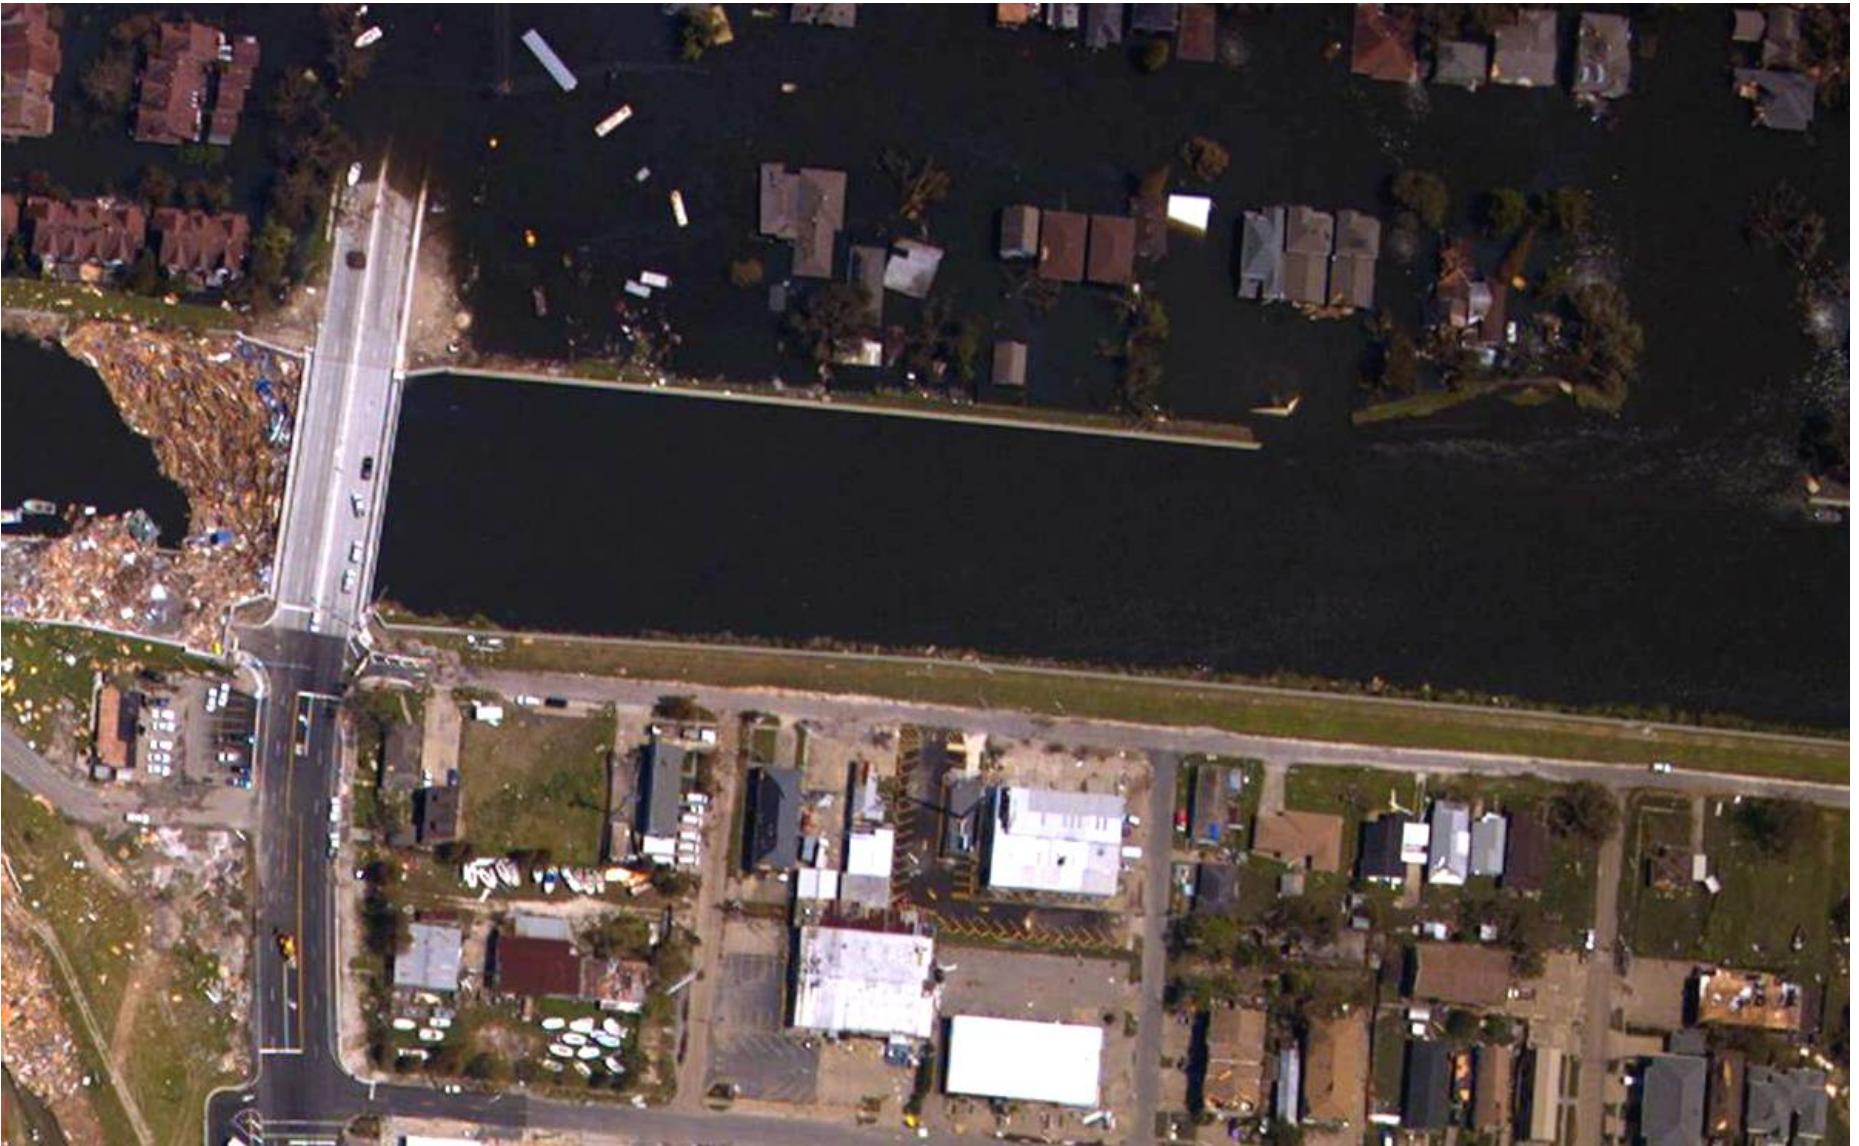
Note that the breach occurred along Belaire Drive where, like the along the London Avenue Canal, houses are backed up against the levee. (All houses bordering the breach area on the west side of Belaire Drive were demolished by the Corps of Engineers in July, 2006). Here, the main part of the breach occurred in a recently cleared empty lot. A tree in that empty lot, close to the levee toe (Fig. 41) can be seen to be toppled in the August 31 image (Fig. 42). Just as at the Mirabeau breach, no eyewitness are available to tell us if the tree toppled due to the hurricane force winds on August 29 or as a result of the levee breach. Without such observations, we note that it is entirely possible that if the tree was toppled by the winds it could have been responsible for the breach at this locality. A house to the south of the main part of the breach, built on a chain wall foundation, was completely removed (see also the photo in the lower right of Figure 51). Natural gas from a line that fed the house can be seen bubbling up through the floodwater in Figure 42. Another house to the north of the empty lot was built on a slab and was also removed by the rushing floodwaters. The natural gas line that fed that house can also be seen bubbling up natural gas, just to the right of the yellow spot (roof of a school bus) in Figure 42.

Also visible in Figure 42 is a section of the levee that was displaced eastward by about 45 feet. Figures 43 and 44 are oblique aerial views of this displaced levee and floodwall. The area in front of the displaced levee was pushed horizontally outward near the position of the yellow school bus. This can also be seen in Figure 45 where the toe of the slide block is seen as an abrupt change in slope of the ground surface.

**Figure 42.** Air photograph of the area where the 17th Street Canal Levee was breached near Belaire Drive (Stop 8). Image acquired Aug. 31, 2005. Source: National Oceanic and Atmospheric Administration's National Geodetic Survey, Katrina Images - <http://ngs.woc.noaa.gov/katrina/>

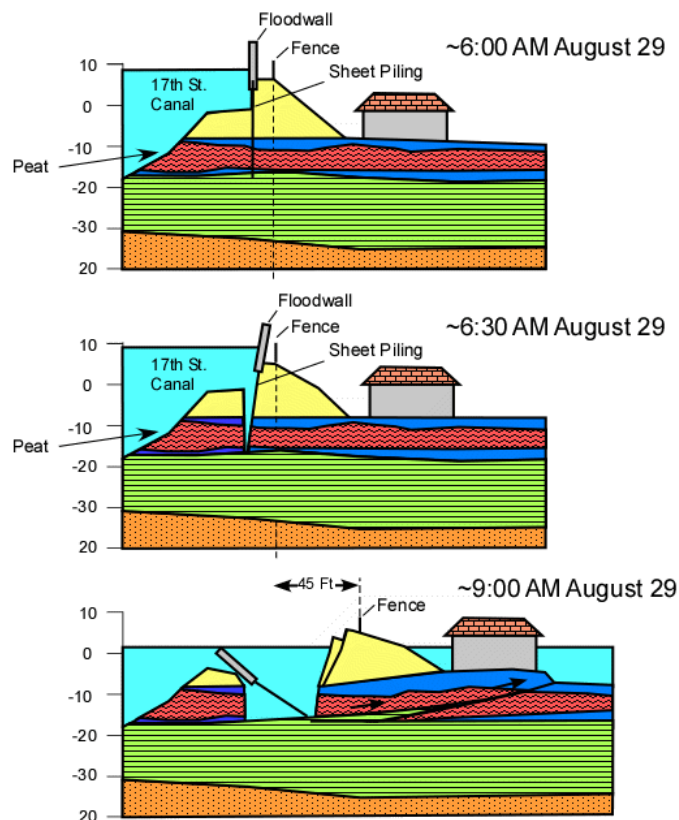
Failure of the 17th St. Canal Levee & Floodwall

The most recent information from the Interagency Performance Evaluation Task Force (IPET) [2006] suggests that the floodwall and levee failed at the 17<sup>th</sup> St. Canal as a result of the water level rising to an elevation of about 8 feet above sea level in the canal. The floodwalls were designed to have tops at an elevation of 14 feet above sea level, but IPET data indicate that by the time of Katrina the tops of the floodwalls on the 17<sup>th</sup> Street Canal were about 12.5 feet above sea level. Thus, IPET estimates that water levels in the canal were still 4 feet below the tops. IPET has collected eyewitness accounts and scoured the neighborhood for clocks that were stopped as a result of the flooding in order to determine the time of the breach. One eyewitness account suggests that the floodwall at the breach area was leaning to the protected side at about 6:30 AM on August 29 and other accounts suggest that the breach was open by about 9:00 AM. This, along with levee breach experiments conducted on scale models in a large centrifuge led IPET to suggest that as water levels rose in the canal, the floodwall and sheet piling was pushed outward toward the land side, opening a gap between the levee and the floodwall on the canal side. This gap allowed water to seep down along the sheet piling and eventually push the levee on the protected side outward away from the canal. Based on sections of the breached levee observed in the breach area, IPET suggests that the failure did not occur along the peat layer, but along a layer of weak clay at the base of the peat. This clay layer was thrust over and through the peat as illustrated in Figure 48.

**Figure 48.** Diagrammatic cross sections across the 17<sup>th</sup> St. Canal in the vicinity of the breach. Based partially on a sketch in Seed and others (2005), ILIT (2006) and IPET (2006).

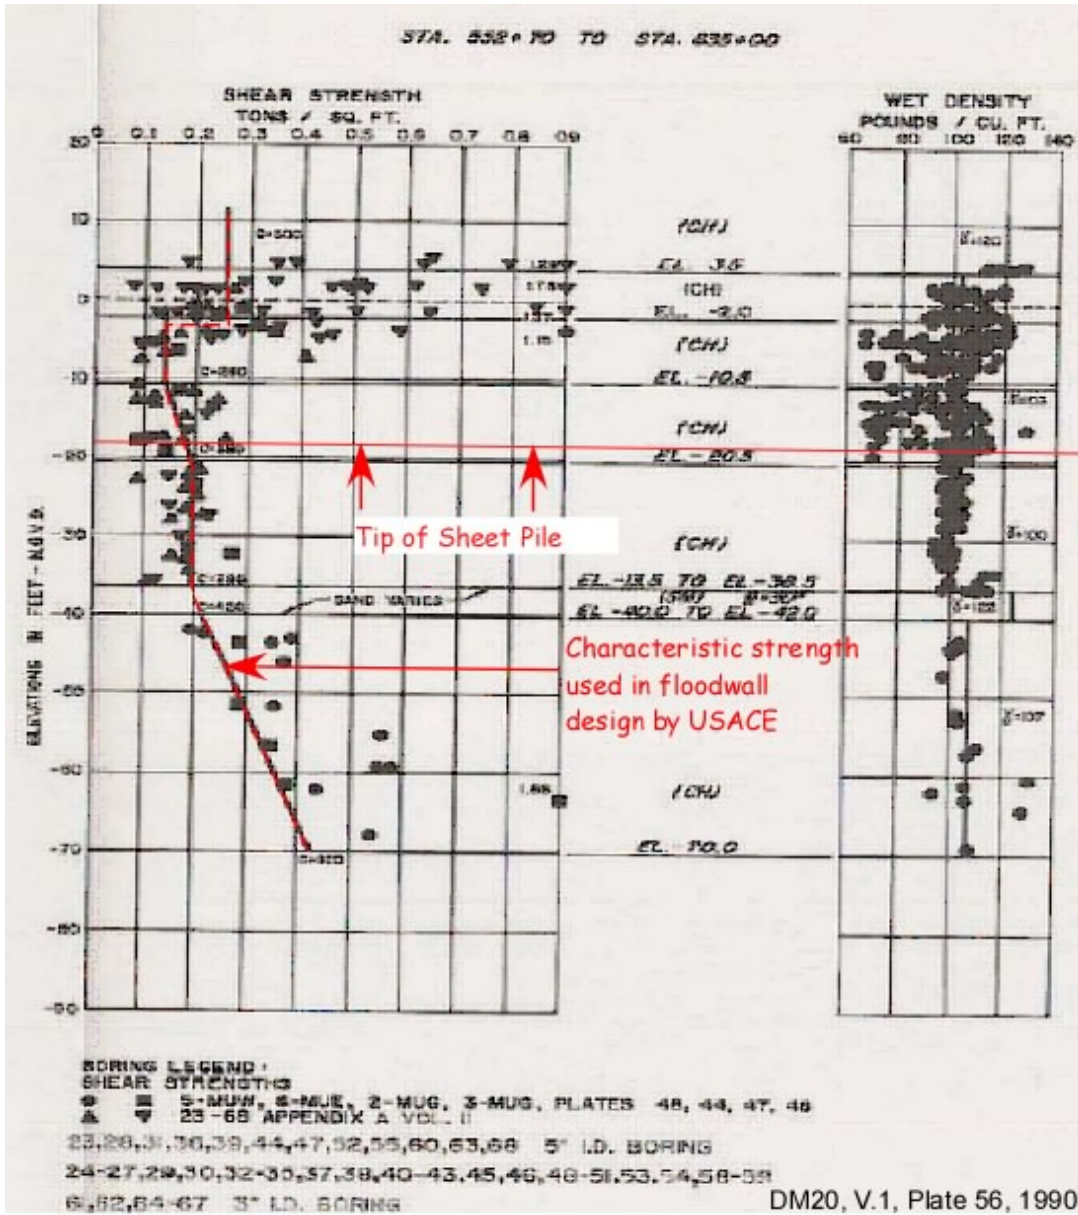
Figure 50 shows graphs of shear strength and wet density versus depth as obtained on samples from soil borings (done before 1990) along an 1800 foot section of the 17<sup>th</sup> St. Canal, which includes the area of the breach. Red lines have been added for emphasis, one showing the depth to the tip of the sheet piling within the breach zone (17.5 feet below sea level) and the other highlighting the characteristic strengths used by the designers to determine the stability of the floodwall. Between the two graphs are lines separating the different kinds of soils. Note that all soils above about -37 feet are shown as CH soils, which are clays with high plasticity. If one looks at the geologic cross-section in Figure 47, there is an interval between about -10 and -18 shown as peaty clays (the same peat that came to the surface as a result of the levee breach). Peats have low density and thus the wet density data in Figure 50 clearly shows a zone of low density material in the depth range between 0 and -20. The strengths in this zone show a range, but the designers chose to use an average value. What is even more troubling, however is that in the depth range between about -15 and -37, the nearly all of the measured strengths fall below the characteristic strength line used in calculations of FS. This is the critical zone, where all investigators think the failure occurred during Katrina. If the strengths were overestimated by 30%, then the true FS value would fall below 1.0 and the structure would be unstable (just as it was during Katrina).

**Figure 50.** Shear strength and wet density versus depth along an 1800 foot section of the 17<sup>th</sup> St. Canal which includes the area of the breach (from U.S. Army Corps of Engineers, 1990, the Design documents for the 17<sup>th</sup> St. Canal floodwall). The author has added the red lines and red labeling showing the depth to the tip of the sheet piles in the breach zone and the characteristic strength values as a function of depth that the Corps used to determine the stability of the floodwall system.

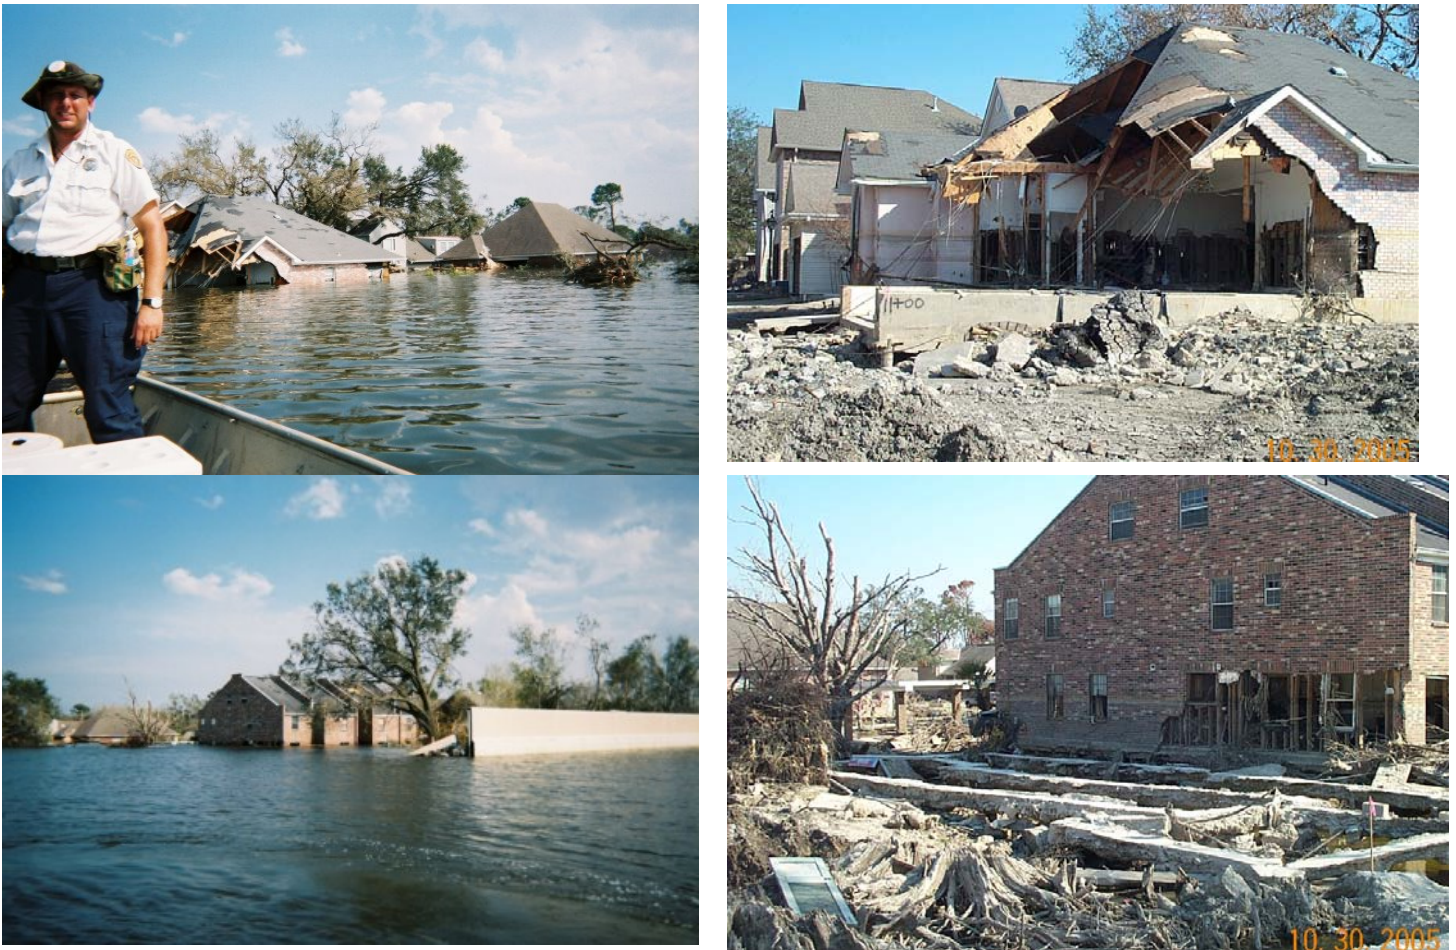
Although throughout the field trip we have seen the water line (scum line) left by standing water, this line does not represent the maximum flood depth. As seen in Figure 51, comparison of the photos on the left, taken when the water level was near its maximum with the water line left on the same structures (photos on the right) indicate that the maximum flood depth was about 1.5 to 2 feet higher than the line left by standing water.

**Figure 51.** Comparison of water levels on Sept.1, 2005 (photos on left by Kevin Himmel), with water lines on same structures indicate lines left by standing water are about 1.5 to 2 feet lower than the maximum water level. Note large block of peat in photo at the upper right. In photo at lower right, note the chainwall foundation of a house that was removed by the burst of water when the levee was breached and the cypress stump from a tree that was probably cut down 100 years ago when this Lakeview neighborhood was reclaimed from the cypress swamp.

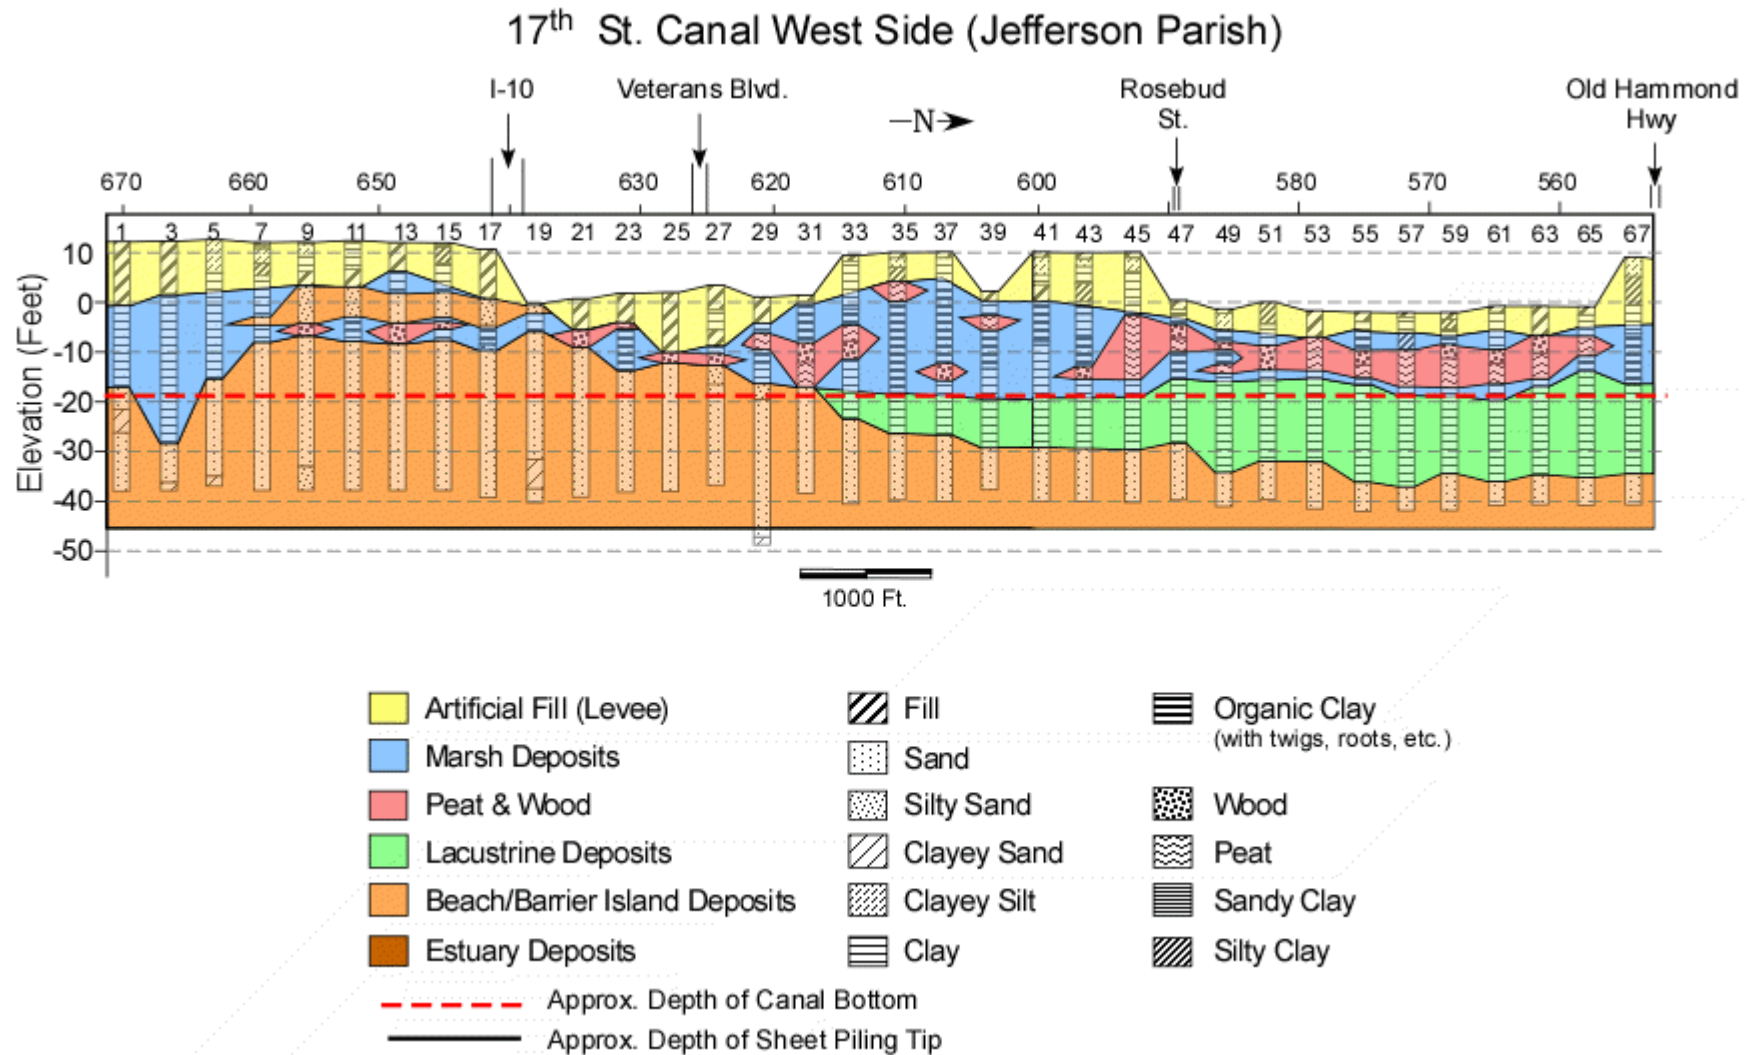
It is notable that the same peat layer and the same levee design and construction are present on the Jefferson Parish side of the canal, which by luck or the path of the storm, did not breach on August 29, 2005. Figure 52 shows a geological cross section of the west bank (Jefferson Parish side) of the 17<sup>th</sup> St. Canal constructed from data provided on the Army Corps of Engineers IPET web site where it can be seen that the same geologic materials are present beneath the Jefferson Parish side as are found on the Orleans Parish side (compare with Figure 47). One major difference on the Jefferson Parish side is that a street occupies the area next to the levee and there are no trees, houses or swimming pools abutting the levee on that side.

**Figure 52.** Geologic cross section of the west bank of the 17<sup>th</sup> St. Canal constructed from data provided to the U.S. Army Corps of Engineers (1990). Note that levee heights appear inconsistent because some of the borings were taken at the toe of the levee rather than on the levee crest. Depth to the tip of the sheet pilings is currently not available for the west side of the 17<sup>th</sup> St. Canal, although Grissett (April 14, 2007) has information that the sheet pile tips extend only to about 4 feet below sea-level at southern end of the canal (south of Veterans Blvd.).

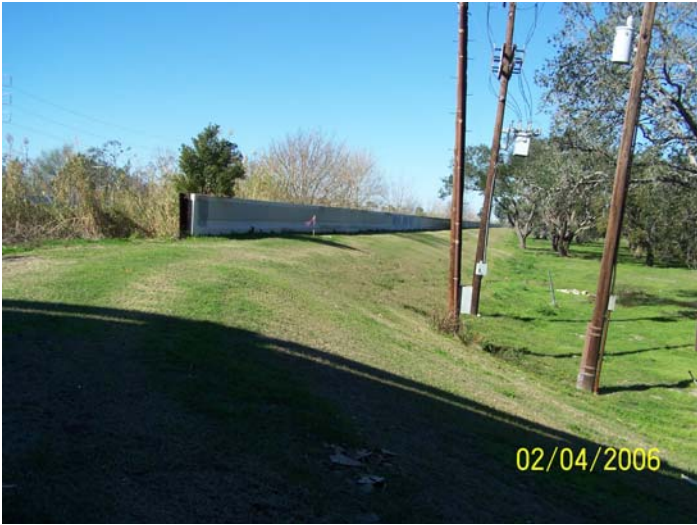
Stop 9 is at the levee of the Orleans Canal just under the I-610 overpass. As we walk up to the levee, note that the floodwall on the top of the levee abruptly ends about 40 yards north of the overpass (Fig. 53). An approximately 100 yard gap thus exists in the flood protection on the canal between the end of the floodwall and Pump Station Number 7 to south on the other side of the overpass. A smaller gap exists on the other side of the canal as well. During Katrina, water from the Orleans Canal was flowing freely through this gap as evidenced by the erosion that occurred around the support structures for the freeway overpass (Figure 54). Fresh concrete has since been poured around the support structures and the levee has been raised about 2 feet from its pre-Katrina level in an attempt to fix the problem. Why was such an obvious gap in the flood protection system allowed to remain? The Independent Levee Investigation Team (2006) offers the following explanation. Apparently, the Orleans Sewerage and Water Board, who run the pump station, objected to the Corps of Engineers plan to build the floodwall right up to the wall of the pump station. They argued that the wall of the pump station was not strong enough to withstand the force of the water if it backed up in the canal, and would fail with the result that the city would flood when the wall failed. Of course the net result was that the city flooded as the water poured through the gap. Nevertheless, the relief of pressure in the canal may have prevented the floodwalls and levees elsewhere on the canal from failing.

**Figure 53.** End of floodwall on Orleans Canal just north of I-610 overpass near Marconi Ave. (Stop 9)
