Hurricane Katrina - What Happened?

Tulane University
Field Trip
1 Year Anniversary Edition
August 29, 2006

Levee Breaches in New Orleans during Hurricane Katrina

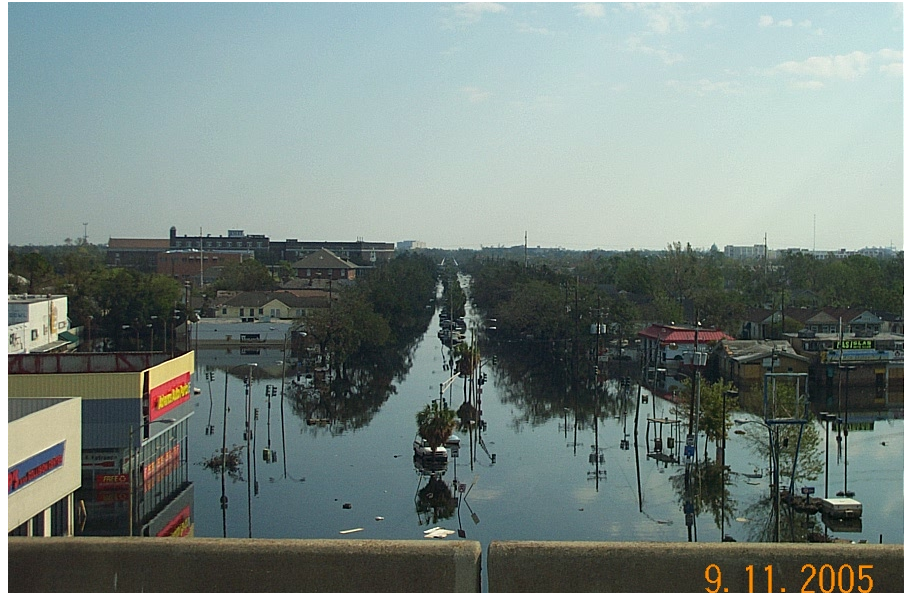
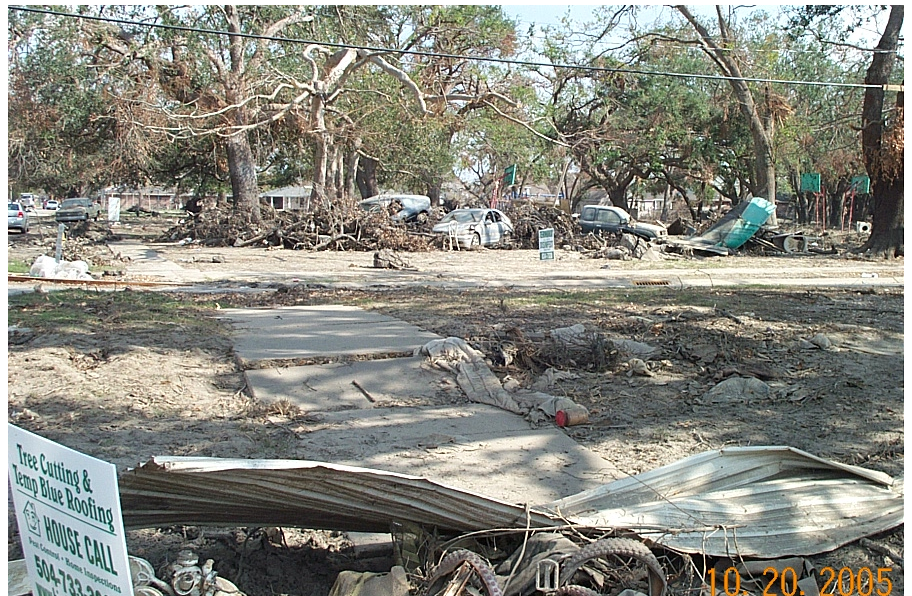
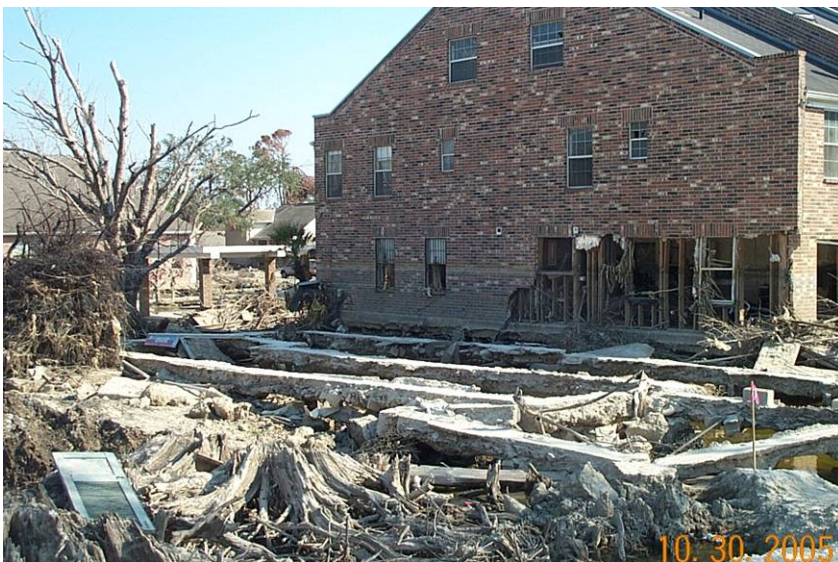
Photos - Top - looking north from I-10 overpass over Carrollton Ave. Middle - cars and other debris in park on Fleur de Lis near 17th St. Canal breach. Bottom - missing house and Cypress stumps at 17th St. Canal Breach (photos by Stephen Nelson)

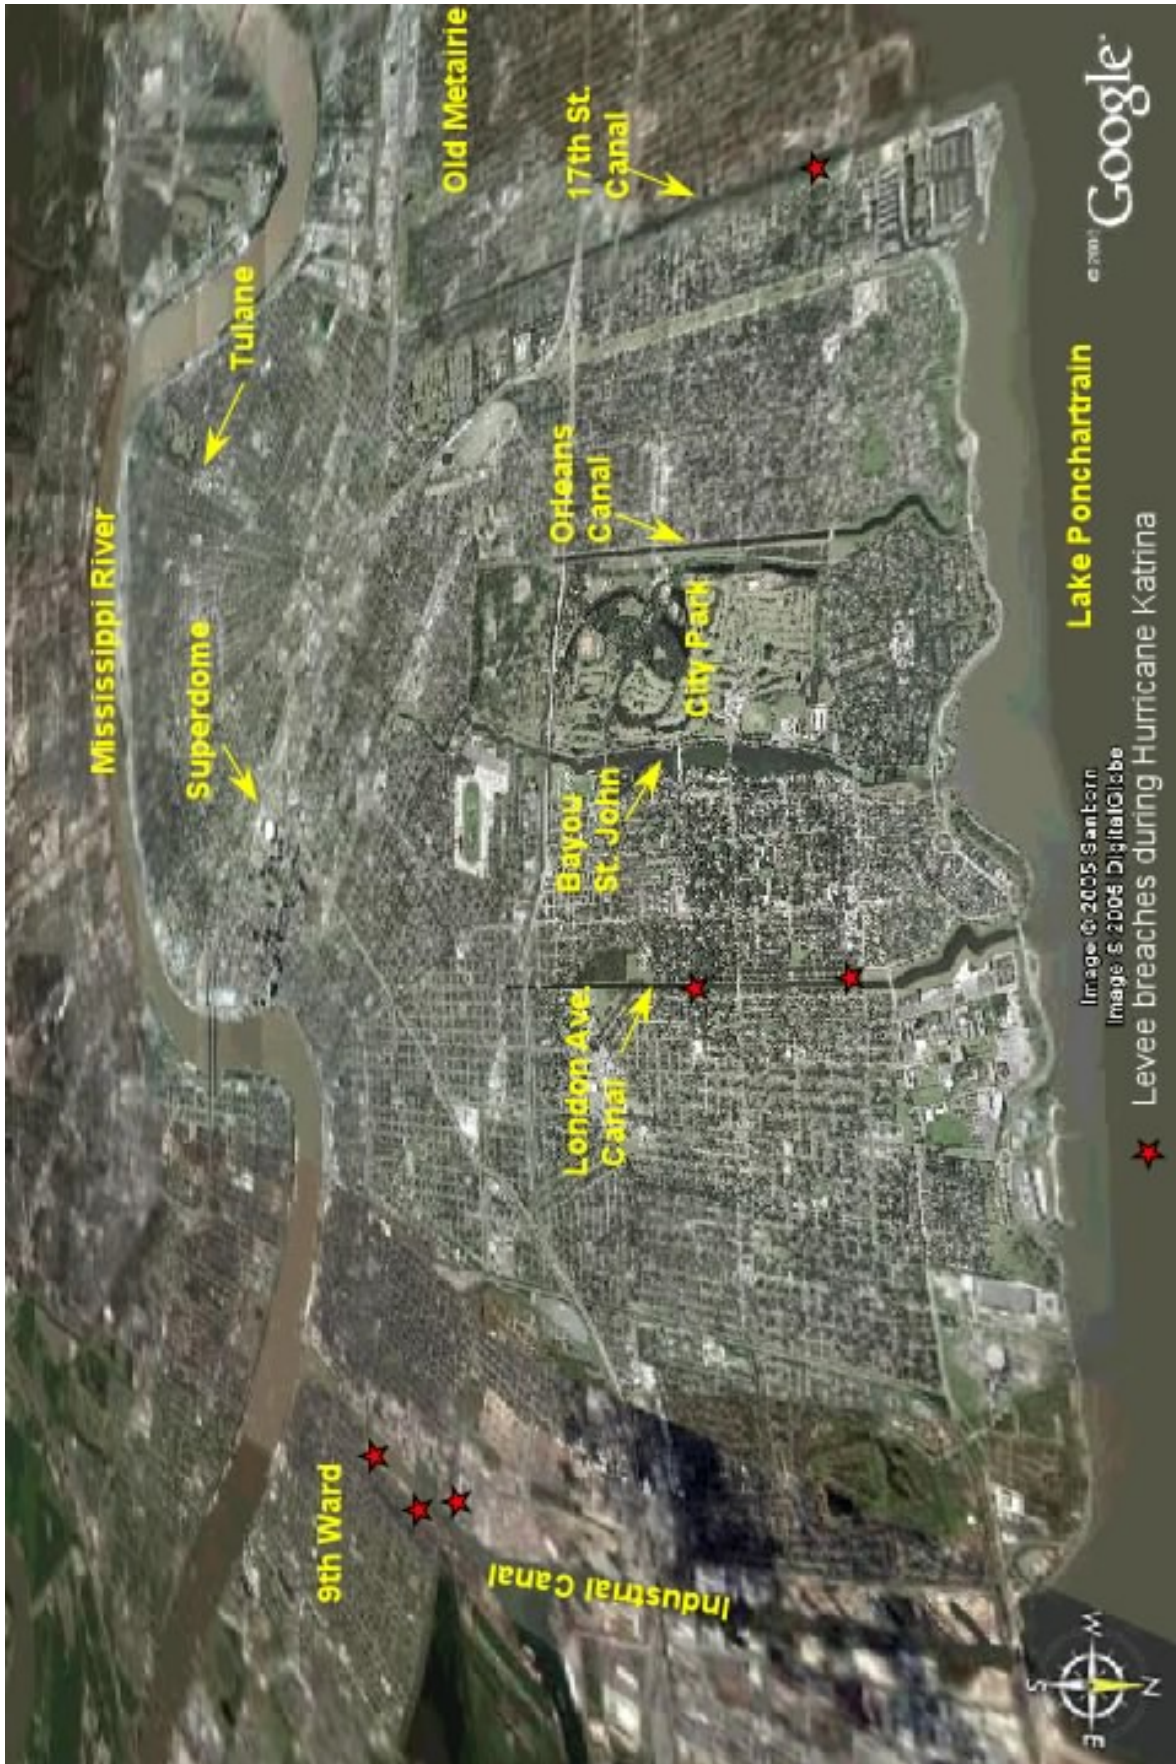
Figure 1. Google Earth oblique view of New Orleans showing location of levee breaches and important geographical features.

2 breaches on the east side of the Industrial Canal - between N. Galvez & N. Roman Streets and at Florida Ave.
Flooded Lower 9th Ward.

2 breaches on the west side of the Industrial Canal near France Road.

2 Breaches on the London Avenue Canal, one near Mirabeau Ave. & Warrington Drive and the other near Robert E. Lee Blvd. & Pratt Drive. These breaches flooded parts of New Orleans near the west side of the Industrial canal and throughout Gentilly.

1 Breach at the 17th St. Canal near Belaire Drive between Stafford Place & 40th Street
Flooded Lakeview, Mid City, Old Metairie, Jefferson, & parts of Uptown

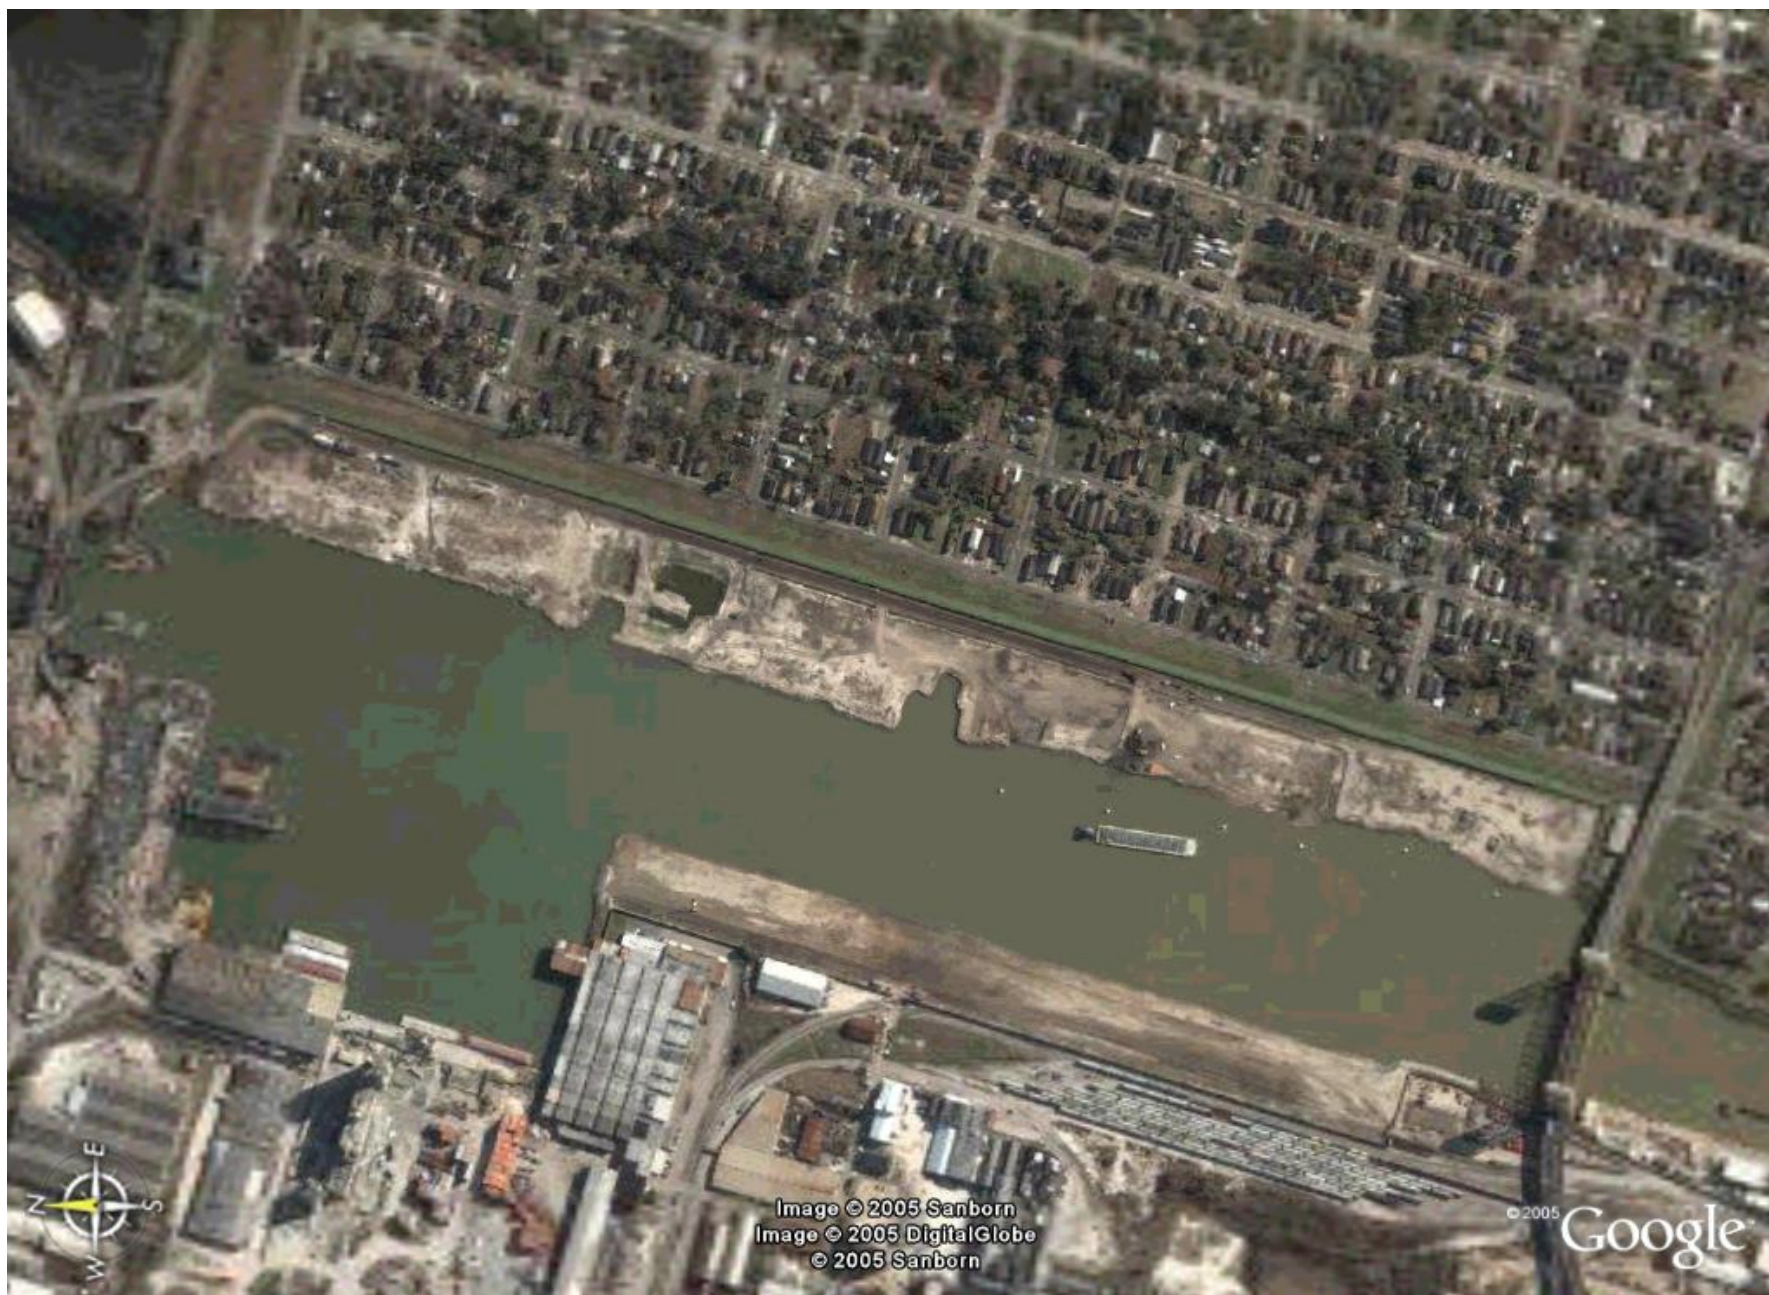
Figure 9. Satellite image of the area along the Industrial Canal where the levee was later breached during Hurricane Katrina. (Source - Google Earth)

Although the Interagency Performance Evaluation Task Force (IPET, 2006) suggested that the main cause of failure here was the result of the surge waters in the Industrial Canal overtopping the floodwall and eroding away the levee on the protected side, the Independent Levee Investigation Team (ILIT, 2006) disputes this. They do agree that erosion of the levee on the protected side could have contributed, but their analysis indicates that the geological conditions present in the subsurface along with the shallow depth to the tip of the sheet pilings resulted in hydraulic piping beneath the sheet pilings which undermined the levee and caused it and the floodwall to collapse. Two layers of highly permeable marsh deposits occur at a shallow depth below the levee (Figure 16). According to the analysis of ILIT (2006), the added pressure in the canal forced water through these permeable layers and out at the toe of the levee on the protected side, thus removing support for the floodwall and levee.

Stop 1 is in the Lower 9th Ward, where we can see into, but not enter, the breach repair. All of the broken floodwall and most of the remaining floodwall have been removed as of mid-February, 2006, and a new floodwall has been completed as of mid-June. The new floodwall rises to an elevation of 15.5 feet above sea level. The floodwall present at the time of Katrina rose to only 14 feet above sea level. The old floodwall was an I-wall that was cemented into $\frac{3}{4}$ " – thick steel sheet pilings that extended to a depth of 8 feet below sea level (Figure 15). The new floodwall is the much more stable T-wall design, which, in cross-section looks like an inverted T.

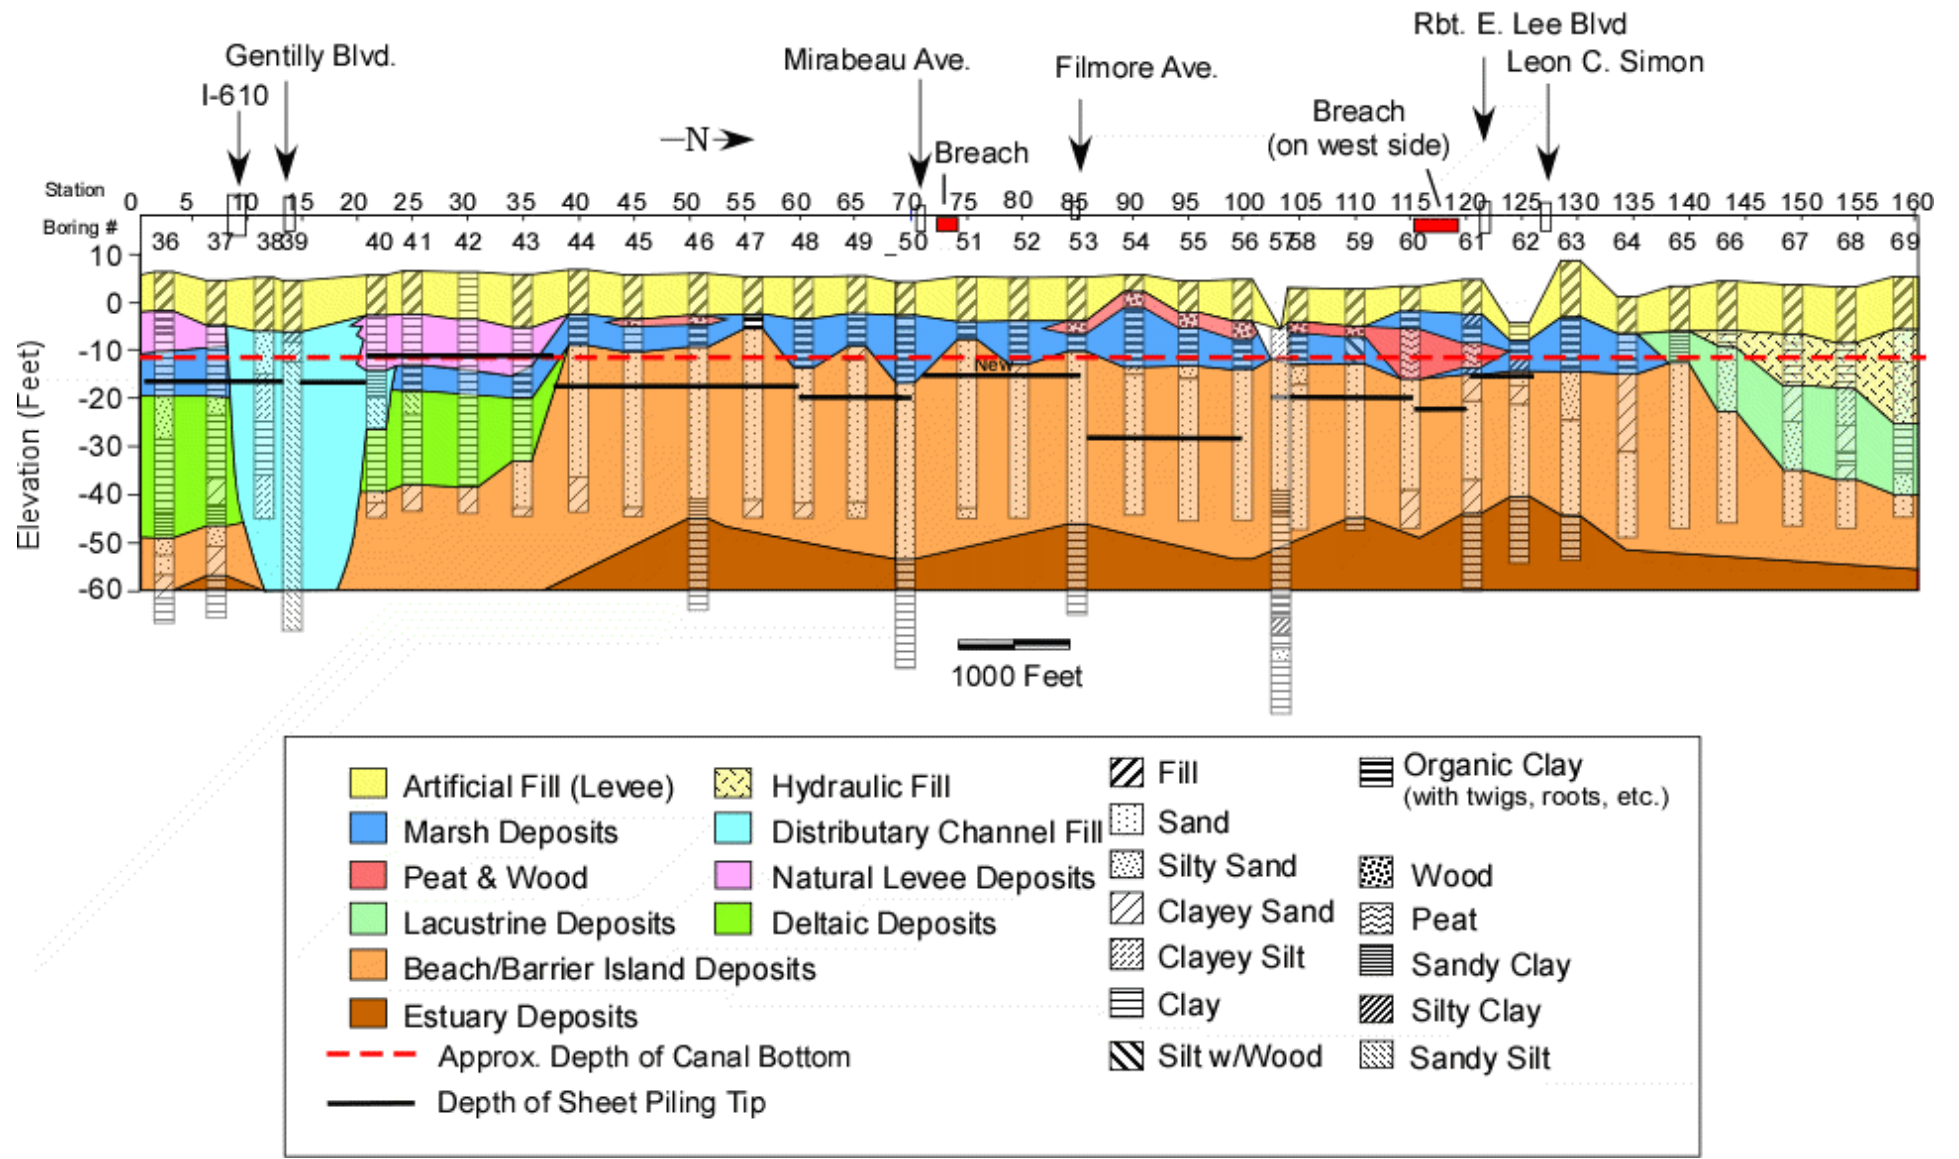
Figure 19. Geological cross-section along the east side of the London Avenue Canal constructed from data in U.S. Army Corps of Engineers (1989).

Sand is a highly permeable material. This means that water can easily be transported between the sand grains, especially when the weight due to overlying water is increased due to the added height of the water column during a storm surge. This increases the pressure and could force the water through the pore spaces in the sand and back up to the surface on the other side of the levee. If enough flow takes place the sand will be picked up by the flowing groundwater and eventually form an underground channel. This could undermine the levee and cause it to collapse. The principle is illustrated in Figure 20 with a simple thought experiment. The underflow (called seepage or siphoning) is the apparent cause of the collapse at this section of the London Ave. Canal. The "As built" design specifications indicate that the sheet pilings (which should form an impermeable barrier to pressure induced flow in the sand) were placed to a depth of 14 feet below sea level (U.S. Army Corps of Engineers, 1994), one can see from the cross section in Figure 21, that the water still has a path back to the surface if it flows as groundwater beneath the sheet pilings. Note that in order to prevent such siphoning, the sheet pilings would need to be placed to a depth of about 50 feet below sea-level where they would penetrate a layer of clay. Clay, because the individual mineral grains stick together and thus reduce pore space and interconnection between pores, is much more impermeable than is sand.

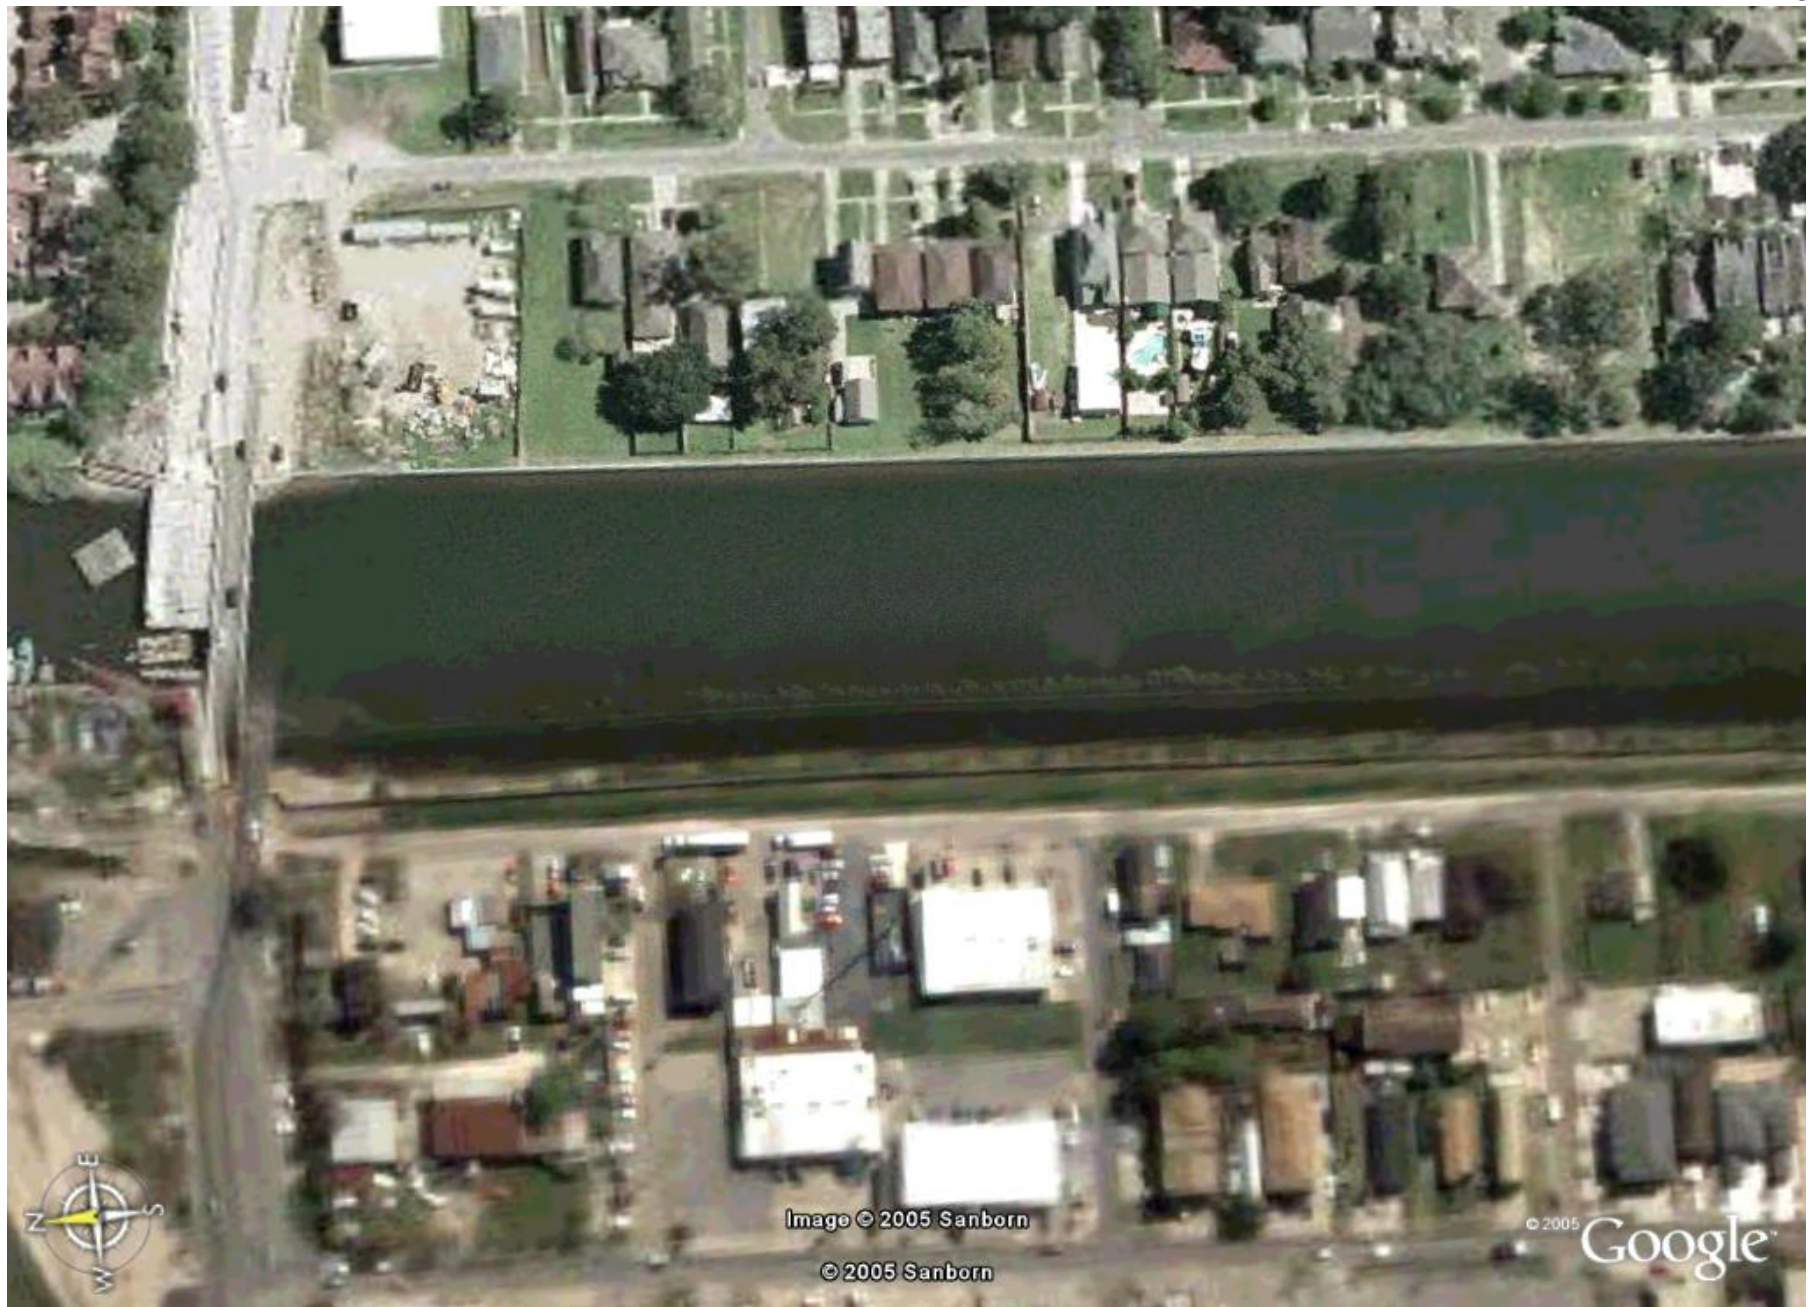
Figure 29. Satellite image of the area along the 17th Street Canal near the Old Hammond Highway Bridge (under construction), where the levee was later breached during Hurricane Katrina (stop 5). (Source - Google Earth)

Stop 5 is in the area of the breach on the 17th St. Canal (also called the Metairie Outfall Canal). According to data presented by IPET (2006) this breach started at about 6:30 AM and was completely open by about 9:00 AM on August 29. It was reported to WWL radio by the New Orleans Fire Department at 11:00 AM. The breach occurred along a 200 ft. section of the levee on the Orleans Parish side of the canal. Figure 29 shows an aerial view of the breach area before Katrina and Figure 30 shows approximately the same area on August 31 as water was still flowing through the breach into Lakeview.
